# Amtranet Limited (New Buildings 2)

14 December 2023

## Structural Inspection Report

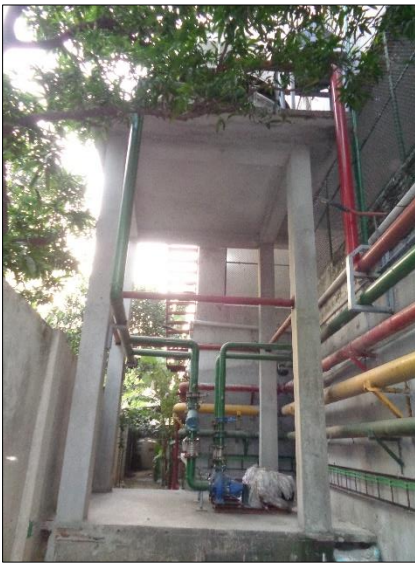
Cooling Tower Building-2

**Observation-15:** Lack of design documents. (Utility Building, Cooling Tower Building-4, Cooling Tower Building-2)

**Description:** During inspection, a full set of design documents was not available for the Utility Building and Cooling Tower Building-4. Only a set of structural drawings for the Cooling tower Building-4 and Utility building where all the required information has not been provided for the Utility Building. No documents were found for the Cooling tower Building-2. The building engineer is required to survey the structures and prepare accurate as-built drawing.
