# Refat Garments Ltd (Extension 2)

144,147,148 Narashingpur, Ashulia, Savar, Dhaka.

20 February 2024

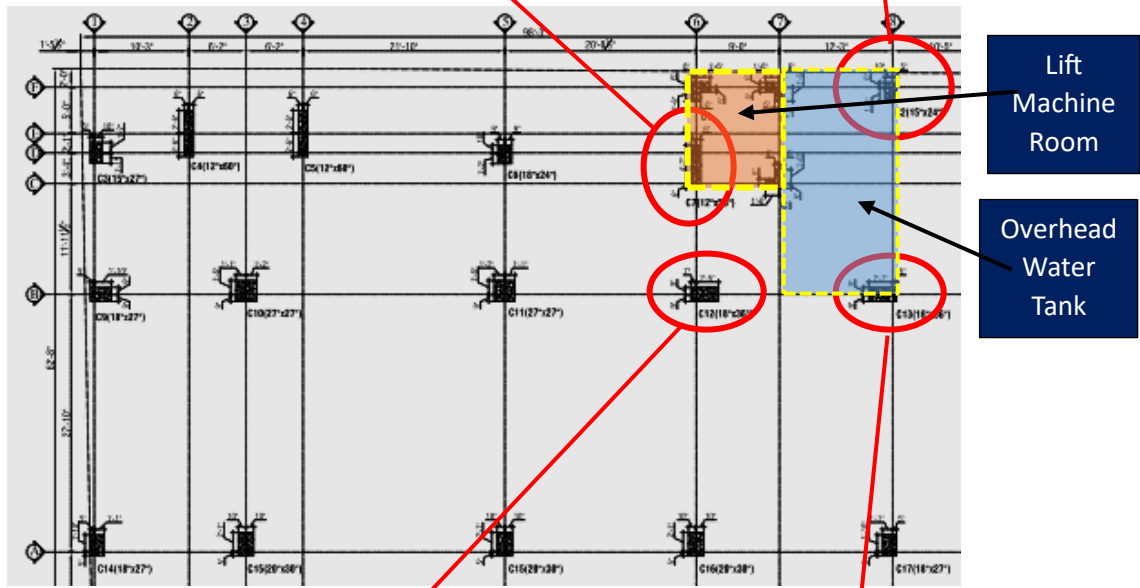
Column Layout

Column size reduced above the roof  
15'X24" to 15' X18"

**Description:** The size of 4 columns below the lift machine room and overhead water tank has been reduced from the roof level. 100 mm thick buildup was found on the 1st floor which was not incorporated in as-built drawing & design report. Mismatch found in concrete compressive strength between as-built drawing and design report (For column: 4500 psi in design report but 4000 psi in drawing, for beam & slab: 3500 psi in design report but 3000 psi in drawing). Live load was mentioned in the design report but no load plan was available during inspection.

The building engineer is required to revise the as-built drawing as per onsite condition, produce the load plan as per BNBC minimum requirement, update the design report as per the revised as-built drawing and load plan and submit all documents to RSC for review.
