# Colour & Co. Ltd.

Tepirbari, Sreepur, Gazipur

3 March 2024

## 2. Observations

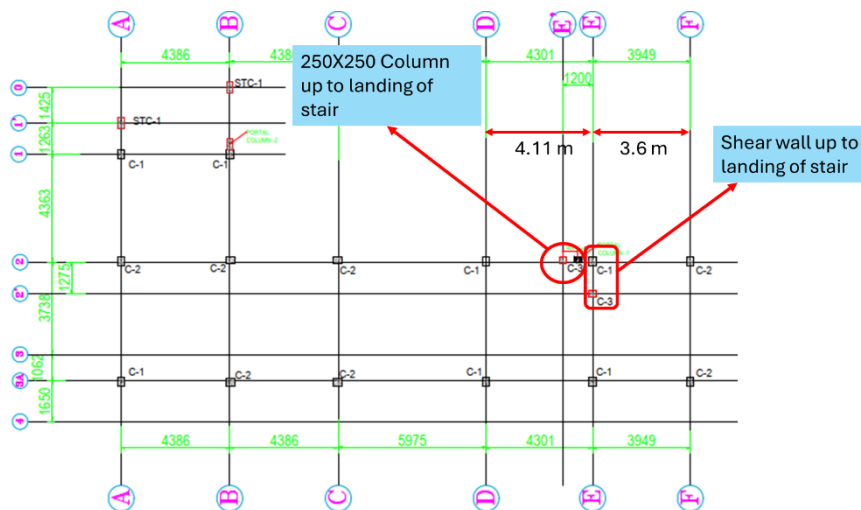
**Observation-7:** Mismatch in as-built drawings (Building-2)

Missing schedule of C3 Column

**Description:** During the inspection, a few mismatches were found in the as-built drawing which is given below.

- Mismatch was found in the marked grid distances.
- A shear wall was found supporting the landing of the stairs. In structural drawing, two columns are shown in place of the shear wall.
- In grid 2-E', C3 column is shown. However, a 250X250 RC column was found in place of the C3 column. Another 250X250 RC column was found supporting the landing of the stairs in place of the brick pier shown in the drawing. Details of C3 column are missing in the column schedule.
- Mismatches were found between the grade beam and floor beam layouts and sections.

The building engineer is required to survey the whole structure and update the as-built drawings as per site conditions.
