# Echotex Ltd. (Extension 2)

Chandra Pollibiddut, Kaliakoir, Gazipur-1751, Bangladesh

11 March 2024

## 2. Observations:

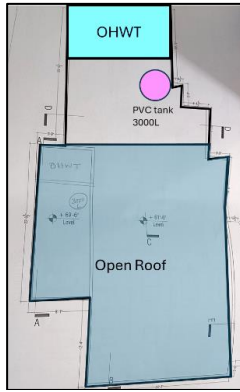
Roof plan

## Observation 10: Inconsistencies in the as-built drawing (Old Utility Building)

**Description:** During the inspection, the mismatch was found in the as-built drawings of the Old Utility building. On the roof, an overhead water tank and a PVC water tank (3000L) were found not mentioned in the drawing. The structural drawing of OHWT was found missing. Floor build-up and false slab are not mentioned in the drawing. The rooftop of the marked portion is a steel shed. No structural details were found for the steel portion. There is a steel stair with the building. No drawing was available for the stairs. There is a discontinuous beam at the rooftop. No rooftop beam layout/structural details were provided. The building engineer is required to survey the structure, prepare accurate as-built drawings, and submit to the RSC.

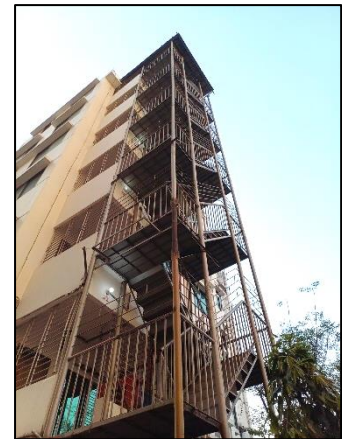
Steel stair

**Description:** During the inspection, apparently non-engineered steel stair was found. The members are apparently inadequate, lack of lateral stability and improper steel connections were observed. The foundation of the structure is also not clear. The building engineer is required to check the lateral stability of the structure, prepare an Engineering Assessment (EA) and submit it to the RSC for review.
