Fakir Apparels Ltd. (Extension)

A-127-131,135-138,142-145, B-501-503, BSCIC Hosiery Ind. Estate, Fatullah, Narayanganj
(23.622441, 90.480205)

14 November 2023 & 1 January 2024

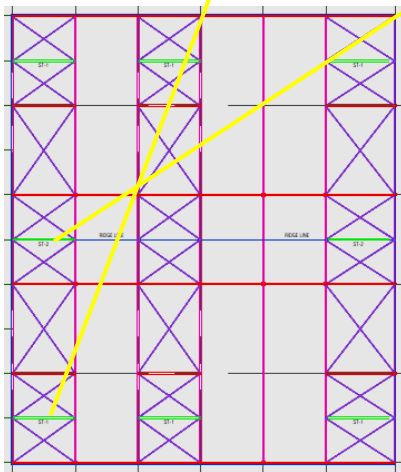
Proposed strut layout

Description: The factory has prepared the DEA of the shed. As per the recommendation of the DEA, some retrofitting works are suggested but no retrofitting work was carried out. The building engineer is required to submit the DEA report to RSC for review before the start of retrofitting work.

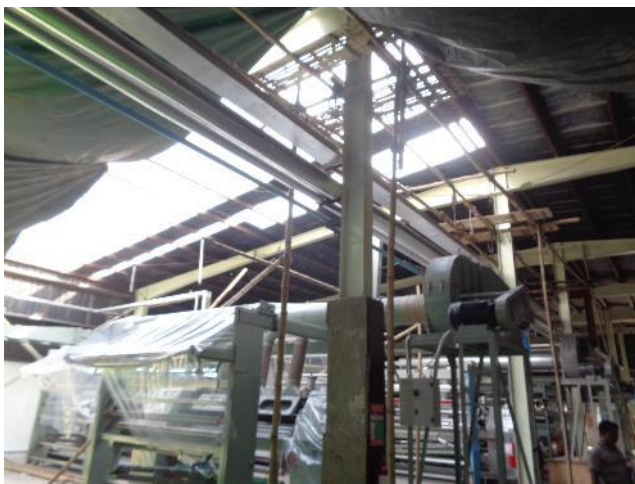
Observation-19: Remediation work raised from fire incident (FAL-33, Washing and Dyeing Finishing)

Description: At the time of inspection remediation work due to the fire incident was ongoing at the time of inspection. The building engineer is required to complete the remediation work as per RSC accepted drawing and timeline.

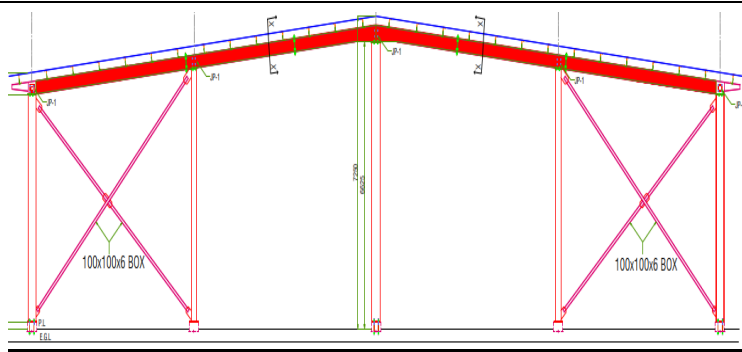
Proposed wall bracing and rafter retrofitting

No compression strut in the long direction

Description: The factory has prepared the DEA of the shed. As per the recommendation of DEA, some retrofitting works were suggested but no retrofitting work was carried out.

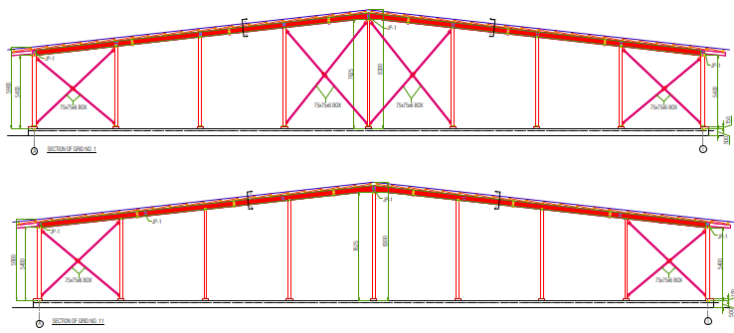
Proposed wall bracing and rafter retrofitting

No compression strut in the long direction

Description: The factory has prepared the DEA of the shed. As per the recommendation of the DEA, some retrofitting works were suggested but no retrofitting work was carried out.

Building engineer is required to submit the DEA report to RSC for review before the start of retrofitting work.

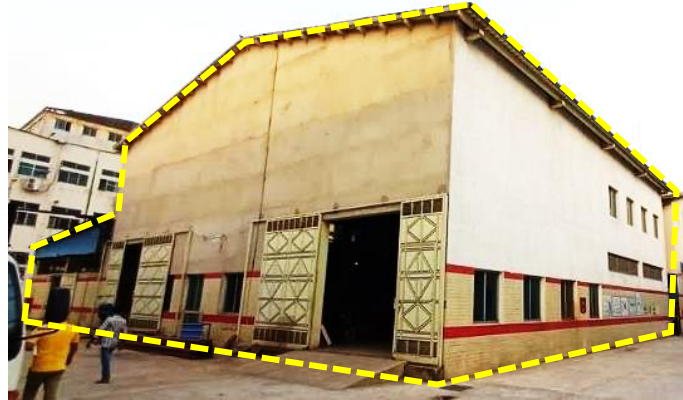
Observation-25: Lack of design documents (FAL-36).

Description: As per BNBC, every building or structure designed shall have its design documents prepared following the provision of Section 1.9.1. During the inspection, the design report and soil test report were not available on site.

The building engineer is required to prepare a set of design documents including as-built drawings, live load plan and a design report based on in-situ material strength and software-based analysis which shall be prepared in compliance with section 1.9.1, part-6 of BNBC.

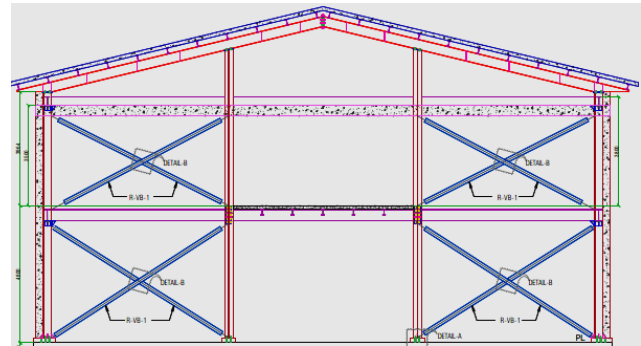
Proposed wall bracing

Description: The factory has prepared the DEA of the shed. As per the recommendation of the DEA, some retrofitting works are suggested but no retrofitting work was carried out.

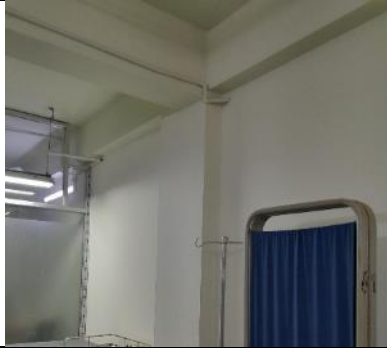
Wrong column retrofitted

Description: During the inspection, a mismatch was found between the drawing and on-site condition. As per the drawing, the wrong column was found retrofitted which was marked in the figure. Retrofitting details of column and foundation were found missing in the drawing. Also, external steel stairs were found connected with structural members of Medical & day care building. The building engineer is required to survey the whole structure and update the as-built drawings and perform Detail Engineering Assessment (DEA).

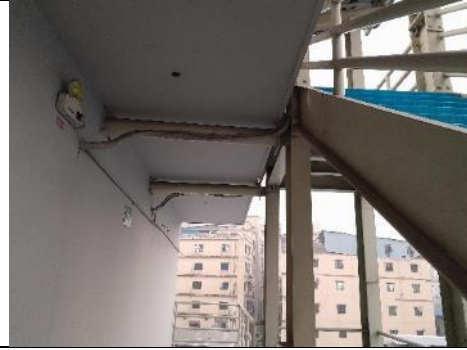
External Steel stair connected with Medical & daycare building.

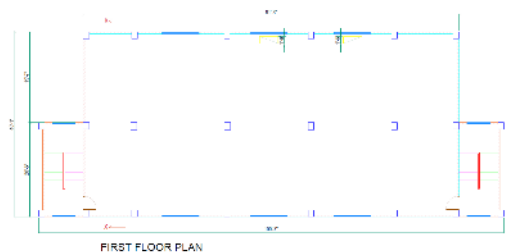
As built architectural drawing

Floor buildup below LT panels at 1st floor

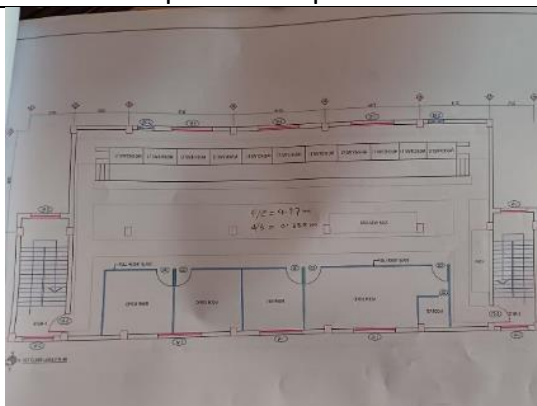
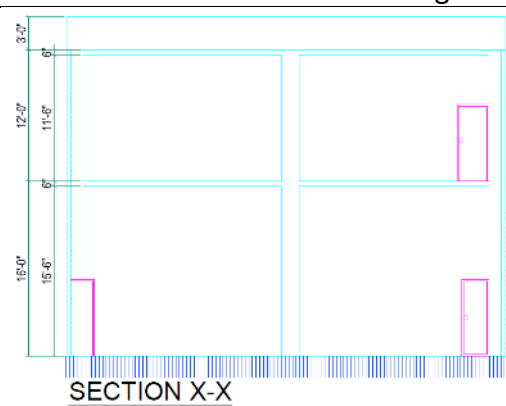
As built architectural drawing

Floor to ceiling height (4.27 m)

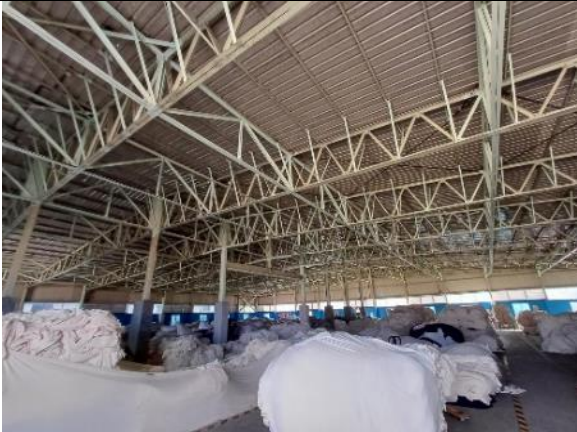
Steel truss along both directions

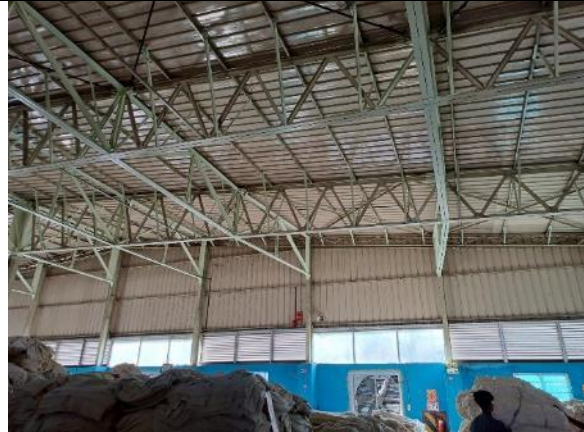
Misalignment of steel truss

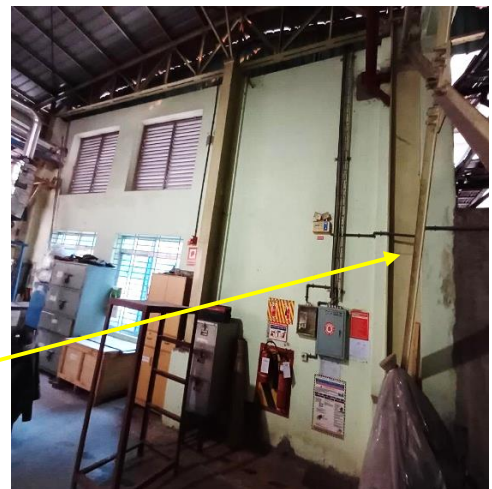
Orientation mismatch - marked columns

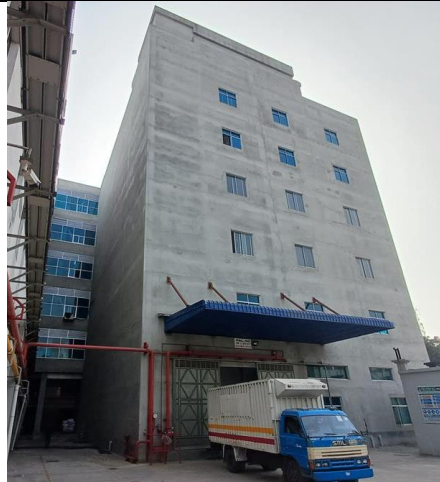
Observation-48: Lack of design documents (FAL-50).

Description: As per BNBC, every building or structure designed shall have its design documents prepared following the provision of Section 1.9.1. During the inspection, the design report and soil test report were not available on site.

The building engineer is required to prepare a set of design documents including as-built drawings, live load plan and a design report based on in-situ material strength and software-based analysis which shall be prepared in compliance with section 1.9.1, part-6 of BNBC.
