# TEXTIL FASHIONS LTD.

Holding no6/1, Plot -168, Soydana, Gazipur

4<sup>th</sup> November, 2015

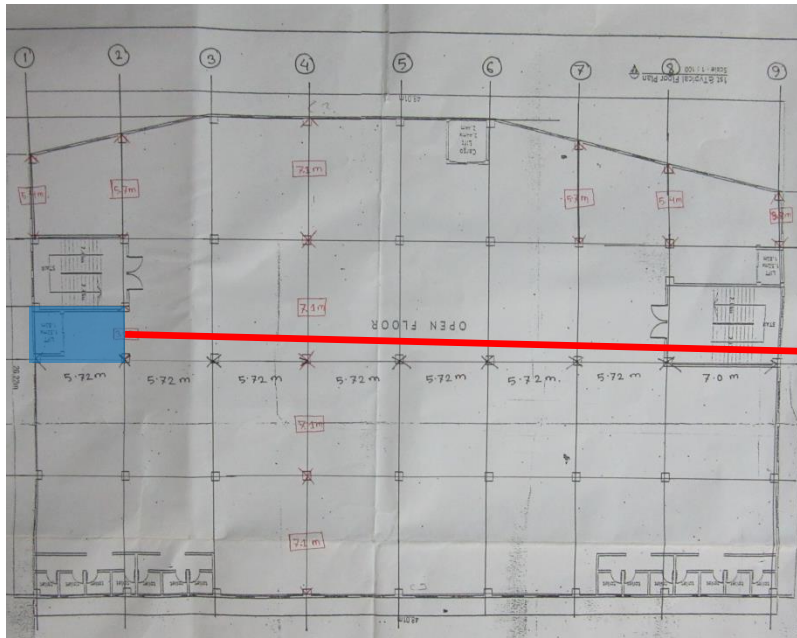
Provided Structural Drawing

Structural drawing shows 4 columns in north–south direction instead of 5 columns which is observed at site and as shown on the architectural drawing.
