INITIAL FIRE SAFETY INSPECTION REPORT

KC Apparels Limited

RSC ID: 24991

Date: 11-Jun-2024

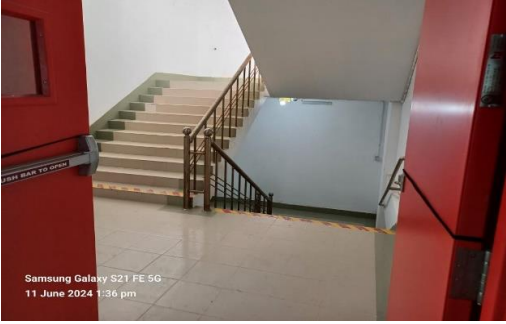
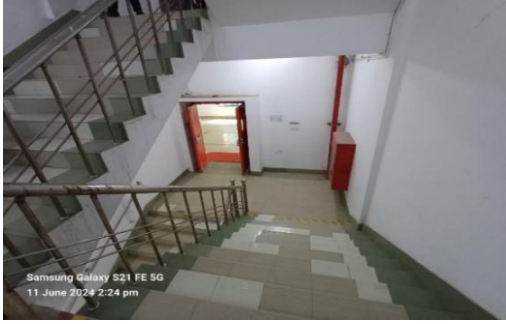
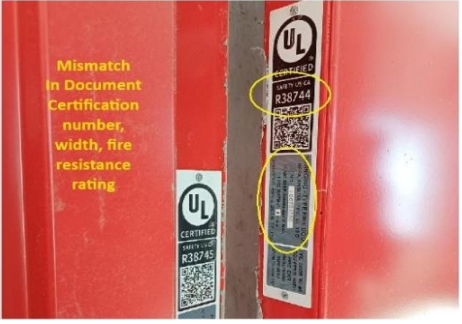
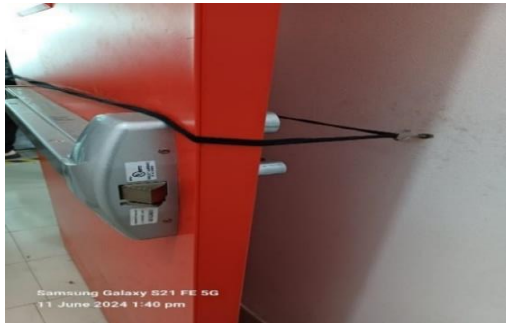
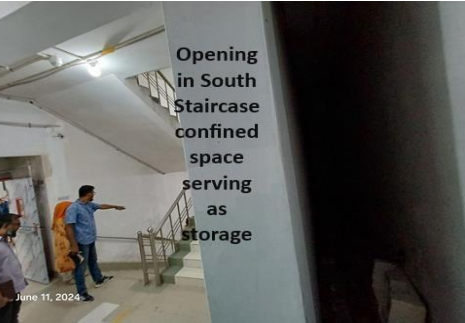
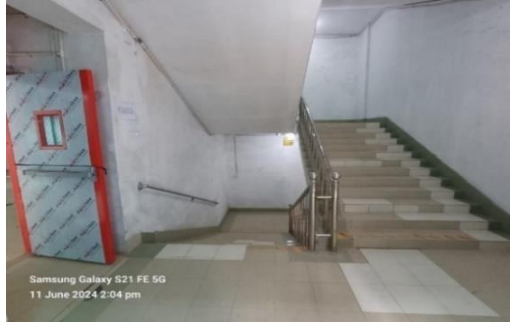
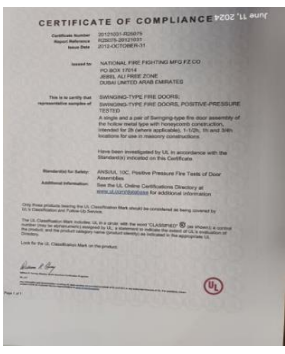
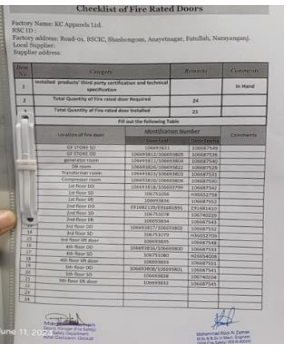
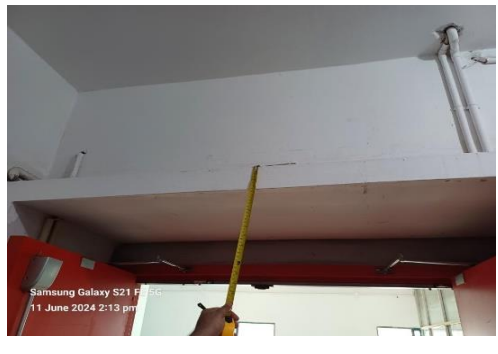
SI No.	Category	Findings	Required Action	Remediation Time Frame
F-1	Fire Rated Construction	<p>The exit stairs are not separated from production and storage areas and other spaces on each floor by fire rated construction due to incomplete installation of fire doors, unsealed penetrations and openings.</p> <p>Moreover, credible documents or certificates are also not found for fire doors installed in south staircase during the visit. certificate tags were missing in a few fire door leafs of south exit. A few door accessories are also missing.</p> <p>Non-functional fire doors are found in both the north and south exits. Fire doors are not interfaced with FACP and doors are found held open manually by external sources.</p> <p>Above fire door, slab thickness is found 3.5 in and does not provide required fire resistance rating.</p> <p>Location: Main Building: North & South Exit Stairs.</p>	<p>The exit stair enclosure shall be provided with a minimum 1-hr fire resistance rating for buildings with 3 or fewer stories and a minimum of 2- hr. fire resistance rating for buildings 4 or more stories. Provide 0.75 hr. fire rated door and seal all penetrations and openings by 1 hr. fire rated fire rated barrier construction for building with 3 or fewer stories. Provide 1.5 hr. fire rated door and seal all penetrations and openings by 2 hr. fire rated fire rated barrier construction for building with 4 or more stories.</p> <p>Ensure that the fire doors are self-closing and positive latching and that they are provided with fire exit (panic) hardware where serving production floors. If fire doors are required to be held open for functional reasons, provide automatic closing devices interfaced to the fire alarm system.</p>	Within 3 Months

<p>Mismatch in Document Certification number, width, fire resistance rating.</p>

<p>Opening in South Staircase confined space serving as storage</p> <p>June 11, 2024</p>

<p>Penetration from fire door to adjacent room</p> <p>Samsung Galaxy S21 FE 5G 11 June 2024 1:43 pm</p>

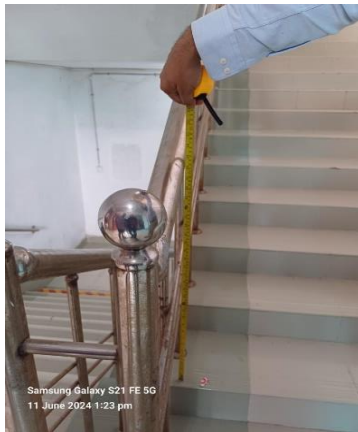
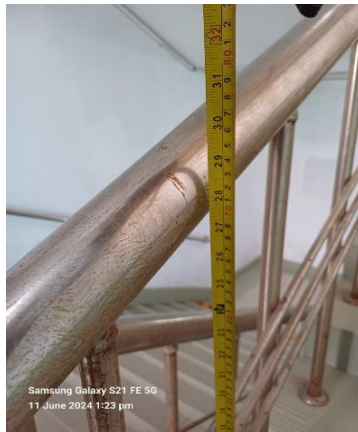
SI No.	Category	Findings	Required Action	Remediation Time Frame
F-16	Means of Egress	Handrails are not provided as per standard as maximum height less than the limit. (30") Location: RCC Building- 01 Production Building	Handrails shall have a minimum height of 865 mm (34 in.) and a maximum height of 965 mm (38 in.) as measured from the leading edge of the tread.	Within 1 Month

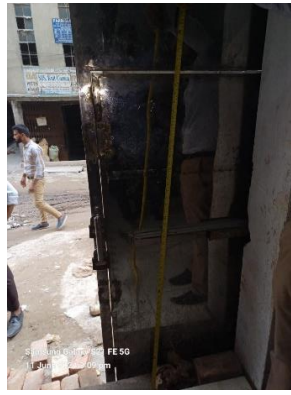
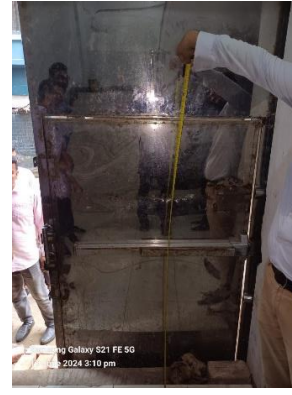
SI No.	Category	Findings	Required Action	Remediation Time Frame
F-17	Means of Egress	Height of south final exit is 4'-7" as it is obstructed at bottom. Height of north final exit is 5'-4". Both the final exit height is less than the minimum height requirement of door in a means egress	Provide doors in a means of egress having a minimum height of 2.0 m (79 in.).	Immediate

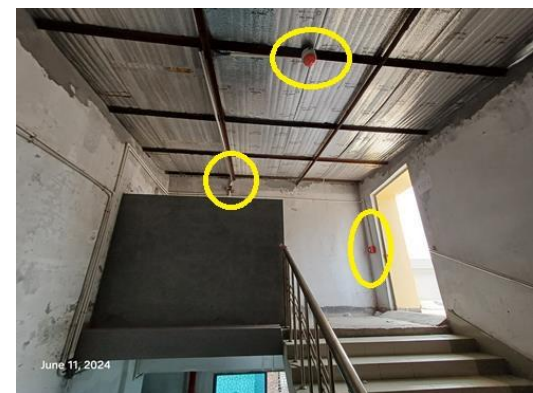
SI No.	Category	Findings	Required Action	Remediation Time Frame
F-24	ITM FADS	Inspection, testing and maintenance for the fire detection and alarm system was not in accordance with standard.	Inspect, test and maintain the fire alarm system and keep written records on-site, in accordance with Table-14.3.1 of NFPA 72.	1 Month after installation
F-25	Fire Protection System	<p>Installation work of the required standpipe system is on-going. Proposed drawing is not found during the visit.</p> <p>Standpipe installation requires detailed review to confirm compliance with NFPA 14, 20 and RSC standards.</p> <p>Location: All floors of RCC building-1</p>	<p>Install a standpipe system in accordance with RSC standard 5.4 and NFPA 14. A class III system shall be installed in buildings with the highest occupiable floor 10 m (33 ft.) above grade or more. A class I system shall be permitted in buildings protected throughout by an approved automatic sprinkler system.</p> <p>Submit the as-built standpipe system drawing to RSC for review. Once reviewed, install or modify the standpipe system throughout the building in accordance with RSC standard and NFPA 14,20,22 and 24. After installation the owner shall contact the RSC for witness of conducting the final acceptance testing of the standpipe system.</p>	Design within 2 Months, installation/modification on within 4 Months

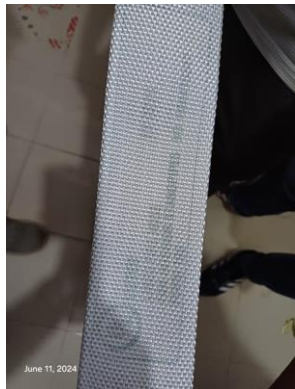
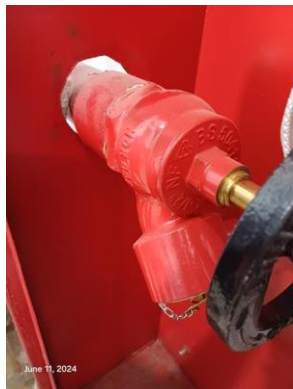
SI No.	Category	Findings	Required Action	Remediation Time Frame
F-26	Fire Protection System	Installation work of fire pump is on-going. Fire pump installation requires detailed review to confirm compliance with NFPA 20 and RSC standards.	<p>Submit as-built drawings, testing records, equipment certification and other relevant documentation to the RSC for review and approval.</p> <p>Submit the standpipe system drawing to RSC for review. Once reviewed, install or modify the standpipe system throughout the building in accordance with RSC standard and NFPA 14 and 20. The factory management shall contact RSC to conduct the final acceptance testing after the installation, testing & commissioning.</p>	Design within 2 Months, installation/modification on within 4 Months
