# Fuli Industrial Ltd.

Plot # 148-151, Dhaka EPZ (Old Zone), Ashulia-1349, Savar, Dhaka.

25 August 2024

## 2. Observation:

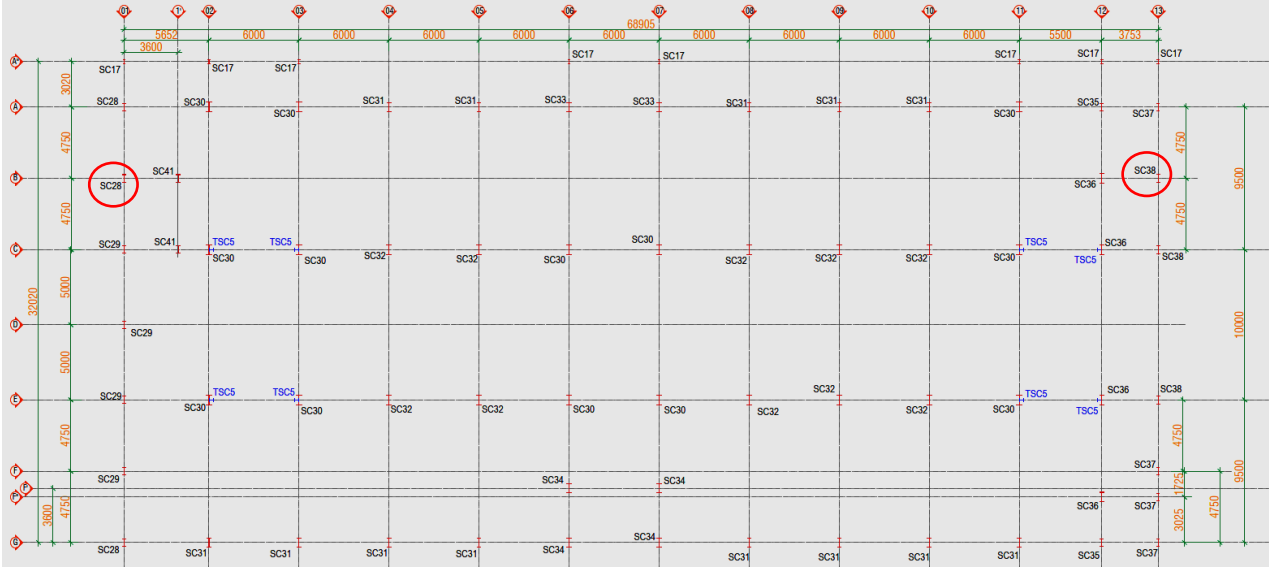
Portal frame

**Description:** In the provided as-built drawing portal frame was shown only at four locations. However, the portal frame was found in twelve locations on each floor.

The building engineer is required to survey the full structure and prepare complete as-built structure drawings. Also, provide construction drawings as the reference for the foundation.
