Southeast Sweaters Ltd. NEW – (Extension)

Structural Inspection Report

Warehouse Building: 3-storied (G+2) prefabricated steel building.
ETP Building: Single-storied RC building.

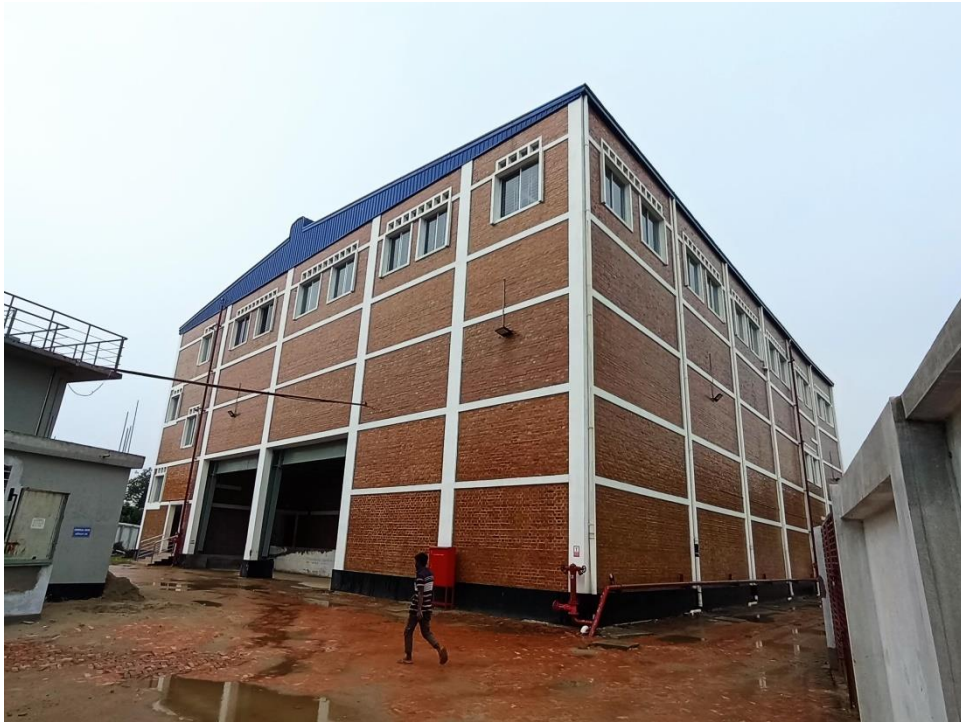
Observation 2: Discrepancy in as-built drawing (Warehouse Building).

Description: The thickness of rafter R-203 was measured as 8mm instead of 10 mm. The building engineer is required to survey the whole structure and update the as-built drawing.
