SP Garments Ltd (Extension 2)

7 October 2024

1. Building Information

1. This is a two-storied (G+1) building. The ground floor has an RC frame, and the first floor is a prefabricated steel structure.

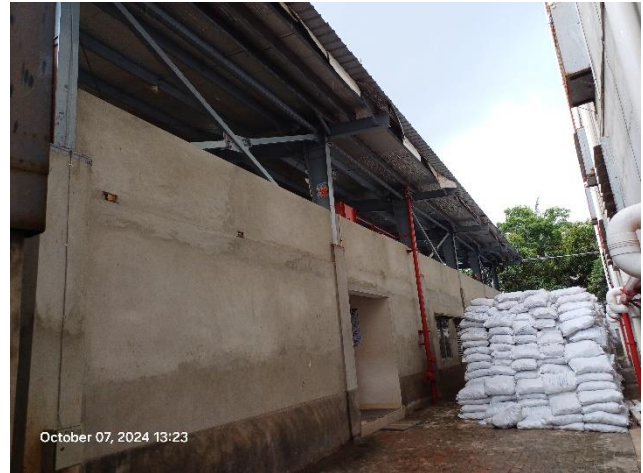
Dining Building

Observation-1: Design report required to be reviewed by RSC for lateral loading. (Dining Building)

Description: A set of design reports for the dining building was available. The design report needs to be reviewed for lateral loading.

Moreover, the marked strut members were not found on-site. The building engineer is required to survey the full structure and prepare complete as-built structural drawings. Also, the stability system should be checked, considering the strut member's position at the site.
