# Columbia Apparels Ltd - Extension

228/1 Tin Sharak, Joydevpur

6 November 2024

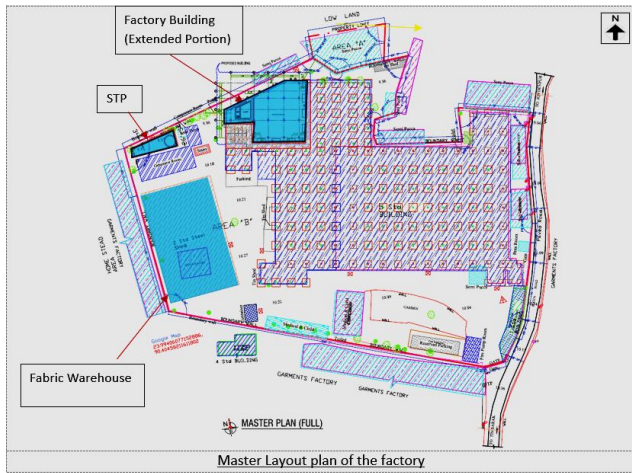
Master layout

**Observation-1:** Building permit from local authority not available. (Factory Building (Extended Portion) and Fabric Warehouse)

**Description:** During the inspection, a building permit from the local authority was not available for the Factory Building (Extended Portion) and Fabric Warehouse. The factory authority is required to collect building permits from the local authority.
