# INITIAL FIRE SAFETY INSPECTION REPORT

**FAKIR KNITWEARS LTD. (Extension - 2)**

**RSC ID: 25930**

**Date: 22 December, 2024**

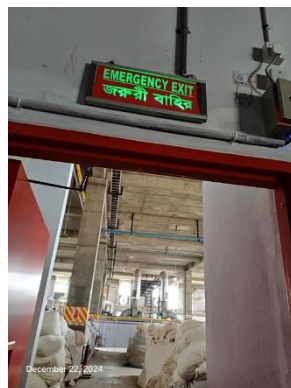
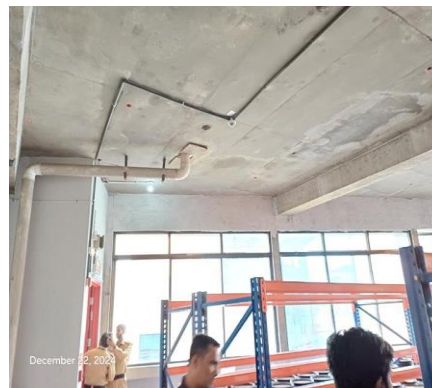
| SI No. | Category | Findings | Required Action | Remediation Time Frame |
|---|---|---|---|---|
| F8 | Fire Rated Construction | <p>Chemical storage room is not properly separated by fire-rated construction from surrounding occupancy. Location: On ground floor of building-12.</p> <p>Rooms used for subchemical storage is also not separated by fire rated construction from printing section on 1st floor .</p> | <p>Either separate the chemical storage room by 4-hr fire rated construction. Seal all penetrations and protect the openings to maintain the required fire separations for 4-hrs. Opening is not permitted for 4- hrs fire rated separation. Keep 16-points SDS of all chemicals in the storage area. Note: Construction type shall be Type-1 and separation shall be as per Table 3.2.1 of BNBC-2006.</p> <p>Or, Limit the chemical contain less than the exempt quantities as specified in Table 3.2.7 BNBC 2006.</p> | Within 3 months |

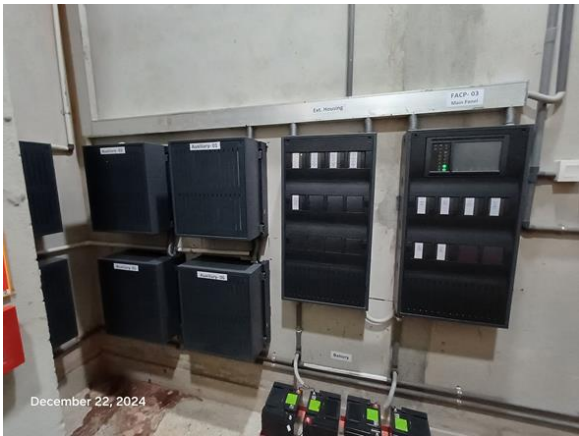
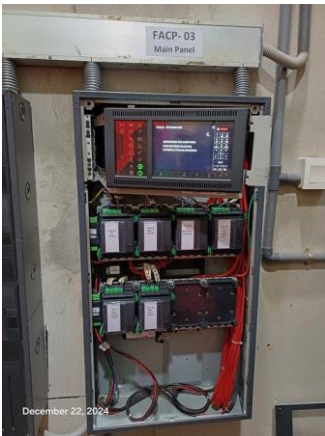
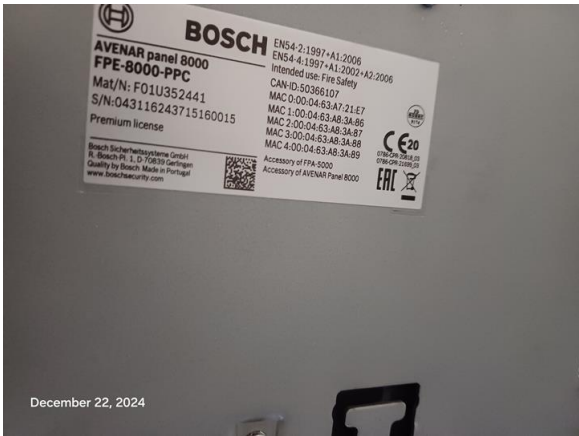
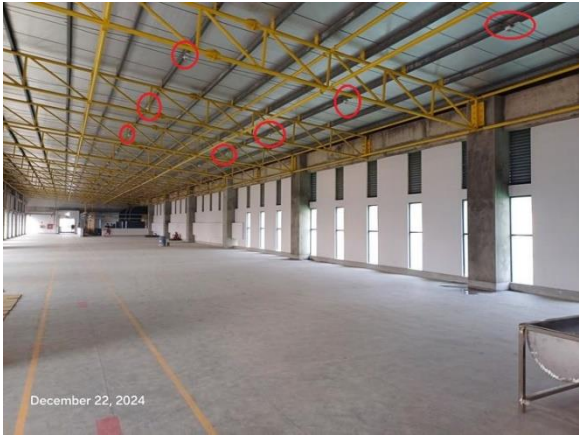
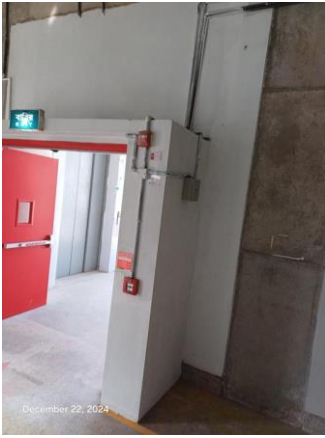
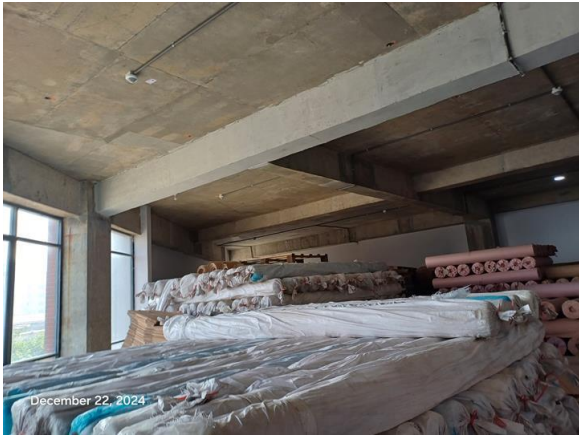
| SI No. | Category | Findings | Required Action | Remediation Time Frame |
|---|---|---|---|---|
| F-11 | Fire Alarm & Detection system | <p>Automatic fire alarm and detection system is being installed which requires detailed review to confirm compliance with NFPA 72 and The RSC Technical Guidelines (Standard).</p> <p>Location: Building-12</p> | <p>Submit the fire alarm system design to RSC for review. Once the design is reviewed, install and modify the fire detection and alarm system throughout the buildings in accordance with review comment, RSC Technical Guidelines (Standard) and NFPA 72. After installation the owner shall conduct internal testing and commissioning and then contact the RSC for witness of final acceptance testing. Also inspect, test and maintain the fire alarm system, and keep written records on-site, in accordance with Table-14.3.1 of NFPA 72.</p> | <p>Design Review within 2 months and installation/modification within 4 months</p> |

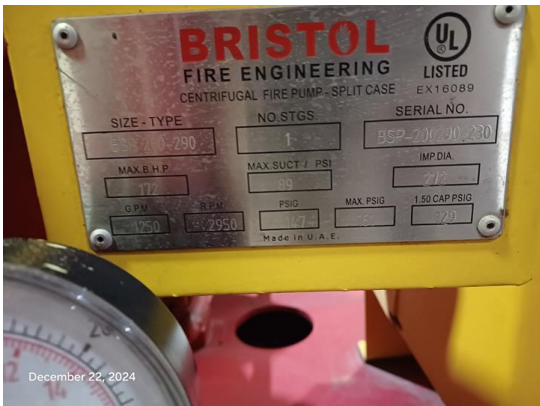
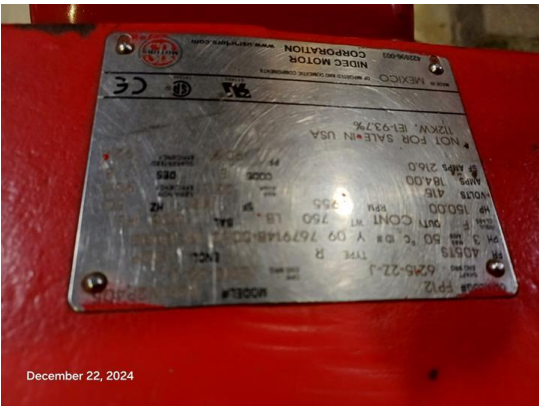
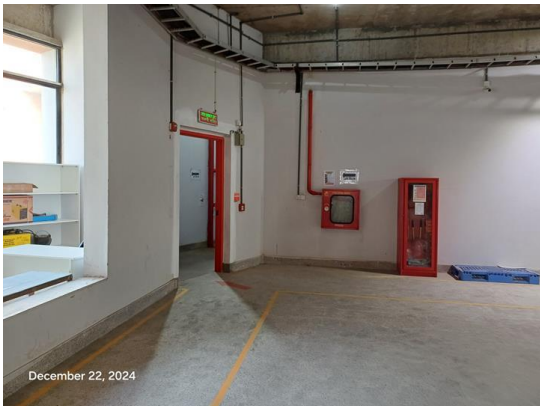
| SI No. | Category | Findings | Required Action | Remediation Time Frame |
|---|---|---|---|---|
| F-14 | Fire Protection System(ITM of fire pump) | Inspection, testing, and maintenance for the fire pump is not in accordance with NFPA 20, 25 and RSC Technical Guideline (Standard). | Inspect, test and maintain the fire pump in accordance with NFPA 20, 25 and RSC Technical Guideline (Standard) and keep written records on-site. | Within 1 Month (after installation/ modification) |

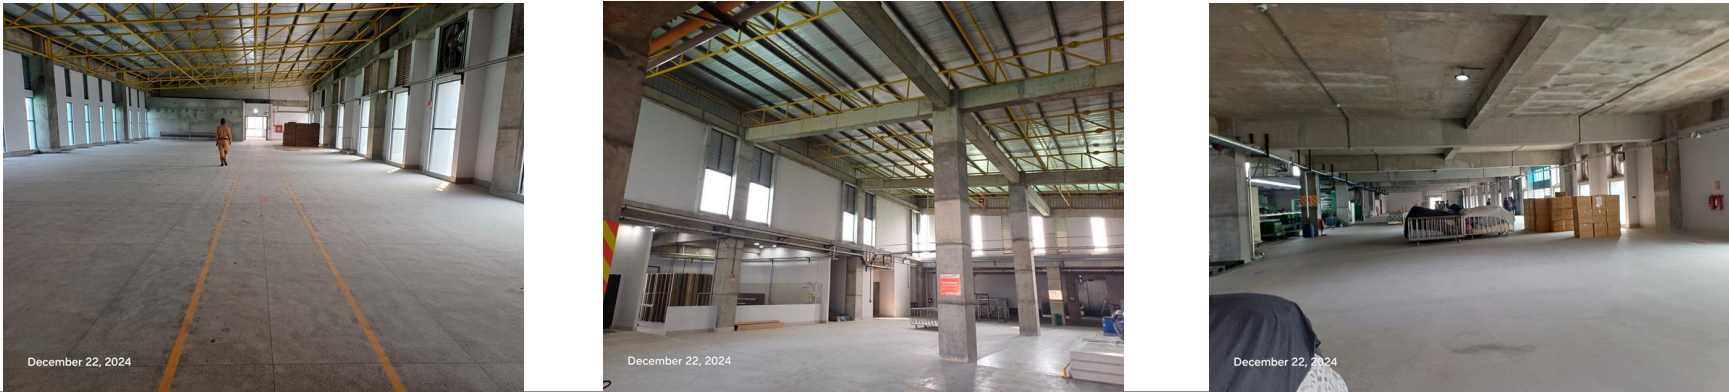
| SI No. | Category | Findings | Required Action | Remediation Time Frame |
|---|---|---|---|---|
| F-19 | Emergency Lighting | Emergency light is not provided in the steel portion on 1st & 2nd floor. Based on the number and location of emergency lights observed, adequate illumination levels are not anticipated along egress routes and at exit stairs on all floors. | Test the emergency lighting system on each floor and provide additional emergency fixtures to supply adequate illumination along the means of egress. Provide a minimum illumination of 10 lux at the floor level within exit stairs and along exit discharge paths and a minimum 2.5 lux along exit access aisles. | Within 1 month |

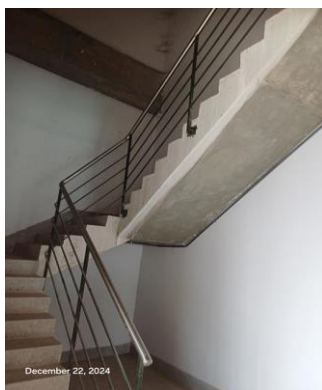
| SI No. | Category | Findings | Required Action | Remediation Time Frame |
|---|---|---|---|---|
| F-23 | Means of Egress | Handrails are not provided on both sides of the exit stairs on the 3rd floor.<br>Intermediate handrail is not provided in discharge stairs more than 2.2m wide.<br>Location: South-west & North-west stair discharge | Both side handrails should be provided to all stairs.<br>Intermediate handrail need to be provided in stairs wider than 2.20m. Handrails shall have a minimum height of 865 mm (34 in.) and a maximum height of 965 mm (38 in.) as measured from the leading edge of the tread. | Within 1 month |

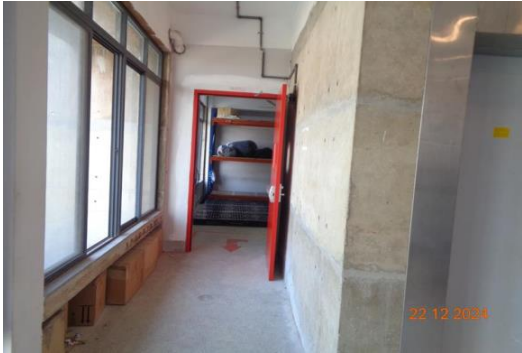
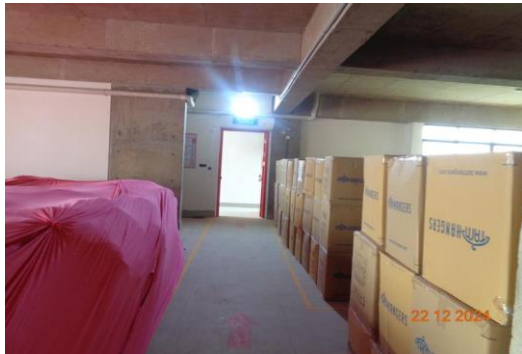
| SI No. | Category | Findings | Required Action | Remediation Time Frame |
|---|---|---|---|---|
| F-29 | Means of Egress | <p>Storage room discharges directly into exit stair enclosure without vestibules.</p> <p>Location: Building-13 ; All stairs at 4th floor, 3rd Floor stair-01 cut panel store</p> | <p>Openings from the exit enclosure to the storage room, shall be provided with a vestibule with fire-rated construction and openings.</p> <p>Provide a 1.5 hr. fire-rated door on the exit stair side and a 1 hr. fire-rated door on the store side. Ensure that the fire rating of the vestibule construction matches that of the exit stair enclosure.</p> <p>The minimum width for vestibules shall not be less than 1.1m and length 1.8m.</p> | Within 3 months |

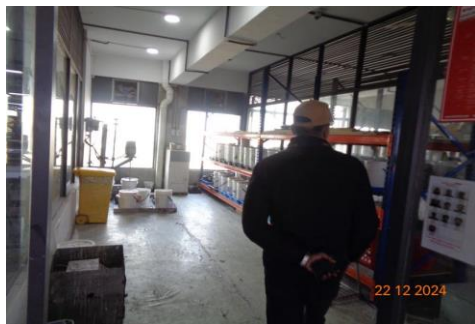
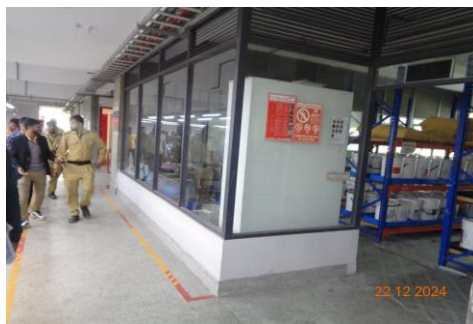
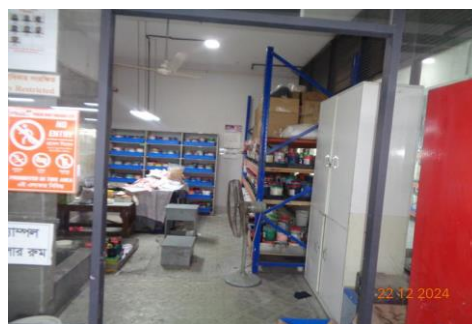
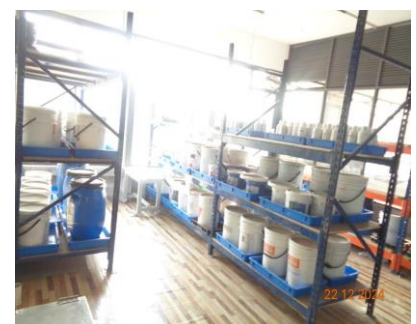
| SI No. | Category | Findings | Required Action | Remediation Time Frame |
|---|---|---|---|---|
| F-33 | Fire Rated Construction | <p>The building is interim construction and Chemical store is located on production floor ( Ground, 1st, 2nd &amp; 3rd floor) with G2 occupancy, which is not permitted without 4-hr fire separation.</p> <p>Location: Building-13</p> | <p>Chemical store shall be separated by G2 or H2 occupancy by 4-hr fire rated construction as per Table 3.2.1 (BNBC 2006).</p> <p>No opening is permitted on 4-hr fire wall. Follow any suitable remediation plan from below:</p> <p>a. Either provide additional required direct exit to exterior open area , OR</p> <p>b. Remove the chemical store from the Location</p> <p>OR</p> <p>c. Ensure exempt amounts of chemical are located on chemical stores with other occupancy as per Table 3.2.7 (BNBC 2006)</p> | Within 3 months |
