# NKM Fashion Limited

Baliapara Jalsha, Jalsha, Dhamrai, Dhaka.

02 February 2025

## **1. Building Information**

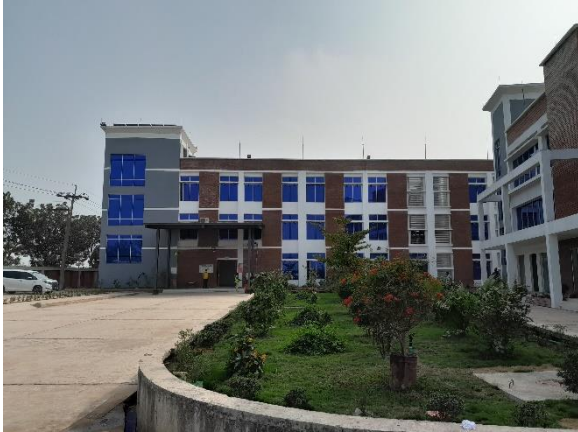
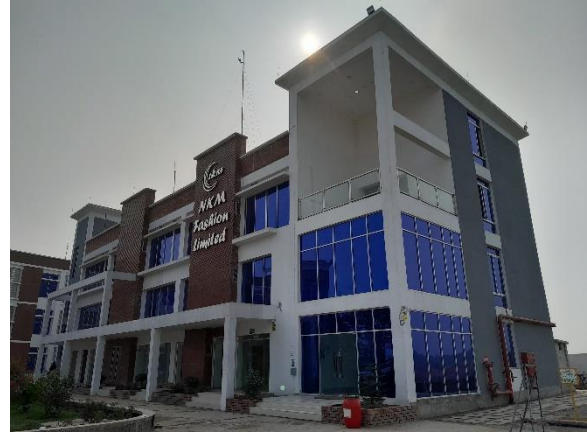
**Observation-1:** Inconsistency in design report & material strength consideration. (Production Building)

**Description:** Detailed Seismic load calculation and seismic detailing calculation are not addressed in the design report. The design concrete strength and frequency of testing, as per BNBC 5.12.1, are not discussed in the design report.

The building engineer is required to review the design report, including the material strength and prepare the design report as per BNBC 1.9.1.
