# SOUTHERN CLOTHINGS LIMITED (EXTENSION-2)

Bottola, Zirabo, Ashulia, Dhaka

9 February 2025

## 2. Observations

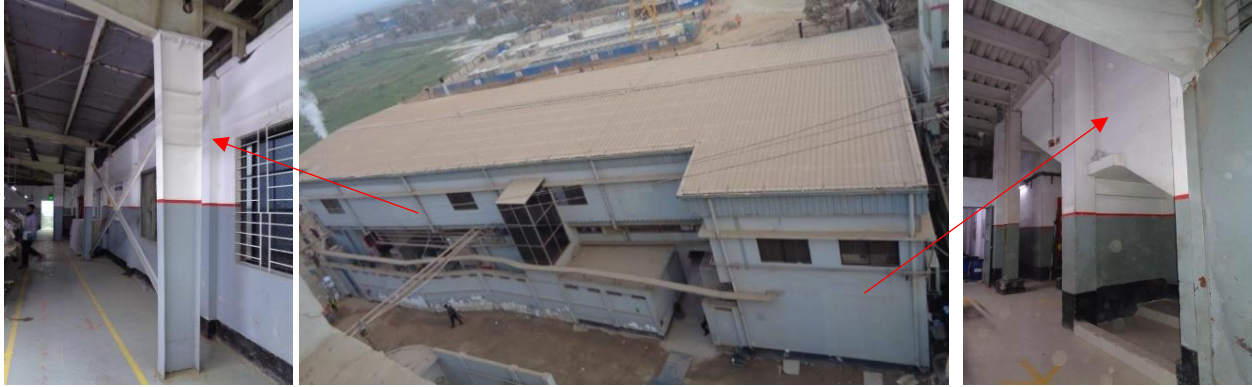
**Observation 01:** Lack of design report, material test report and foundation details. (Building-2 Wash)

**Description:** The building consists of steel and reinforced concrete parts. It was extended horizontally, adding seven bays instead of the three shown in the permit drawings. No design documents exist for the current structure. The provided structural drawing lacks foundation details for the RC part, and the foundation details for the steel section do not reflect the as-built condition. There is no in-situ material test report for the building. Furthermore, there is no continued lateral load transfer media (compression strut) in the lateral load resisting system in the roof.

The building engineer is required to carry out Detail Engineering Assessment (DEA) for the structure to verify the foundation details, in-situ material strength, check the design against lateral forces, stresses and serviceability's. Prepare a full set of DEA documents with detailed remedial action plan. Submit the DEA documents to the RSC for review.

| SL | Observation | Action Plan | Timeline |
|---|---|---|---|
| 1. | Lack of design report, material test report and foundation details. (Building-2 Wash) | Verify in-situ concrete material strength by taking concrete cores (minimum 4 nos and 100 mm diameter) from lower tier building columns. Also, verify steel plate strength for column and beam/rafter. | within 6 weeks |
| 2. | | Verify foundation details | within 6 weeks |
