INITIAL FIRE SAFETY INSPECTION REPORT

GENESIS FASHIONS LTD. (Extension - 2)

RSC ID: 26201

Date: 21 April, 2025

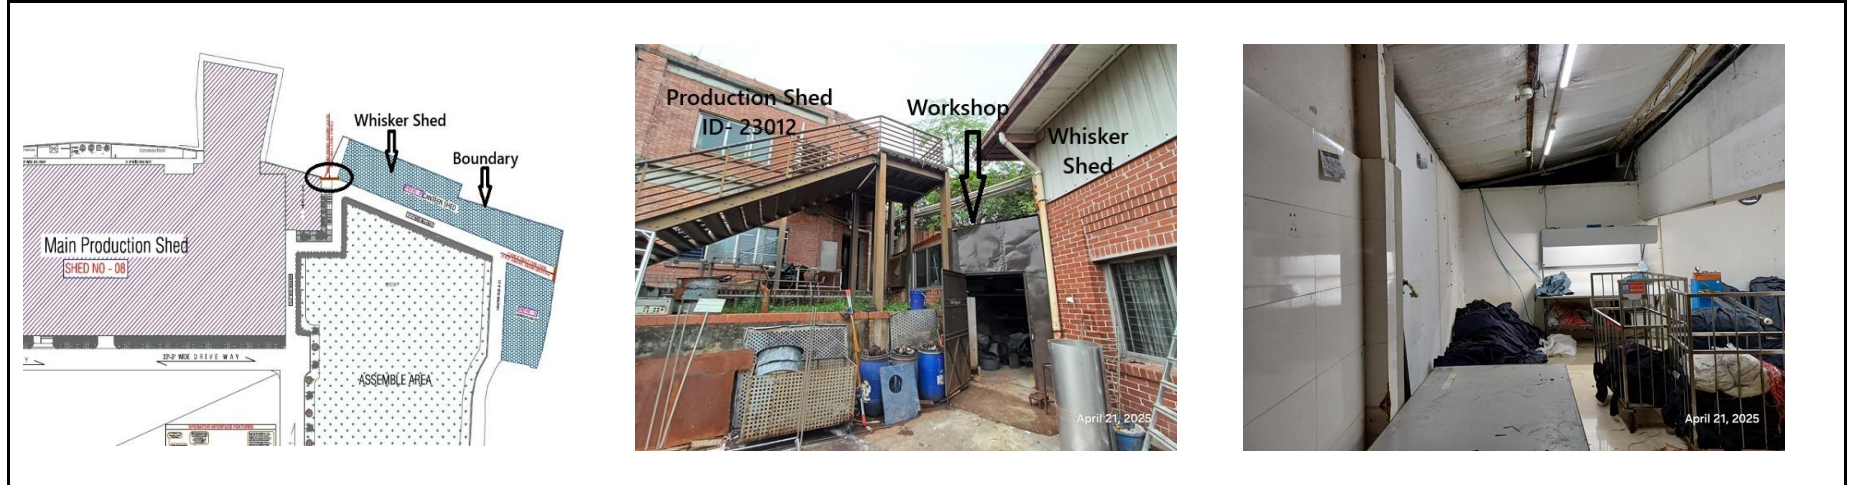
SI No.	Category	Findings	Required Action	Remediation Time Frame
F1	Fire Rated Construction	The required fire separation distance for Building-01: Whisker Shed does not comply with the requirements of BNBC 2006.	The exterior walls shall have a fire resistance and opening protection as specified in BNBC 2006, Part 3 Section 2.4.1.3. & Tables 3.2.2	Within 6 Months

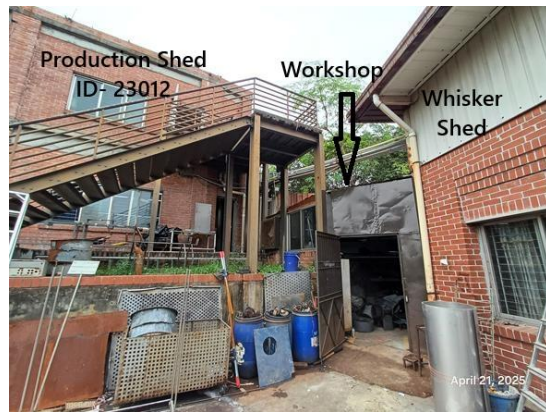
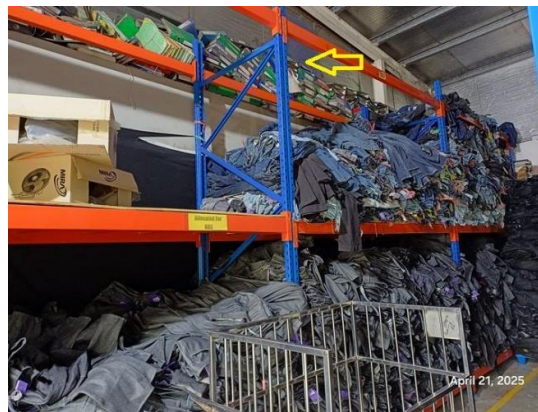
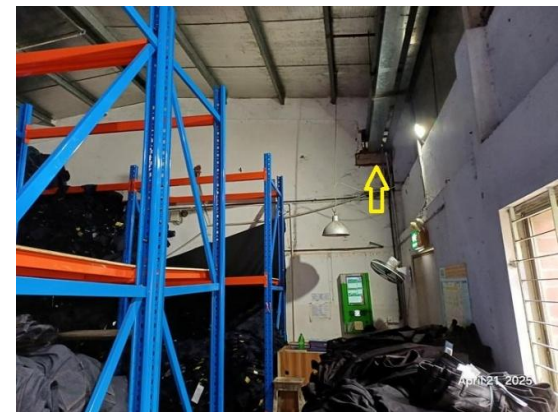
SI No.	Category	Findings	Required Action	Remediation Time Frame
F2	Fire Rated Construction	<p>Rooms used for storage of combustible materials are not separated from the surrounding occupancy (Whisker Section).</p> <p>Location: Ground floor of Whisker Shed</p> <p>Non-compliance reason: Fire resistance rating of exterior wall not ensured and unprotected opening/ penetration with production (whisker Section) area.</p>	<p>Rooms used for storage of combustible materials shall be separated from the surrounding occupancy with a minimum 1 hour construction in accordance with section 3.4.2.1.5 of RSC Technical Guideline (Standard).</p> <p>Seal all penetrations and openings in fire rated assemblies by a listed through-penetration fire stop system tested in accordance with ASTM E814 or approved alternative standard to maintain minimum 1-hr. fire resistance rating. Installation shall be as per manufacturer published installation guideline and the certification authority guideline to ensure the fire-rating in accordance with section 4.7 of RSC Technical Guideline (Standard)</p>	Within 3 Months

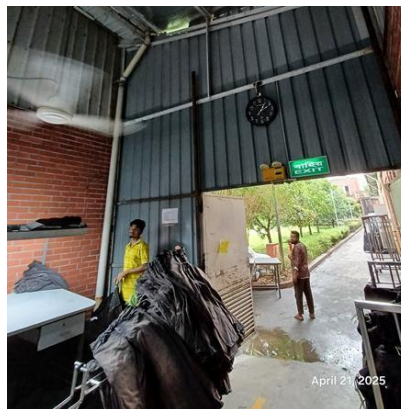
SI No.	Category	Findings	Required Action	Remediation Time Frame
F11	Means of Egress	<p>Building does not have occupant load signs at required locations on all floors.</p> <p>Location: All Exits in Whisker Shed</p>	<p>Post the occupant load for every assembly and production floor in a facility in a conspicuous space near the main exit or exit access doorway for the space in accordance with RSC Technical Guidelines (Standard)¹ V1.0 Section 6.4.4 .</p>	<p>Within 1 Month</p>

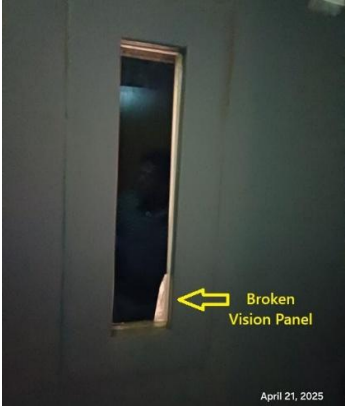
SI No.	Category	Findings	Required Action	Remediation Time Frame
F12	Means of Egress	<p>The exit stair enclosures are not separated from work areas and other spaces on each floor by fire-rated construction.</p> <p>Location: Building-2: Annex Building</p> <p>Non-compliance reason: (i) Unsealed openings are found fire rated barrier construction; (ii) Proper certification is not available for fire rated doors and door accessories installed in the factory. & (iii) Vision panel is missing in a fire door.</p>	<p>The exit stair enclosure shall be provided with a minimum 1-hr fire resistance rating for buildings with 3 or fewer stories and a minimum of 2- hr. fire resistance rating for buildings 4 or more stories. Provide 1-hr. fire rated door and seal all penetrations and openings by 1 hr. fire rated fire rated barrier construction for building with 3 or fewer stories. Provide 1.5 hr. fire rated door and seal all penetrations and openings by 2 hr. fire rated fire rated barrier construction for building with 4 or more stories in accordance with section 6.3.1.2 of RSC Technical Guidelines (Standard)¹ V1.0.</p> <p>Ensure that the fire doors are self-closing and positive latching and that they are provided with fire exit (panic) hardware where serving production floors. If fire doors are required to be held open for functional reasons, provide automatic closing devices tied to the fire alarm system.</p> <p>Keep proper datasheet & certifications for installed fire doors & accessories on-site for verification. The clearance under the bottom of a door shall be a maximum of 3/4 in. (19 mm).</p>	Within 3 Months

SI No.	Category	Findings	Required Action	Remediation Time Frame
		  <p>Opening in Staircase</p> <p>April 21, 2025</p>	  <p>Opening in Staircase</p> <p>April 21, 2025</p>

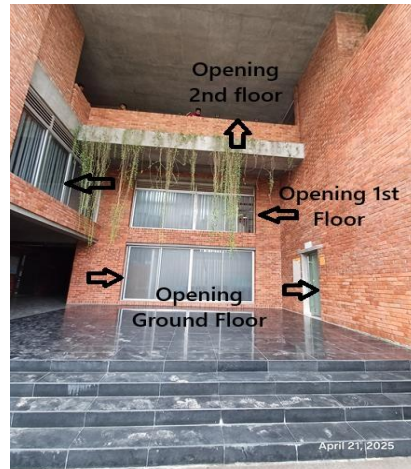
SI No.	Category	Findings	Required Action	Remediation Time Frame
F14	Means of Egress	<p>Exit stair-1 (South-East) terminates the occupants inside the building which does not comply with section 6.17 of RSC Technical Guidelines (Standard)¹ V1.0.</p> <p>Location: South-East Exit Stair-1 Discharge on ground floor of Annex Building.</p> <p>Non-compliance reason: Unsealed openings are found (i) From production area on ground, 1st and 2nd floor; (ii) From Lift Shaft, FACP room and Toilet zones on ground floor</p>	<p>Exits shall discharge directly to the exterior of the building unless meeting the requirements of 6.17.2 or 6.17.3 as per RSC Technical Guidelines (Standard)¹ V1.0.</p>	<p>Within 3 Months</p>

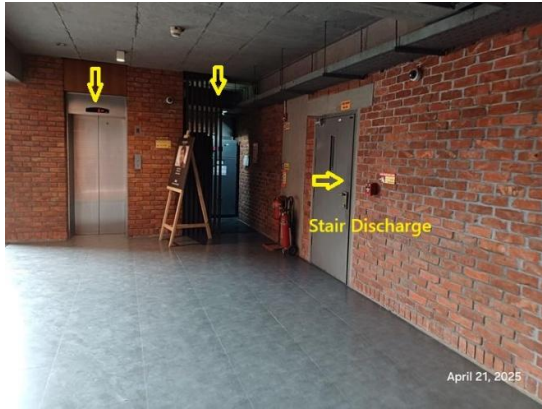
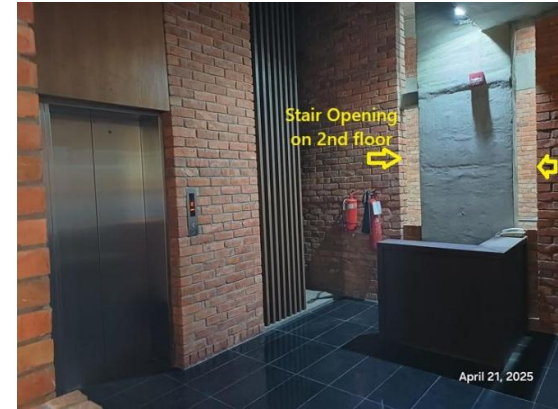
SI No.	Category	Findings	Required Action	Remediation Time Frame
F15	Fire Rated Construction	<p>Elevator/ Lift shafts open directly into the exit enclosure on 2nd floor and protected discharge on ground floor, which doesn't comply with RSC Technical Guidelines (Standard) , section 6.14.3.</p> <p>Location: Lift Shaft near Stair-1 in Annex Building</p>	<p>Provide a minimum 2-hr fire rated elevator shaft to separate it from stair enclosure. No discharge is accepted through elevator shaft. Seal all openings to maintain fire separations.</p>	<p>Within 3 Months</p>

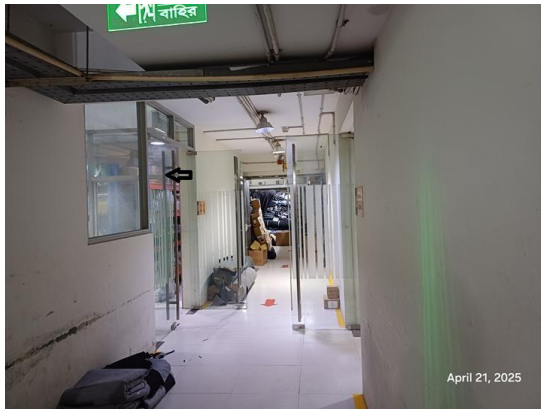
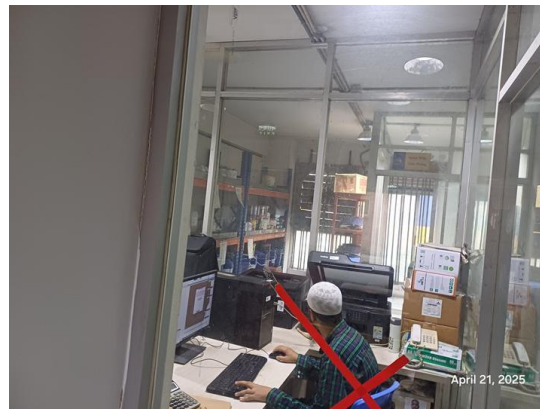
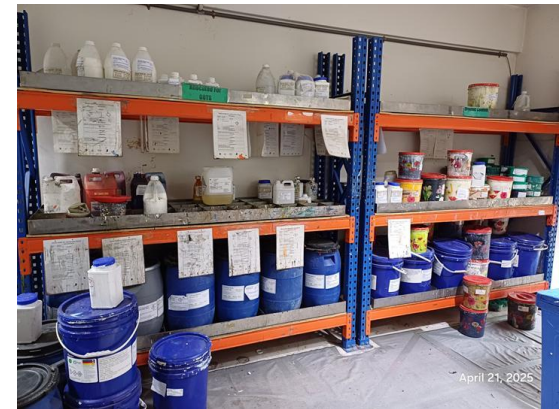
SI No.	Category	Findings	Required Action	Remediation Time Frame
F18	Fire Rated Construction	<p>Rooms used for storage of combustible materials are not separated from the surrounding occupancy.</p> <p>Location: Store on 1st floor adjacent to production and sub-chemical store adjacent to printing section on ground floor of Annex Building.</p>	<p>Rooms used for storage of combustible materials shall be separated from the surrounding occupancy with a minimum 1 hour construction in accordance with section 3.4.2.1.5 of RSC Technical Guideline (Standard).</p>	Within 3 Months

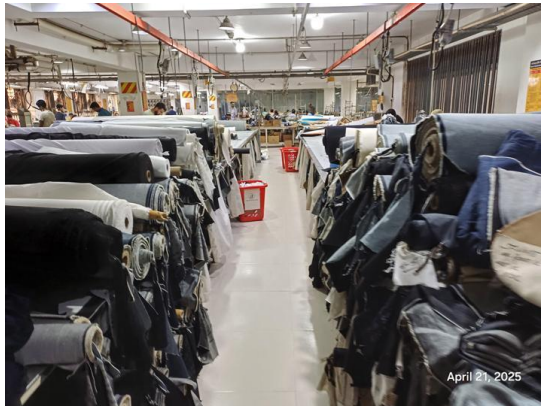
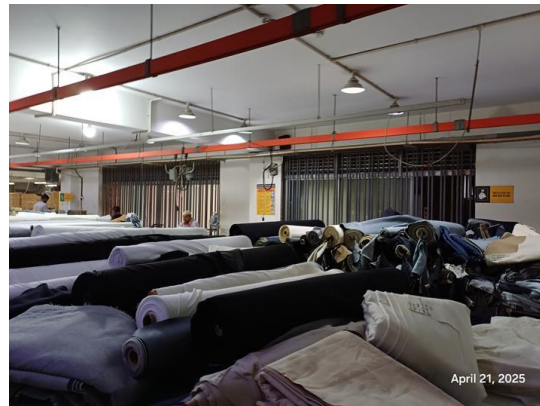
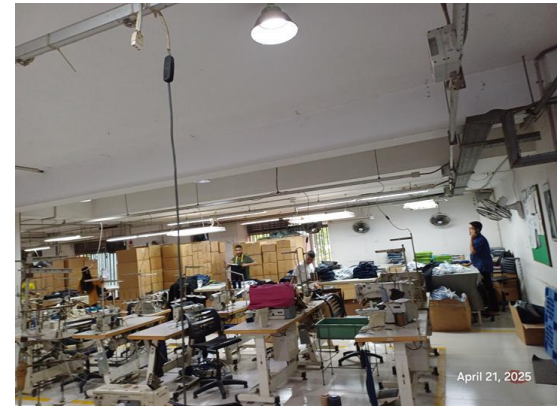
SI No.	Category	Findings	Required Action	Remediation Time Frame
F19	Fire Rated Construction	<p>Areas used for in-process storage of combustible materials are open to the surrounding occupancy.</p> <p>Location: On 1st floor of Annex building</p>	<p>Provide defined storage areas and limit the storage arrangement as follows: Maximum height of 2.45 m and maximum area of 23 m² and is separated by a minimum 3.0 m (10ft) from other storage areas and they do not exceed 10 percent of the building area of the story in which they occur.</p> <p>or,</p> <p>If sprinkler protected, Maximum height 12 ft (3.66 m) and maximum area of 1000 ft² (93 m²) and separated by a at least 25 ft (7.62 m) and does not constitute more than 10 percent of the building area or 4000 ft² (372 m²) of the sprinklered area, whichever is greater.</p> <p>or,</p> <p>Enclose the storage area from the surrounding occupancy with a minimum 1 hour construction.</p>	Within 3 Months

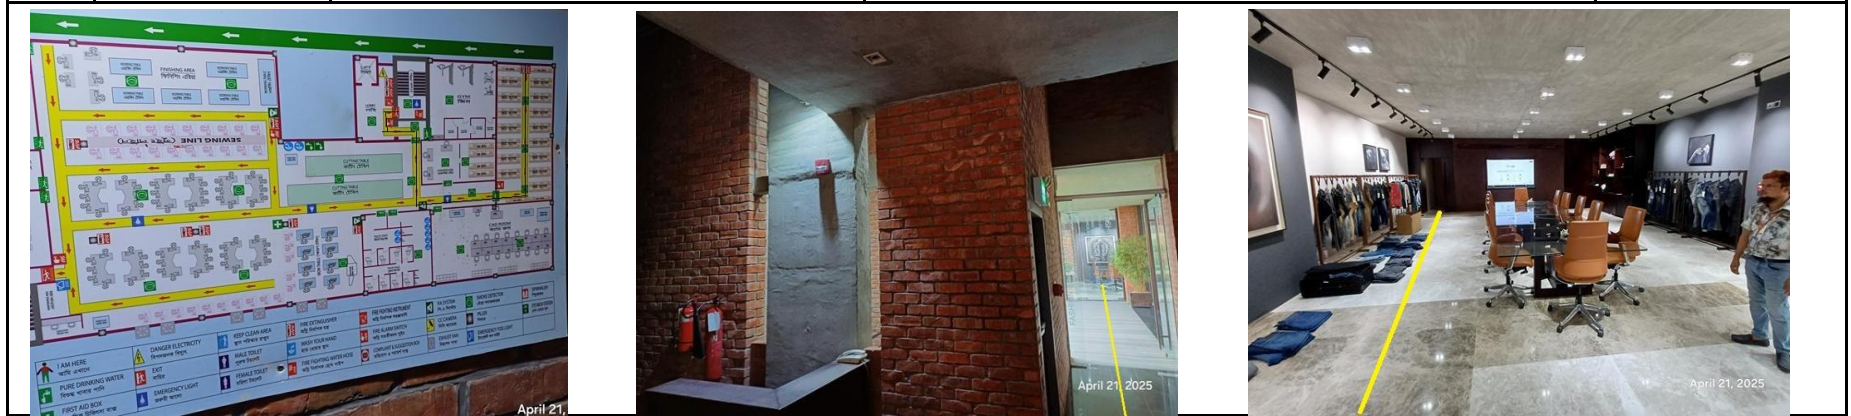
SI No.	Category	Findings	Required Action	Remediation Time Frame
F20	Means of Egress	<p>Common path of egress travel exceeds 30.0 m on 1st floor from storage area. Common path of egress travel exceeds 23.0 m on 2nd floor from staff dining area.</p> <p>Location: Annex Building.</p>	<p>Reconfigure the egress arrangement to reduce the maximum common path of travel to not more than 23 m from staff dining on 2nd floor and 30 m from storage area on 1st floor. The common path of egress travel shall not exceed 23 m (75 ft). Where the building is provided with a complete automatic sprinkler system, the common path of egress travel shall not exceed 30 m (100 ft). The common path of egress travel for Group H (storage) occupancies with not more than 30 occupants shall not exceed 30 m (100 ft). The common path of egress travel for Group J (high hazard) occupancies shall not exceed 8 m (25 ft).</p> <p>Section 6.13.2 of RSC Technical Guidelines (Standard) shall meet.</p>	Within 3 Months

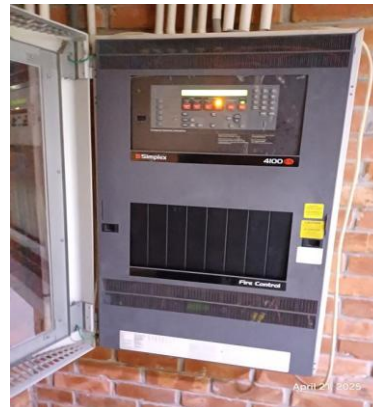
SI No.	Category	Findings	Required Action	Remediation Time Frame
F24	Fire Alarm & Detection System (FADS)	<p>The factory has installed a fire alarm and detection system that requires a detailed review to confirm compliance with NFPA 72 and RSC Technical Guidelines (Standard).</p> <p>Location: Annex Building</p> <p>Note- FACP is located at common area on ground floor of Annex Building. FACP serves 3 Storied Annex building, Single Storied Store Building-02 and 3 storied child care, medical and dining building.</p>	<p>Submit the fire alarm and detection system design to RSC for review.</p> <p>Once the design is reviewed, install and modify the fire detection and alarm system throughout the building in accordance with review comment, RSC Technical Guidelines (Standard) and NFPA 72.</p> <p>After installation/modification the owner shall conduct internal testing and commissioning and then contact the RSC for witness of final acceptance testing.</p>	<p>Design within 2 month and modification/ installation with 4 months</p>

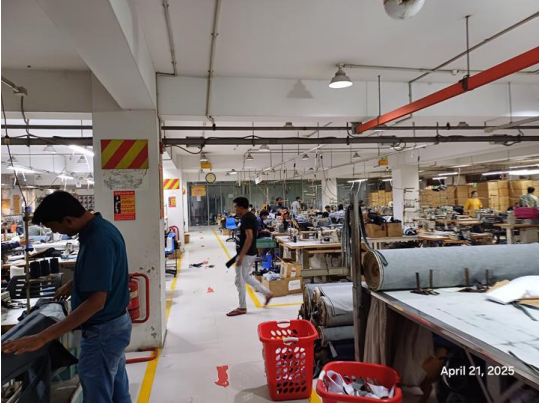
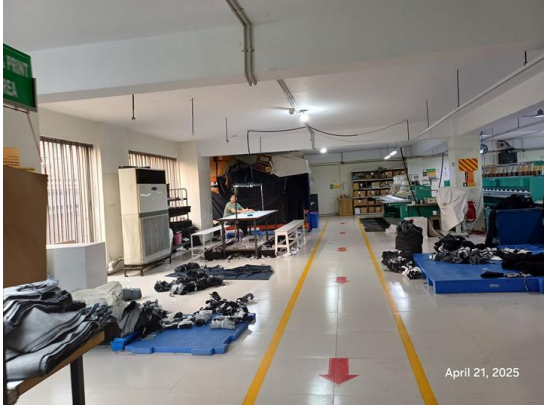
SI No.	Category	Findings	Required Action	Remediation Time Frame
F-29	Means of Egress (Exit Sign, Stair sign & occupant load sign)	<p>Directional signs are not provided where direction of the path of travel to an exit has changed.</p> <p>Location: All floors of Annex Building</p>	<p>Illuminated directional signs shall be provided where there is a change in the direction for the path of travel and the direction to an exit is not obvious in accordance with RSC Technical Guidelines (Standard)¹ V1.0 Section 6.11.3.</p>	Within 1 Month

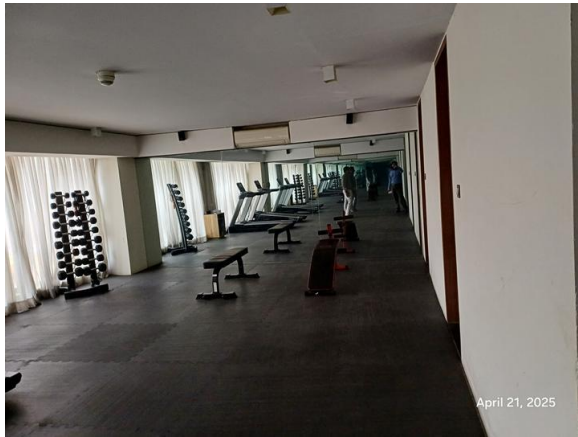
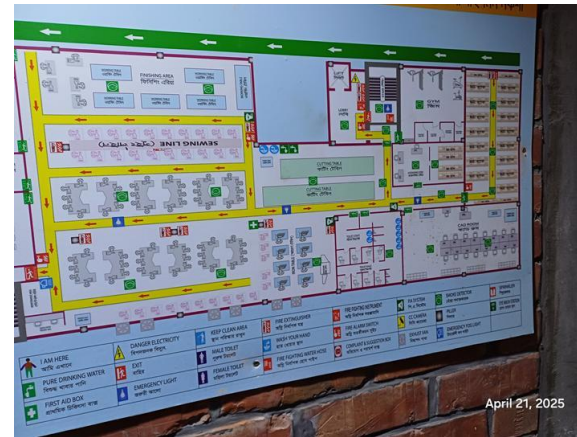
SI No.	Category	Findings	Required Action	Remediation Time Frame
F-31	Fire Rated Construction	<p>Gymnasium (E4 occupancy) is not separated from production (G2 occupancy) with fire rated assemblies.</p> <p>Location: 1st Floor of Annex Building</p>	<p>Separate the dining area from other occupancies with 3-hr fire rated construction, provide minimum 3-hr. rated doors for the openings and seal the unprotected penetrations.</p> <p>Provide required exits that lead directly to the street or exit stairwell or leading to a corridor or open space.</p>	Within 3 Months

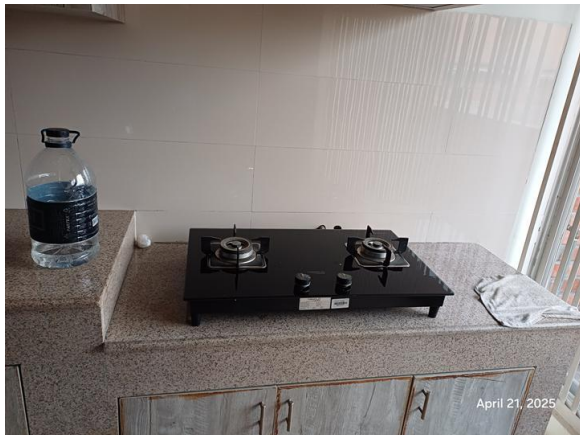
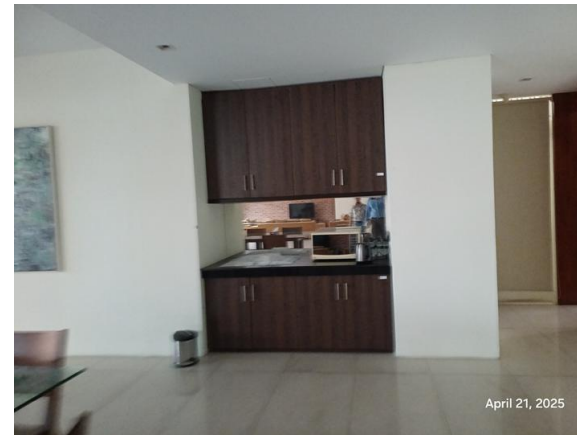
SI No.	Category	Findings	Required Action	Remediation Time Frame
F-32	Fire Rated Construction	<p>Cooking Operation on kitchen area doesn't meet section 5.10 of RSC Technical Guideline (Standard)</p> <p>Location: 2nd Floor of Annex Building</p>	<p>Cooking operations that produce grease laden vapors shall be prohibited in factory premises.</p> <p>If cooking operation is required, ensure ventilation and a fire protection system is provided in accordance with NFPA 96.</p>	Within 1 Month

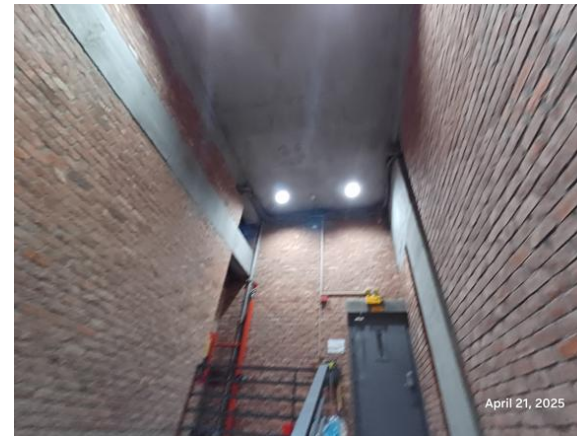
SI No.	Category	Findings	Required Action	Remediation Time Frame
F-33	Means of Egress (Exit Sign, Stair sign & occupant load sign)	<p>Building does not have occupant load signs at required locations on all floors.</p> <p>Location: 2nd Floor of Annex Building</p>	<p>Post the occupant load for every assembly and production floor in a facility in a conspicuous space near the main exit or exit access doorway for the space in accordance with RSC Technical Guidelines (Standard)¹ V1.0 Section 6.4.4 .</p>	<p>Within 1 Month</p>

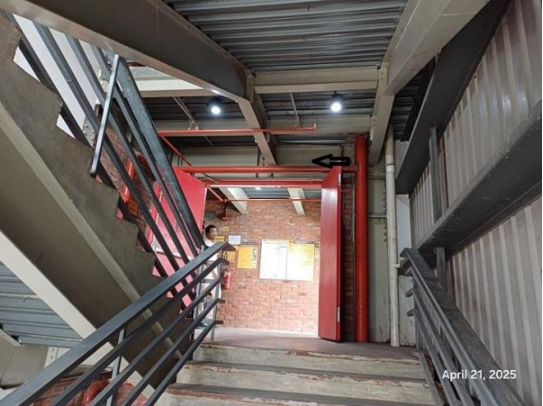
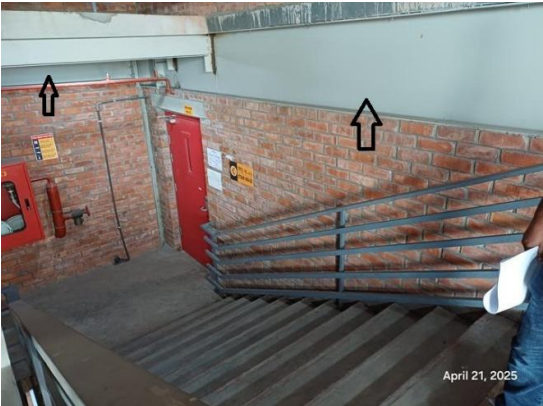
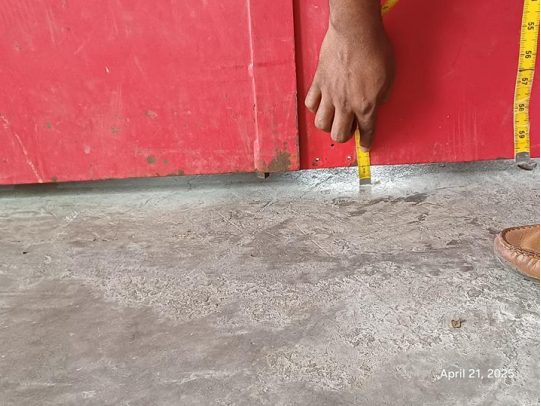
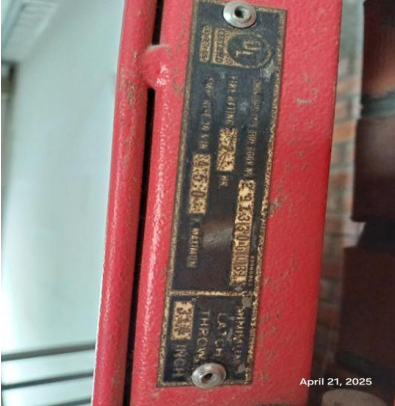
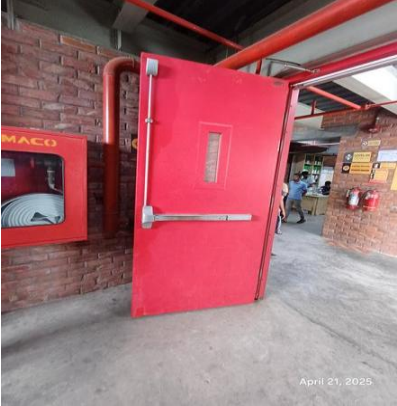
SI No.	Category	Findings	Required Action	Remediation Time Frame
F-35	Means of Egress	<p>The exit stair enclosures are not separated from work areas and other spaces on each floor by fire-rated construction.</p> <p>Location: Building-3: Store Building-01</p> <p>Non-compliance reason: (i) Unsealed openings are found fire rated barrier construction; (ii) Proper certification is not available for fire rated doors and door accessories installed in the factory. 19mm gaps at bottom of fire door, clarification of listing mark on one leaf, broken panic bar & (iii) Steel Beam and Columns in fire barrier which does not provide required fire rating.</p>	<p>The exit stair enclosure shall be provided with a minimum 1-hr fire resistance rating for buildings with 3 or fewer stories and a minimum of 2- hr. fire resistance rating for buildings 4 or more stories. Provide 1-hr. fire rated door and seal all penetrations and openings by 1 hr. fire rated fire rated barrier construction for building with 3 or fewer stories. Provide 1.5 hr. fire rated door and seal all penetrations and openings by 2 hr. fire rated fire rated barrier construction for building with 4 or more stories in accordance with section 6.3.1.2 of RSC Technical Guidelines (Standard)¹ V1.0.</p> <p>Ensure that the fire doors are self-closing and positive latching and that they are provided with fire exit (panic) hardware where serving production floors. If fire doors are required to be held open for functional reasons, provide automatic closing devices tied to the fire alarm system.</p> <p>Keep proper datasheet & certifications for installed fire doors & accessories on-site for verification. The clearance under the bottom of a door shall be a maximum of 3/4 in. (19 mm).</p>	Within 3 Months

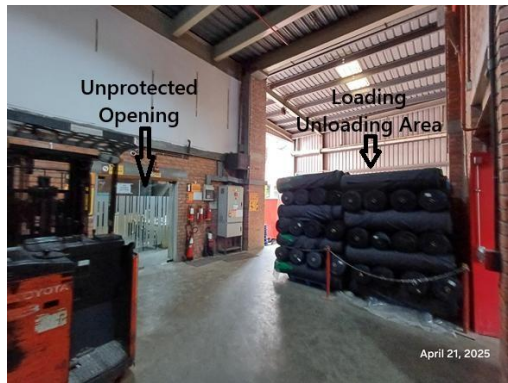
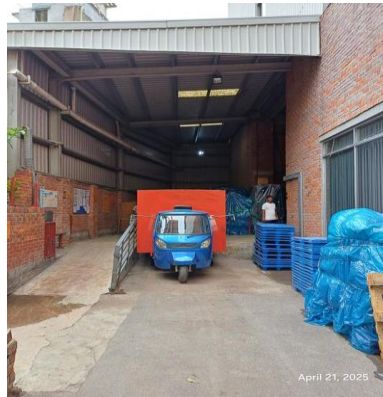
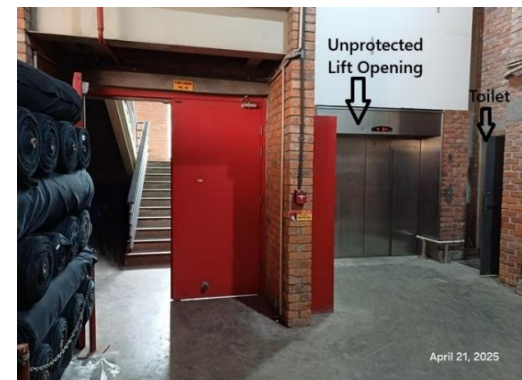
SI No.	Category	Findings	Required Action	Remediation Time Frame
F-37	Means of Egress	<p>Exit stair-1 (South-East) terminates the occupants inside the building which does not comply with section 6.17 of RSC Technical Guidelines (Standard)¹ V1.0.</p> <p>Location: South-West Exit Stair-1 Discharge on ground floor of Store Building-01.</p> <p>Non-compliance reason: On ground floor, Unsealed openings are found (i) From Storage area; (ii) From Lift Shaft and Toilet zones. Loading Unloading area on ground floor.</p>	<p>Exits shall discharge directly to the exterior of the building unless meeting the requirements of 6.17.2 or 6.17.3 as per RSC Technical Guidelines (Standard)¹ V1.0.</p>	<p>Within 3 Months</p>

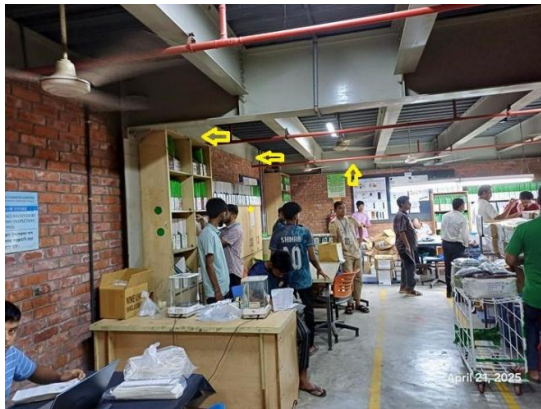
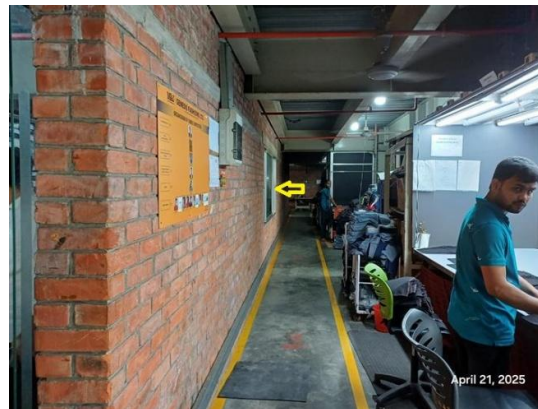
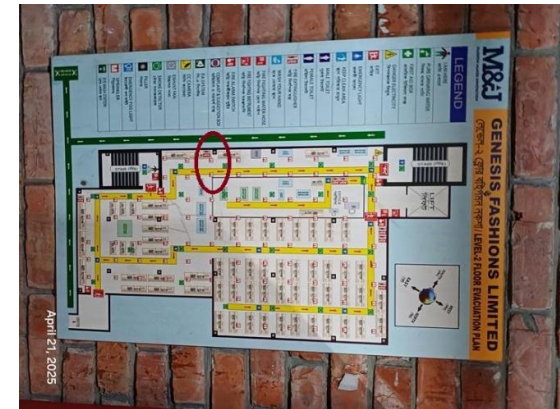
SI No.	Category	Findings	Required Action	Remediation Time Frame
F-40	Fire Rated Construction	<p>Rooms used for storage of combustible materials are not separated from the surrounding occupancy.</p> <p>Location: Store on 1st & 3rd floor adjacent to inspection & office area respectively in Store Building-01.</p>	<p>Rooms used for storage of combustible materials shall be separated from the surrounding occupancy with a minimum 1 hour construction in accordance with section 3.4.2.1.5 of RSC Technical Guideline (Standard).</p>	Within 3 Months

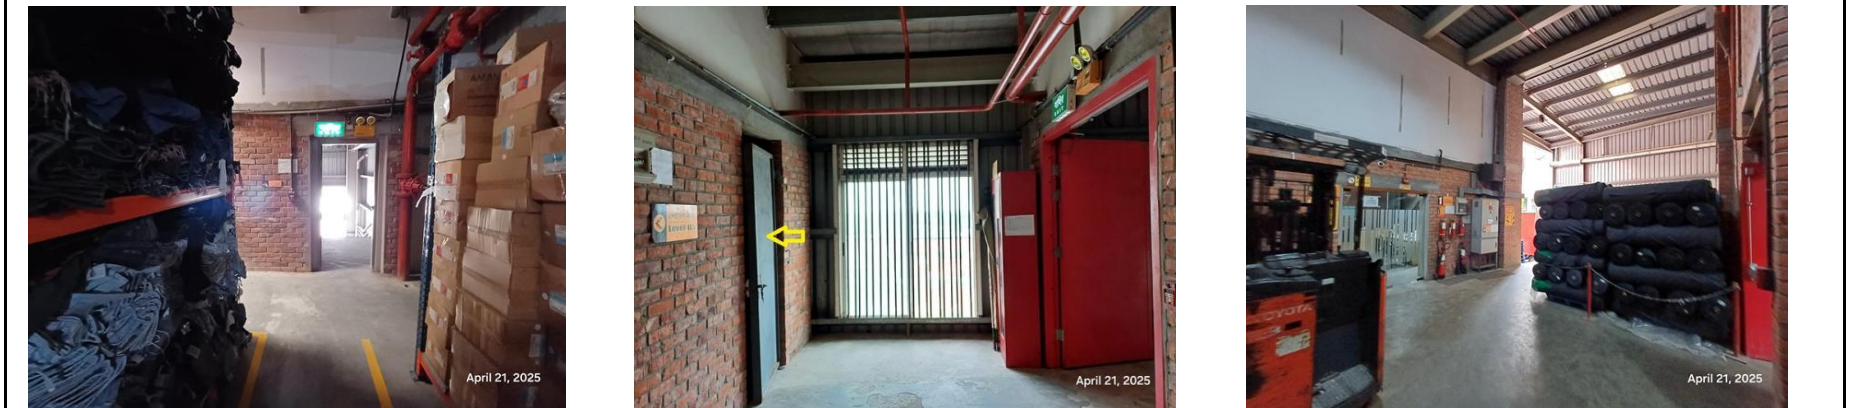
SI No.	Category	Findings	Required Action	Remediation Time Frame
F-41	Means of Egress	Storage areas discharges directly into the south-east exit stair-2 enclosure in all floors and into the south-west stair-1 enclosure on ground and 4th floor.	<p>Openings from exit enclosure to Storage areas/ basements/ transformer rooms/ generator rooms/ boiler rooms and similar normally unoccupied spaces shall be provided with a vestibule with fire rated construction and openings in accordance with section 6.14.3 of RSC Technical Guidelines (Standard)¹ V1.0. Provide a min 1-hr fire rated door on the exit stair side and a 1.5 hr. fire rated door on the Store, generator, sub-station room side . Ensure that the fire rating of the vestibule construction matches that of the exit stair enclosure as per RSC Technical Guidelines (Standard)¹ V1.0. section 6.14.3. The minimum width for vestibules shall not be less than 1.1m and length 1.8m.</p> <p>Or, Provide Sprinkler System in accordance to NFPA-13.</p>	Within 3 Months

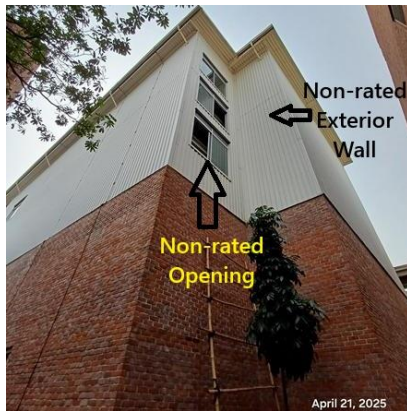
SI No.	Category	Findings	Required Action	Remediation Time Frame
F-42	Means of Egress	<p>The exterior of the south-east stair-2 is enclosed by nonrated walls or unprotected openings, which are exposed to other parts of the building at an angle of less than 180 degrees (3.14 rad).</p> <p>Location: Store Building-01</p>	<p>Nonrated walls or unprotected openings enclose the exterior of the stairway and the walls or openings are exposed by other parts of the building at an angle of less than 180 degrees (3.14 rad), the building exterior walls within 3050 mm (10 ft) horizontally of a nonrated wall or unprotected opening shall have a fire-resistance rating of not less than 1 hr. in accordance with section 6.14.7 of RSC Technical Guidelines (Standard)¹ V1.0. Openings within such exterior walls shall be protected by opening protectives having a fire protection rating of not less than ¾ hr.</p>	Within 3 Months

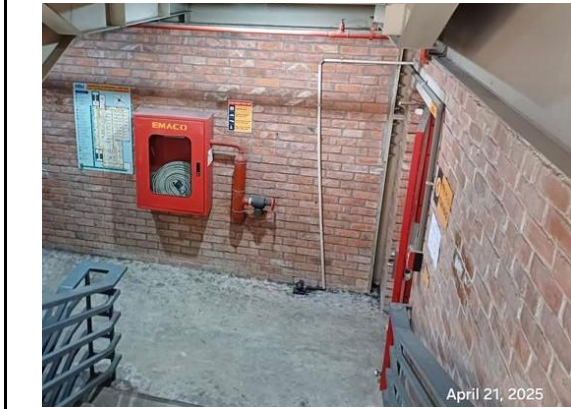
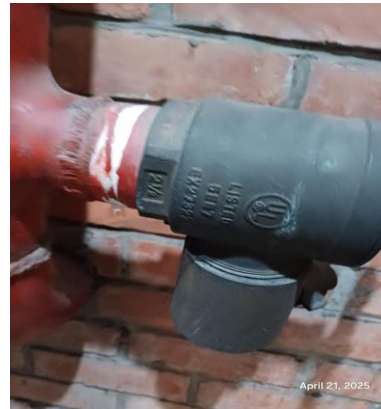
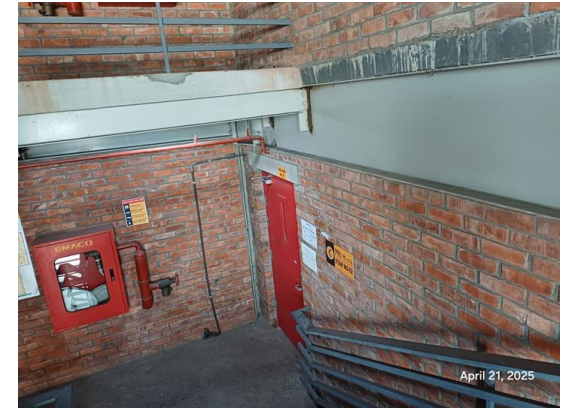
SI No.	Category	Findings	Required Action	Remediation Time Frame
F-48	Fire Suppression System (SUPS)	<p>The factory has installed a standpipe & Hose system that requires a detailed review to confirm compliance with NFPA 14,20, 24 and RSC Technical Guidelines (Standard).</p> <p>Location: 5 Storied Store Building-01</p>	<p>Submit the standpipe system drawing to RSC for review.</p> <p>Once reviewed, install or modify the standpipe system throughout the building in accordance with RSC Technical Guidelines (Standard)¹ V1.0. and NFPA 14, 20,22 and 24.</p> <p>After installation the owner shall contact the RSC for witness of conducting the final acceptance testing of the standpipe system.</p>	<p>Design within 2 month and modification/ installation with 4 months</p>

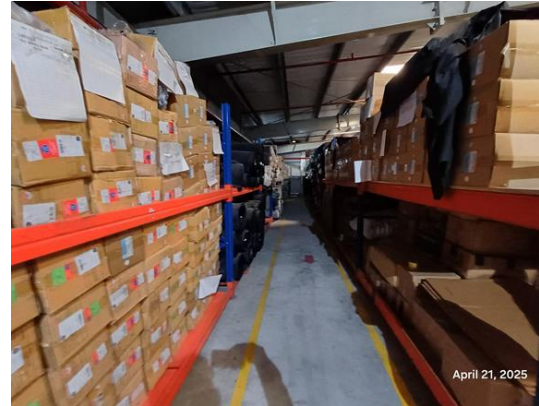
SI No.	Category	Findings	Required Action	Remediation Time Frame
F-55	Means of Egress (Egress Lighting)	<p>Based on the number and location of emergency lights observed, adequate illumination levels are not anticipated along egress routes.</p> <p>Location: 2nd, 3rd & 4th Floor of store Building 01</p>	<p>Test the emergency lighting system on each floor and provide additional emergency fixtures to provide adequate illumination along the means of egress. Provide a minimum illumination of 10 lux at the floor level within exit stairs and exit discharge paths and minimum 2.5 lux along exit access aisles. Illumination on means of egress shall meet in accordance with RSC Technical Guidelines (Standard)¹ V1.0 Section 10.12.2.</p>	Within 3 Months

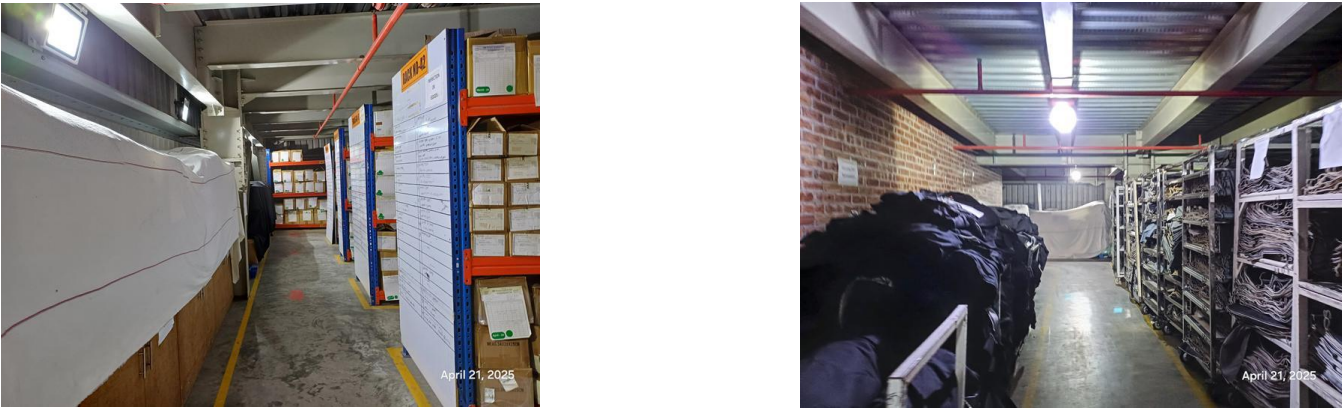
SI No.	Category	Findings	Required Action	Remediation Time Frame
F-56	Means of Egress (Exit Sign, Stair sign & occupant load sign)	<p>Directional signs are not provided where direction of the path of travel to an exit has changed.</p> <p>Location: All floors of of store Building-01</p>	Illuminated directional signs shall be provided where there is a change in the direction for the path of travel and the direction to an exit is not obvious in accordance with RSC Technical Guidelines (Standard) ¹ V1.0 Section 6.11.3.	Within 1 Month

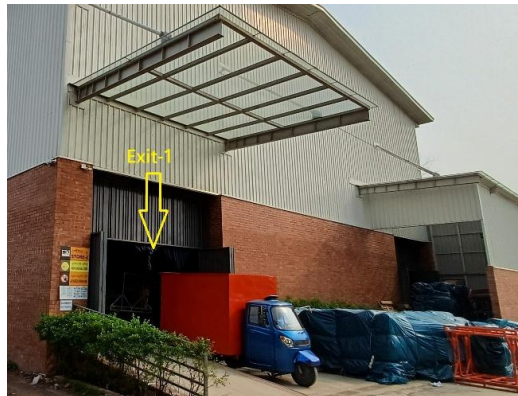
SI No.	Category	Findings	Required Action	Remediation Time Frame
F-60	Means of Egress (Exit Adequacy)	<p>Common path of egress travel exceeds 30.0m.</p> <p>Location: Single Storied Store Building-02</p> <p>Occupancy/Process: H2</p> <p>Available Common Path: 43.90m</p>	<p>Reconfigure the egress arrangement to reduce the maximum common path of travel to not more than 30.0 m.</p> <p>The common path of egress travel shall not exceed 23 m (75 ft). Where the building is provided with a complete automatic sprinkler system, the common path of egress travel shall not exceed 30 m (100 ft). The common path of egress travel for Group H (storage) occupancies with not more than 30 occupants shall not exceed 30 m (100 ft). The common path of egress travel for Group J (high hazard) occupancies shall not exceed 8 m (25 ft).</p> <p>Section 6.13.2 of RSC Technical Guidelines (Standard) shall meet.</p>	Within 3 Months

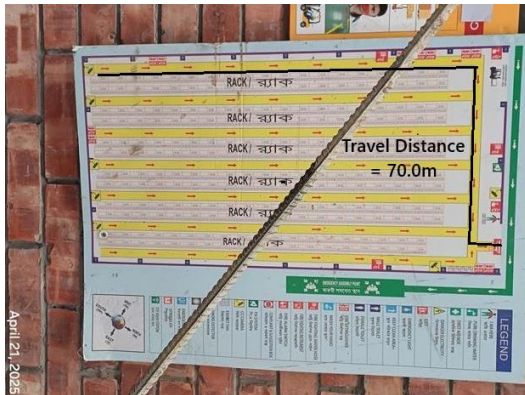
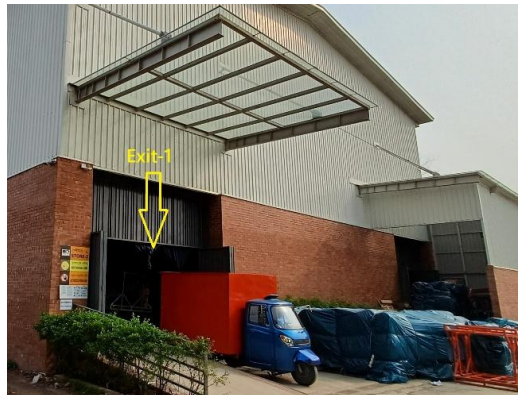
SI No.	Category	Findings	Required Action	Remediation Time Frame
F-61	Means of Egress (Exit Adequacy)	<p>A single means of exit has been provided on ground floor of store building-02. Another door is found which declared as not an exit.</p> <p>Location: Single Storied Store Building-02</p> <p>Occupant Load: 30 Travel distance: 70.0m</p>	<p>The number of means of egress from any floor, story or portion thereof shall not be less than 2 except where a single exit is permitted by RSC Technical Guideline (Standard), section 6.6.2.</p> <p>Provide additional exit and ensure that the exit doors or means of egress openings are located a distance apart as per RSC Technical Guideline (Standard) section of 6.6.6. Ensure that travel distance does not exceed 38.0m or for fully sprinklered building travel distance does not exceed 45.0m.</p>	Within 3 Months

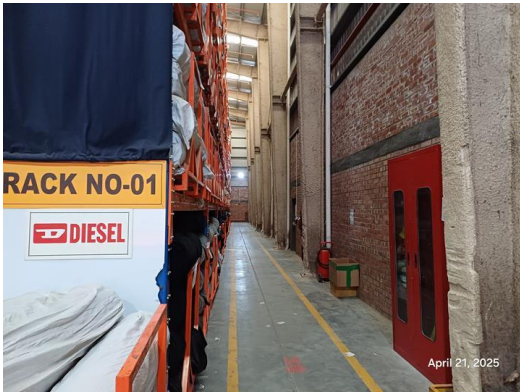
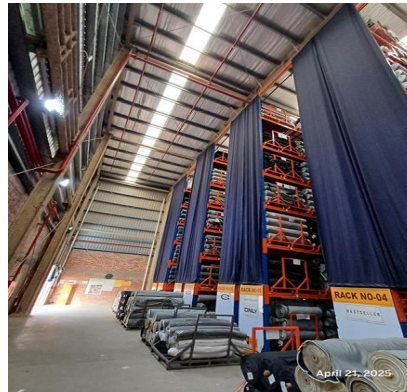
SI No.	Category	Findings	Required Action	Remediation Time Frame
F-64	Sprinkler system Design & Installation	<p>Sprinkler system is not mandatory for the building based on height and type of construction but the system installed for the building along with standpipe system in lieu of automatic detection system. Both the system requires detailed review to confirm compliance with NFPA 13, 14, 20, 22, 24 and RSC Technical Guidelines (Standard).</p> <p>Location: Single Storied Store Building-02</p>	<p>Submit the sprinkler system drawing to RSC for review. Once the design is reviewed, install and modify the sprinkler/standpipe system throughout the building in accordance with review comment, RSC Technical guideline (Standard) and NFPA 13,14,20,22 and 24. After installation the owner shall conduct internal testing and commissioning and then contact the RSC for witness of final acceptance testing.</p> <p>(Provide automatic sprinkler protection along with class-I standpipe system throughout the building in accordance with NFPA 13, 14, 20 and 22. Submit design to RSC for review prior installation.)</p>	Design within 2 month and modification/ installation with 4 months

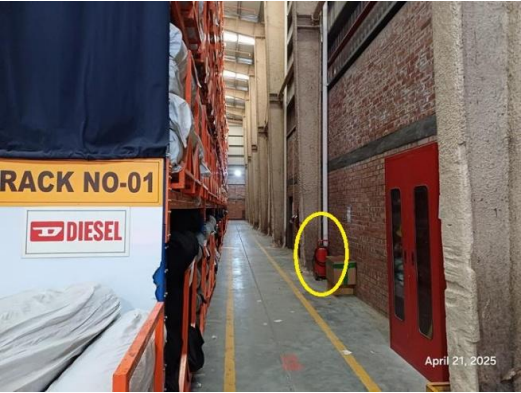
F-69	Fire Suppression System (SUFS)	<p>Fire extinguishers were found at several areas but placed on floors.</p> <p>Location: Single storied Storage Building-02</p>	<p>In no case shall the clearance between the bottom of the hand portable fire extinguisher and the floor be less than 4 in. (102 mm). As per NFPA 10 section 6.1.3.8.3</p>	Within 1 Month

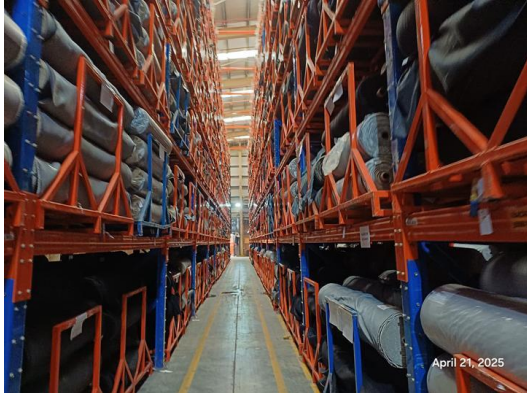
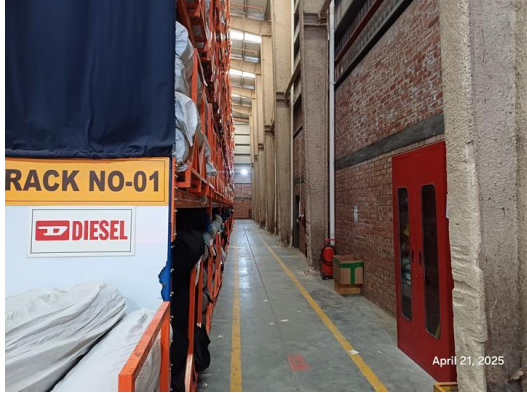
SI No.	Category	Findings	Required Action	Remediation Time Frame	
F-71	Means of Egress (Exit Sign, Stair sign & occupant load sign)	<p>Directional signs are not provided where direction of the path of travel to an exit has changed.</p> <p>Location: Single storied Storage Building-02</p>	<p>Illuminated directional signs shall be provided where there is a change in the direction for the path of travel and the direction to an exit is not obvious in accordance with RSC Technical Guidelines (Standard)¹ V1.0 Section 6.11.3.</p>	Within 1 Month

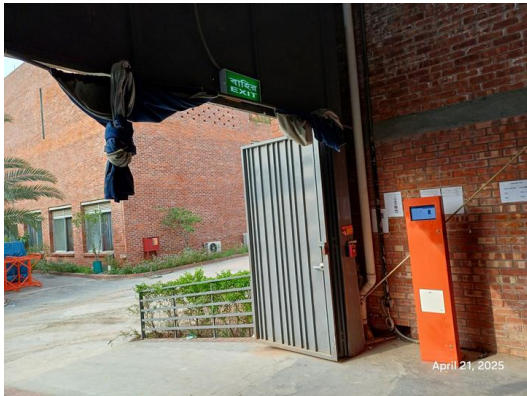
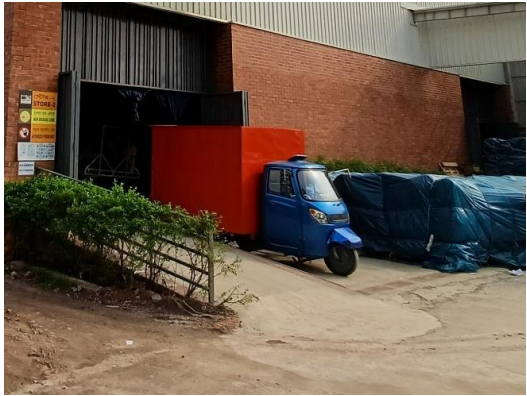
SI No.	Category	Findings	Required Action	Remediation Time Frame
F-73	Means of Egress (Exit Adequacy)	Doors are swing out over Ramps. Location: Single storied Storage Building-02	A landing shall be provided on both sides of doors used in the means of egress to facilitate uninterrupted egress of occupants. Door shall not swing out over stairs. Landings with same width as the stair clear width shall be provided at each level and at intermediate landings.	Within 3 Months

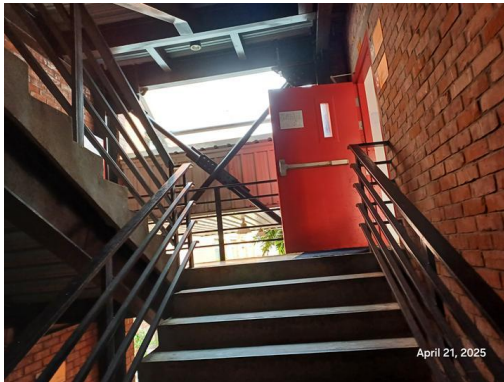
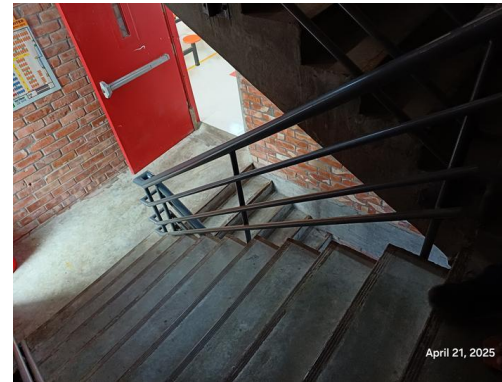
SI No.	Category	Findings	Required Action	Remediation Time Frame
F-75	Means of Egress (Exit stair openings)	<p>The exit stair enclosures are not separated from work areas and other spaces on each floor by fire-rated construction.</p> <p>Location: 3 Storied Daycare, Medical & Dining Building</p> <p>Non-compliance reason: (i) Proper certification is not available for fire rated doors</p>	<p>The exit stair enclosure shall be provided with a minimum 1-hr fire resistance rating for buildings with 3 or fewer stories. Provide 1-hr. fire rated door and seal all penetrations and openings by 1 hr. fire rated fire rated barrier construction for building with 3 or fewer stories in accordance with section 6.3.1.2 of RSC Technical Guidelines (Standard)¹ V1.0.</p> <p>Ensure that the fire doors are self-closing and positive latching and that they are provided with fire exit (panic) hardware where serving production floors. If fire doors are required to be held open for functional reasons, provide automatic closing devices tied to the fire alarm system.</p> <p>Keep proper datasheet & certifications for installed fire doors & accessories on-site for verification. The clearance under the bottom of a door shall be a maximum of 3/4 in. (19 mm).</p>	Within 3 Months

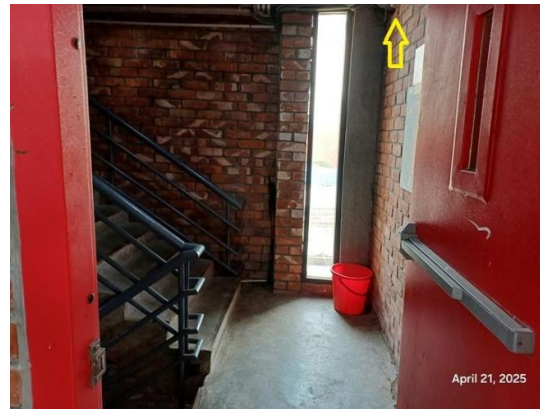
SI No.	Category	Findings	Required Action	Remediation Time Frame
F-76	Means of Egress	<p>Unsealed penetrations and openings are located in exit stair enclosures. Electrical cable/ BBT raceway passing through the exit enclosure.</p> <p>Location: Mid-East stair-1 of 3 Storied Daycare, Medical & Dining Building</p>	<p>No other penetration into and through the exit enclosure except for fire alarm equipment electrical raceway, required exit doors, sprinkler piping, standpipes, and electrical conduit serving the exit enclosure is permitted in accordance with section 6.14.4 of RSC Technical Guidelines (Standard)¹ V1.0. So, relocate the electrical wires/raceways to somewhere else avoiding the exit enclosure, and seal the created unprotected openings with a minimum of 1.5 hours listed/certified fire-rated materials. Installation shall be as per manufacturer published installation guideline and the certification authority guideline to ensure the fire-rating. Or seal the penetration by 2-hr masonry construction.</p>	Within 3 Months

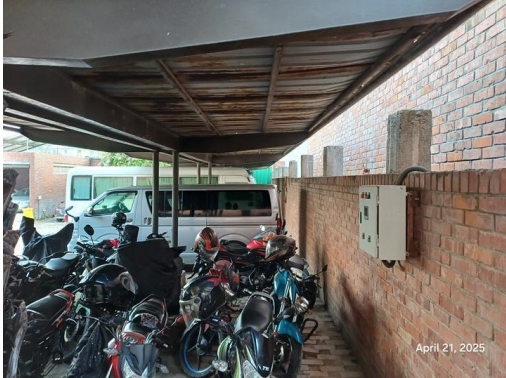
F-79	Fire Rated Construction	The required fire separation distance for 3 Storied Daycare, Medical & Dining Building does not comply with the requirements of BNBC 2020.	The exterior walls shall have a fire resistance and opening protection as specified in BNBC 2020 Part 3 Section 2.4.1.3 Table 3.2.2 & 3.2.3 and BNBC 2020 Part 3 Table 3.3.1 (a). Or, Relocate other occupancy by maintaining proximity distance.	Within 6 Months

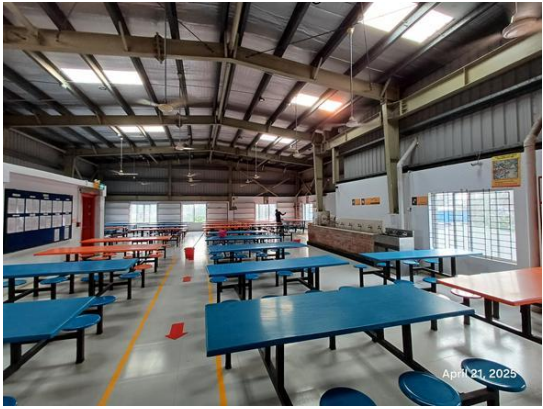
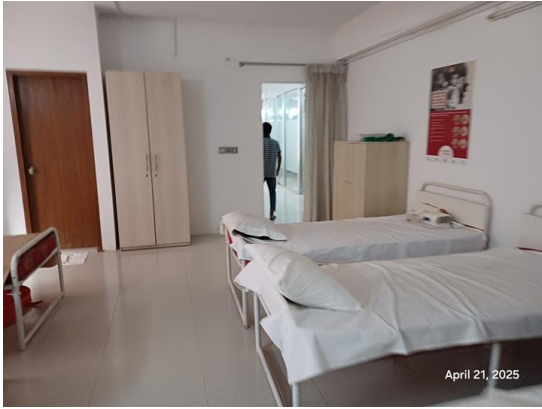
SI No.	Category	Findings	Required Action	Remediation Time Frame
F-87	Means of Egress (Exit Sign, Stair sign & occupant load sign)	<p>Directional signs are not provided where direction of the path of travel to an exit has changed.</p> <p>Location: All Floors of 3 Storied Daycare, Medical & Dining Building</p>	Illuminated directional signs shall be provided where there is a change in the direction for the path of travel and the direction to an exit is not obvious in accordance with RSC Technical Guidelines (Standard) ¹ V1.0 Section 6.11.3.	Within 1 Month

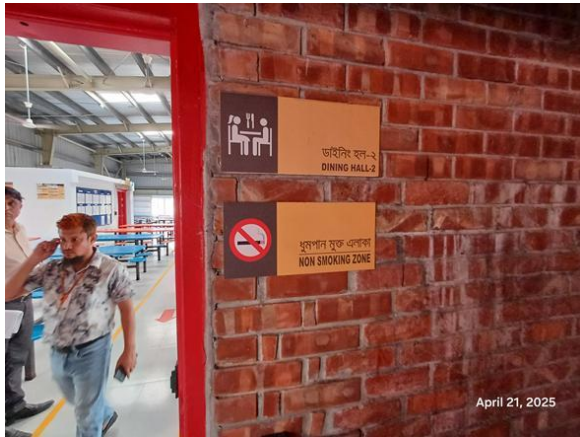
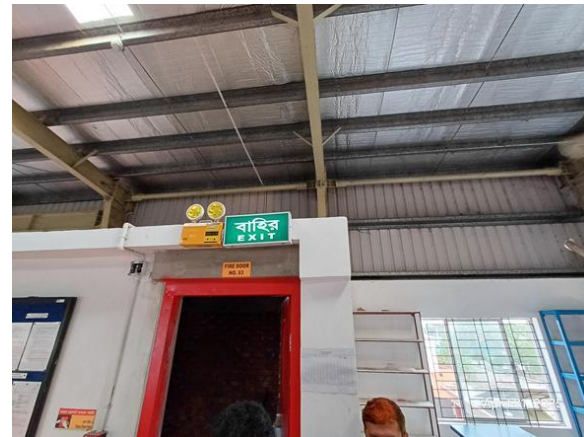
SI No.	Category	Findings	Required Action	Remediation Time Frame
F-89	Means of Egress (Exit Sign, Stair sign & occupant load sign)	<p>Building does not have occupant load signs at required locations on all floors.</p> <p>Location: All Floors of 3 Storied Daycare, Medical & Dining Building</p>	Post the occupant load for every assembly and production floor in a conspicuous space near the main exit or exit access doorway for the space in accordance with RSC Technical Guidelines (Standard) ¹ V1.0 Section 6.4.4 .	Within 1 Month
