INITIAL FIRE SAFETY INSPECTION REPORT

GENESIS FASHIONS LTD. (Extension - 2)

RSC ID: 26201

Date: 21 April, 2025

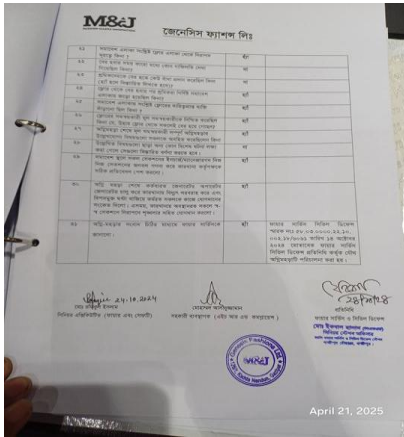
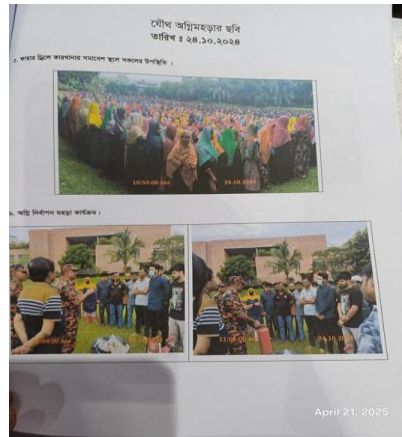
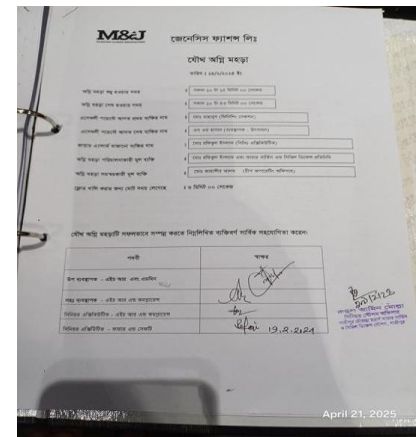
SI No.	Category	Findings	Required Action	Remediation Time Frame
F-90	Licenses and certificates	Fire drills are not conducted at 3 months interval for first two years under a fire safety director in according to section 13.2 of RSC Technical Guidelines (Standard) ¹ V1.0.	Fire drills shall be conducted according to section 13.2 of RSC Technical Guidelines (Standard) ¹ V1.0. Fire drills shall be conducted on a monthly basis as outlined in BNBC 2006 Part 4 Appendix A.	Within 1 Month
