# Haesong Corporation Limited

## Haesong Sweater Ltd.

Hizalhati (Baroipara), Kaliakair, Gazipur, Bangladesh  
(24.027194N, 90.23911123E)

30 October 2013

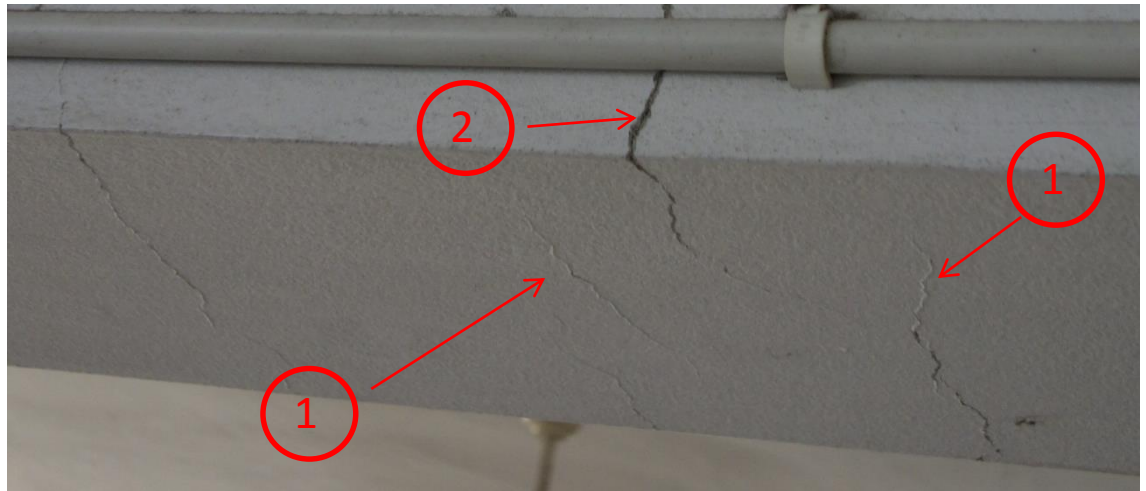
Cracks appear be bigger that they are due to paint is lost both sides of crack.

1-After cracking plastic paint swells and produce a bubble.

2-Paint peels off and ends falling down around crack.

| Item No. | Observation | Recommended Action Plan | Recommended Timeline |
|---|---|---|---|
| 11 | Shrinkage cracking on all beams | Shrinkage cracks need to be sealed against water entry and moisture to prevent corrosion. Building's Engineer must specify a sealant system. Common repair methods include chipping out the crack and applying a mortar patching compound to the surface, use of epoxies, or other sealants. | 6-months |
