# Elite Garments Ind. Ltd.

Bade Kalmeswer, Board Bazar, Gazipur, Bangladesh  
(23.954199, 90.380240)

5th April 2014  
8th April 2015

**Building N7**

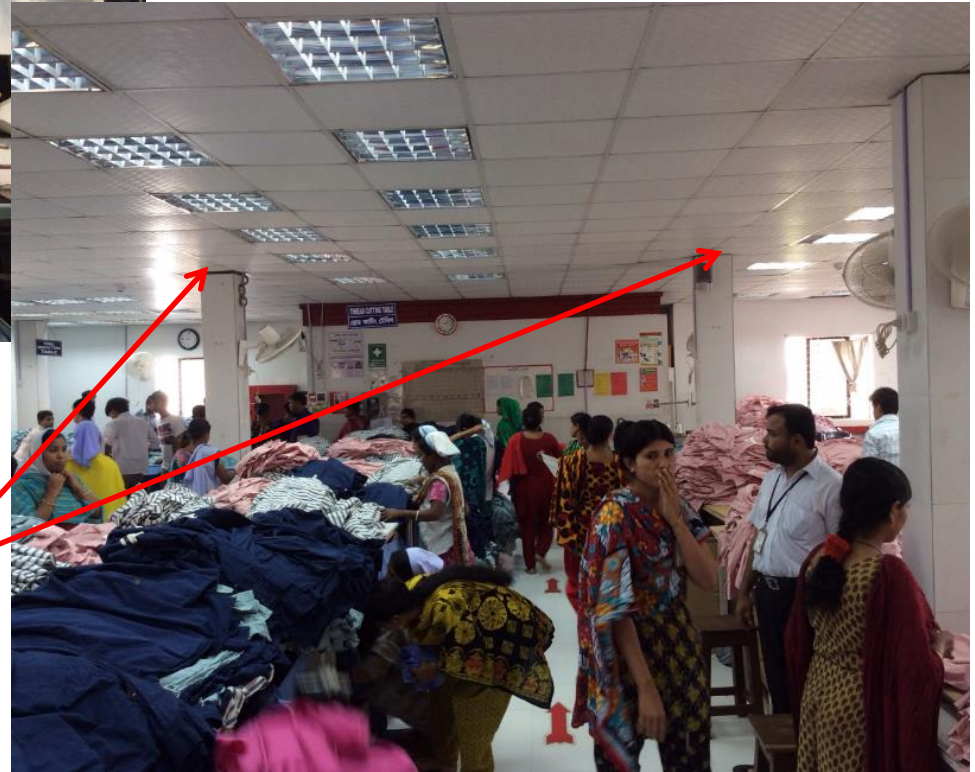
## Steel Roof Sections – Building 2

Steel roof over Building 2

Steel Roof support connections in Building 2 could not be inspected due to drop ceiling in place. These should be design checked by Building Engineer.

| Item No. | Observation | Recommended Action Plan | Recommended Timeline |
|---|---|---|---|
| 8 | Check design of steel roofs and connections for Buildings 2, 3 and 4. | Implement any recommendations made by the Building Engineer for the steel roofs. | 6-months |

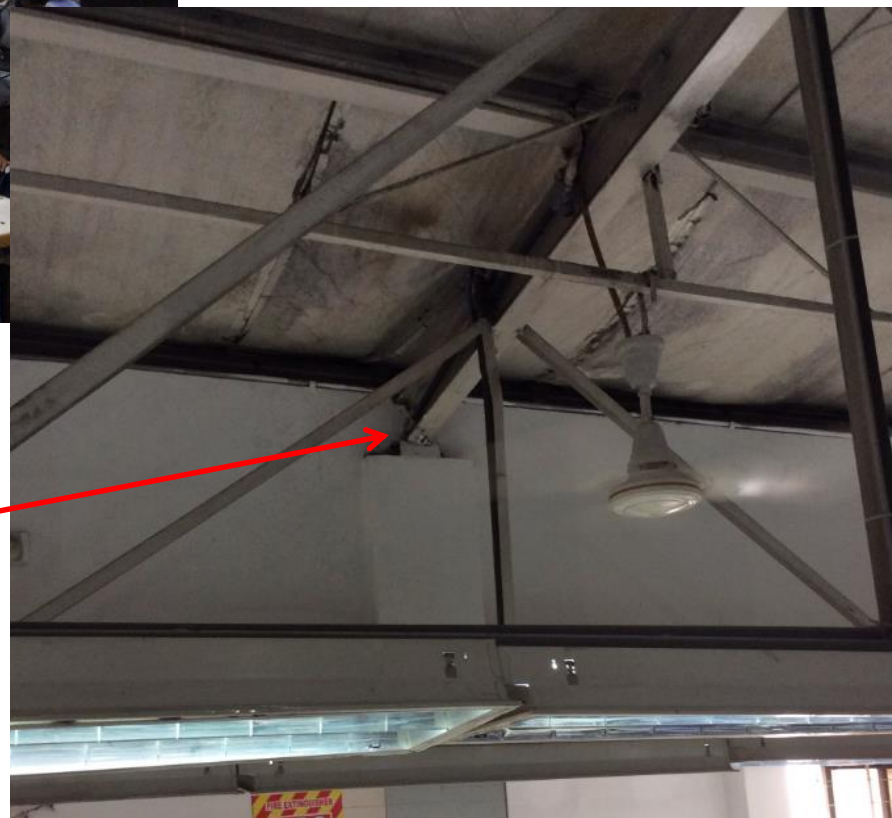
## Steel Roof Sections – Building 3

Steel roof over Phase I section of Building 3

Steel Roof connections in Building 3 appear inadequate to resist high wind loading and should be checked by a Building Engineer.

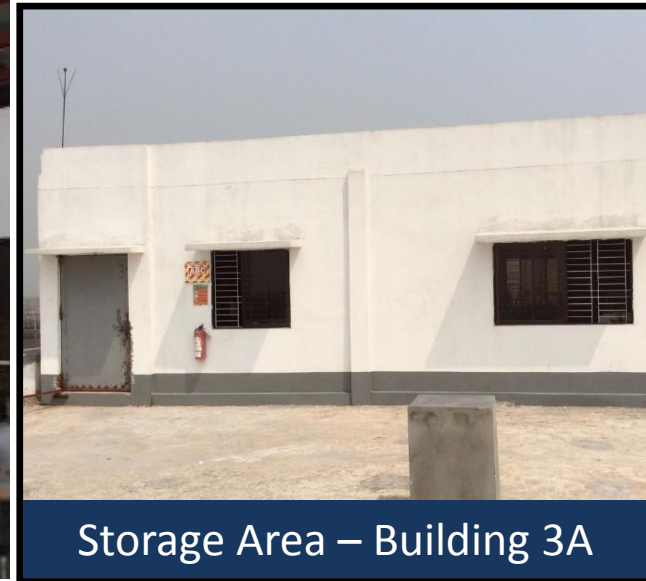
Storage Area – Building 3A

Steel roof over storage section of Building 3A. Section sizes appear inadequate to support roof and should be checked by a Building Engineer.
