# SQ Celsius Ltd.

Beraiderchala, Keowa, Maona, Sreepur, Gazipur, Bangladesh.  
(24°12'36"N, 90°24'58" E)  
3<sup>rd</sup> June 2014

## Structural Inspection Report

### Observations & Actions

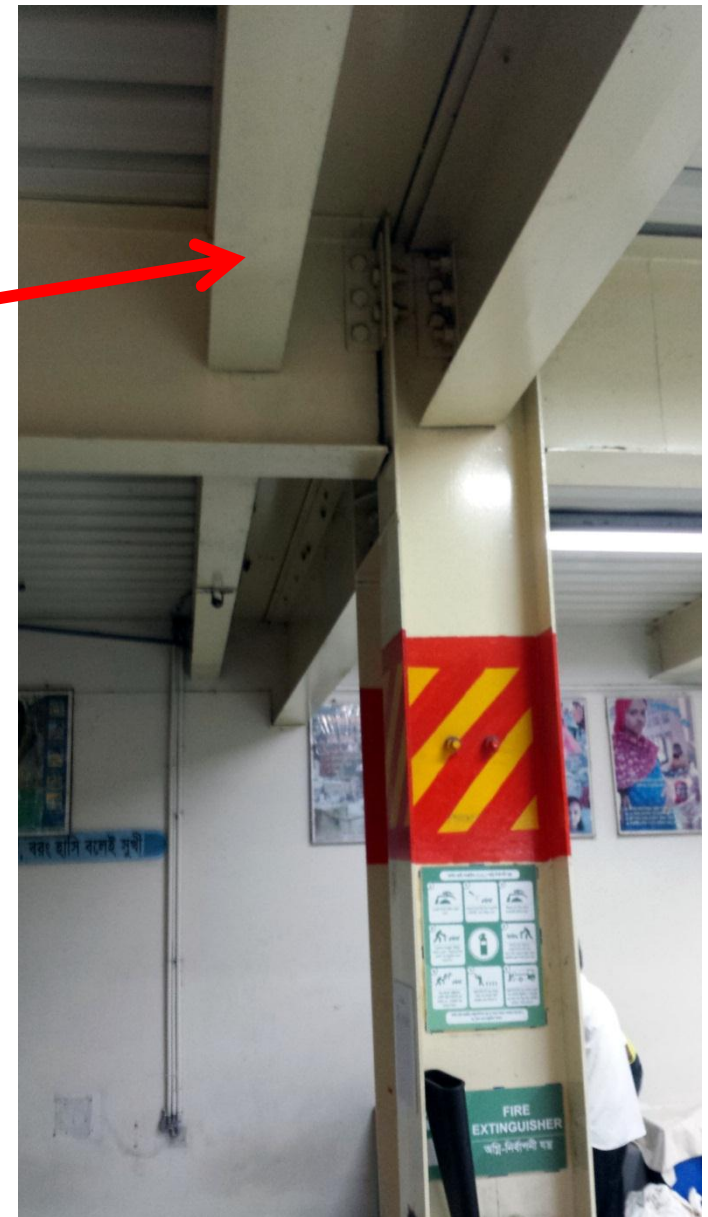
Mezzanine extension not shown on drawings

- The extended structure on 2<sup>nd</sup> Floor composite steel / concrete structure to be indicated on the structural drawings
- The extended 2<sup>nd</sup> Floor in Production Bldg-1 structure checked for the additional loads and verified.
