Gumti Textile Ltd. (Extension)

Shafipur, Anser Academy, Kalikour, Gazipur

21 August 2025

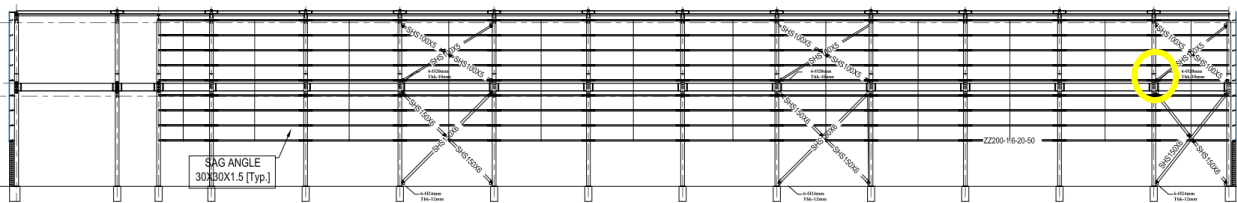
Description: Discrepancies were observed between the construction drawings and onsite conditions regarding the roof bracing and compression strut layout. Eccentric connections (highlighted in yellow) were found where concentric connections were specified. The building engineer is required to survey the entire structure and prepare as-built drawings that accurately reflect site conditions.

5.		Carry out the required remedial work where required.	within 6 months
6.	Inconsistency between the construction drawing and the on-site conditions (Building D)	The building engineer is required to survey the entire structure and prepare as-built drawings that accurately reflect the actual site conditions.	within 6 weeks

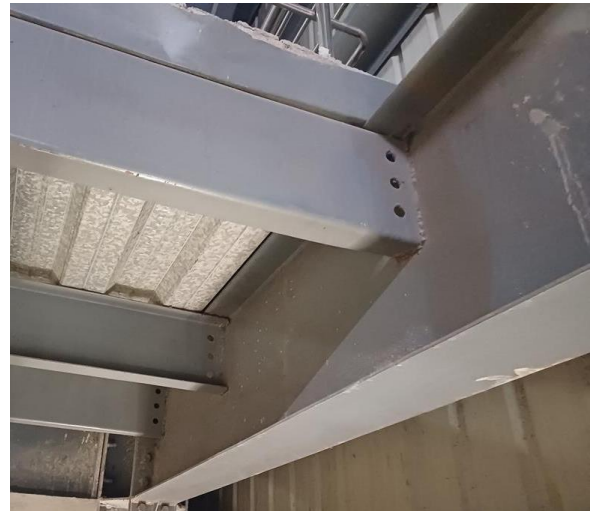
extra hole in the connection

Description: During inspection, faulty erection was observed at several locations. The building engineer is required to investigate, identify & rectify all fabrication faults by suitable methods.
