# INITIAL FIRE SAFETY INSPECTION REPORT

**GAVA PRIVATE LIMITED**

**RSC ID: 26131**

**Plot # 114-120, Dhaka Export Processing Zone (Old Zone), Ganakbari, Ashulia, Dhaka-1349**

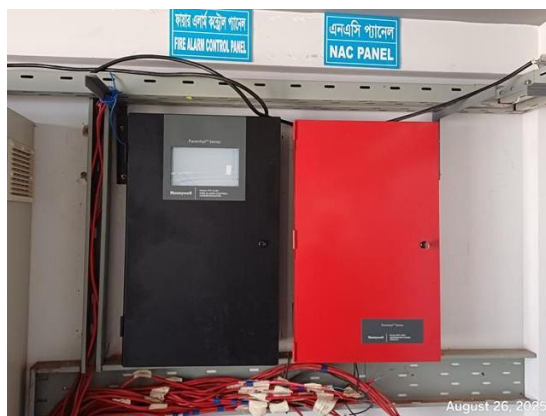
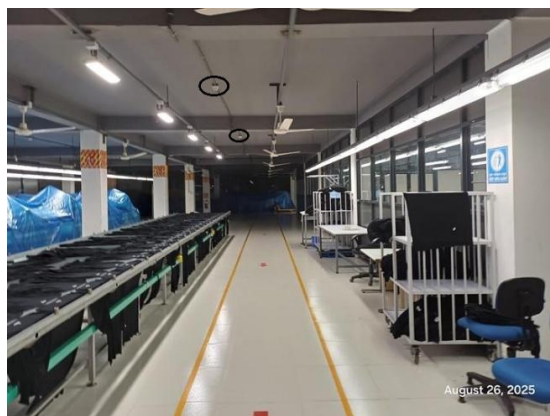
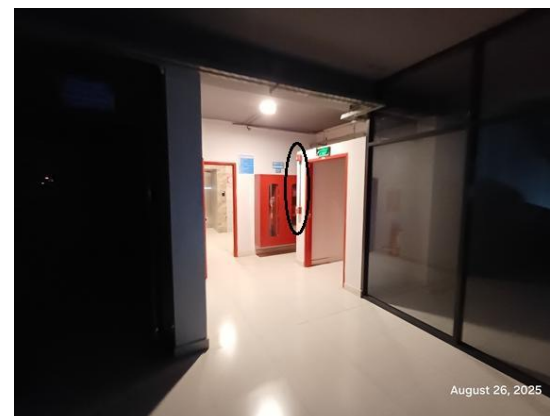
| SI No. | Category | Findings | Required Action | Remediation Time Frame |
|---|---|---|---|---|
| F5 | Fire Alarm & Detection system | <p>The factory has installed a fire alarm and detection system that requires a detailed review to confirm compliance with NFPA 72 and RSC Technical Guidelines (Standard).</p> <p>Location: Office Building-1</p> | <p>Submit the fire alarm and detection system design to RSC for review.</p> <p>Once the design is reviewed, install and modify the fire detection and alarm system throughout the building in accordance with review comment, RSC Technical Guidelines (Standard) and NFPA 72.</p> <p>After installation the owner shall conduct internal testing and commissioning and then contact the RSC for witness of final acceptance testing.</p> | Design within 2 Months and modification/ installation with 4 Months |

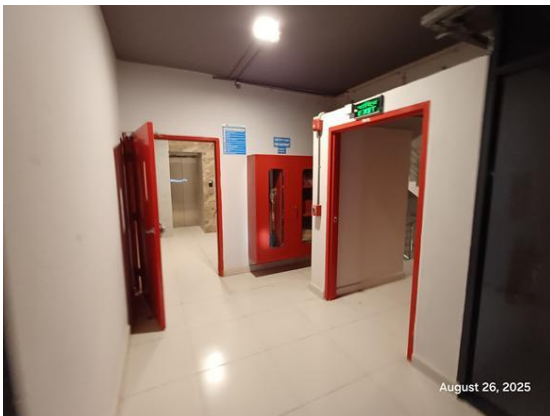
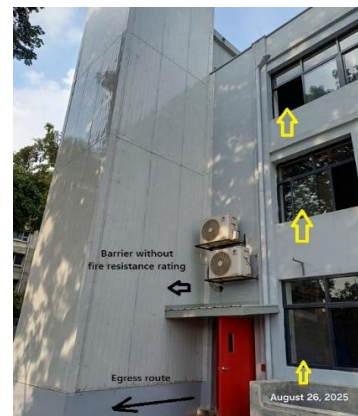
| SI No. | Category | Findings | Required Action | Remediation Time Frame |
|---|---|---|---|---|
| F8 | Fire Rated Construction | <p>Elevator shafts open directly into the production floor without proper fire separation due to unprotected shaft barrier (enclosure) and unprotected opening.</p> <p><b>Non-Compliance Reason:</b> Exterior side of lift shaft does not provide 2-hr fire resistance rating and unprotected window opening on 1st and 2nd floor and egress route from ground floor is within 10.0 ft distance. The fire doors interfacing with the fire alarm system were not properly functional during the inspection. Proper certification was not available for fire rated doors and door accessories installed in the factory.</p> <p><b>Location:</b> Office Building-1</p> | <p>Elevator shaft shall be separated from production area by 2 hours fire rated construction. 2-hr fire barriers shall be protected with minimum 1.5-hr fire protective opening assemblies.</p> <p>Keep proper datasheet &amp; certifications for installed fire doors &amp; accessories on-site for verification. The clearance under the bottom of a door shall be a maximum of 3/4 in. (19 mm).</p> | Within 3 Months |

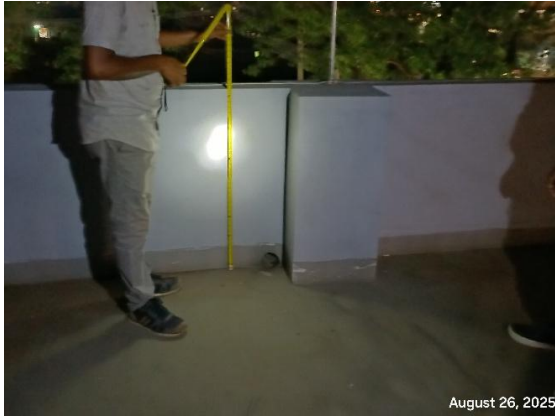
| SI No. | Category | Findings | Required Action | Remediation Time Frame |
|---|---|---|---|---|
| F14 | Means of Egress (Guard rails or parapet wall) | Parapets or guards are not provided as per standard in occupiable roof.<br><br>Location: Office Building-1 | Provide parapets or guards with a minimum height of 1067mm (42 inch.) in accordance with RSC Technical Guidelines (Standard) <sup>1</sup> V1.0 Section 6.12. | Within 3 Months |

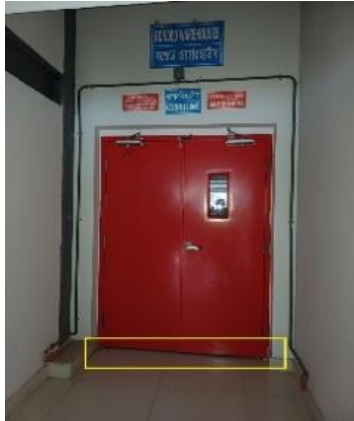
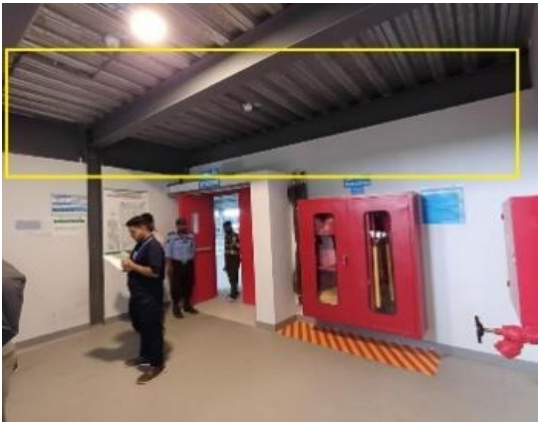
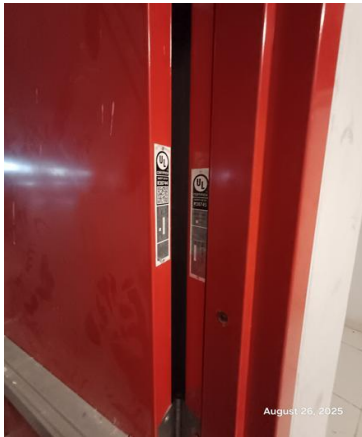
| Sl No. | Category | Findings | Required Action | Remediation Time Frame |
|---|---|---|---|---|
| F18 | Means of Egress | <p>The exit stair enclosures are not separated from work areas and other spaces on each floor by fire-rated construction.</p> <p><b>Location:</b> Main Factory Building- 2</p> <p><b>Non-compliance reason:</b> (i) Unsealed penetrations are found fire rated barrier construction; (ii) Unprotected steel structural element is found in all staircases; (iii) Proper certification is not available for fire rated doors and door accessories installed in the factory. &amp; (iv) The fire doors were found tied by unauthorized means and also interfacing with the fire alarm system &amp; door closers were not properly functional during the inspection.</p> | <p>The exit stair enclosure shall be provided with a minimum 1-hr fire resistance rating for buildings with 3 or fewer stories and a minimum of 2- hr. fire resistance rating for buildings 4 or more stories. Provide 1-hr. fire rated door and seal all penetrations and openings by 1 hr. fire rated fire rated barrier construction for building with 3 or fewer stories. Provide 1.5 hr. fire rated door and seal all penetrations and openings by 2 hr. fire rated fire rated barrier construction for building with 4 or more stories in accordance with section 6.3.1.2 of RSC Technical Guidelines (Standard)<sup>1</sup> V1.0.</p> <p>Ensure that the fire doors are self-closing and positive latching and that they are provided with fire exit (panic) hardware where serving production floors. If fire doors are required to be held open for functional reasons, provide automatic closing devices tied to the fire alarm system.</p> <p>Keep proper datasheet &amp; certifications for installed fire doors &amp; accessories on-site for verification. The clearance under the bottom of a door shall be a maximum of 3/4 in. (19 mm).</p> | Within 3 Months |

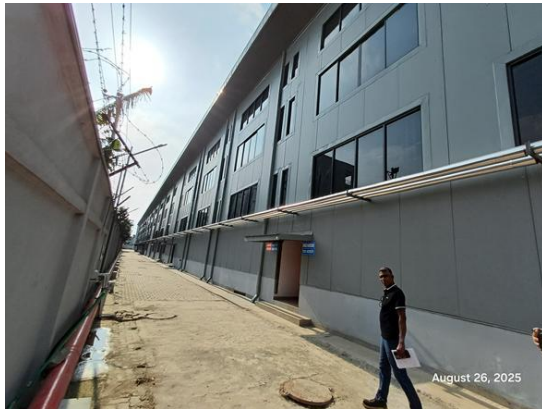
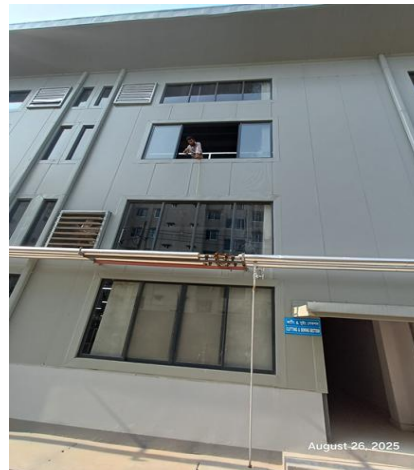
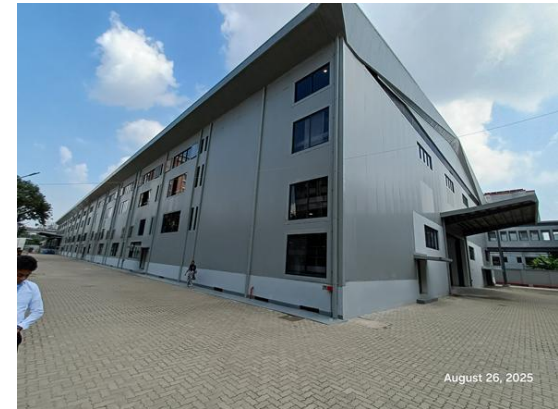
| SI No. | Category | Findings | Required Action | Remediation Time Frame |
|---|---|---|---|---|
| F20 | Fire separation | <p>Unprotected openings in the exterior wall in two consecutive floors lying within 1.5 m and vertical spread of fire is not restricted.</p> <p><b>Location:</b> Main Factory Building- 2</p> <p><b>Non-compliance reason:</b> Unprotected window opening are located 1.50m apart but the exterior sandwich panel do not ensure required fire resistance rating.</p> | <p>Provide flame barriers as similar as sunshades or cornices or projected wall at least 750 mm from the external face of the exterior wall.</p> <p>The flame barrier shall have a fire resistance rating of not less than three-fourths hour.</p> <p>For new building, BNBC 2020 Part III chapter 3 clause 3.1.9.2 Keep proper datasheet &amp; certifications for installed sandwich panel in exterior facade.</p> | Within 6 Months |

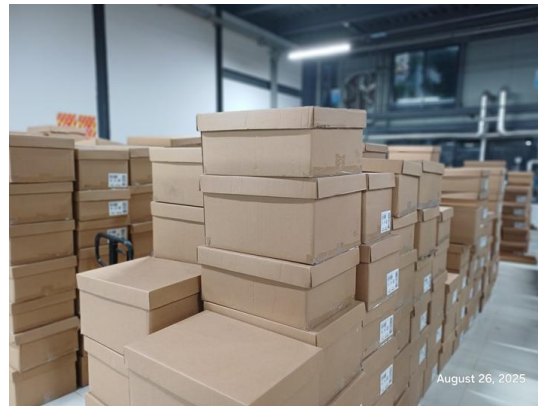
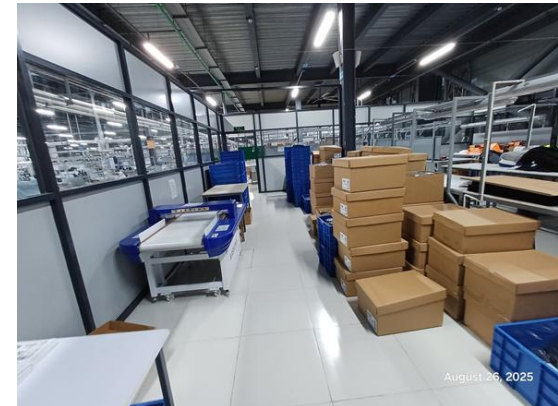
| SI No. | Category | Findings | Required Action | Remediation Time Frame |
|---|---|---|---|---|
| F25 | Fire Rated Construction | <p>Areas used for in-process storage of combustible materials are open to the surrounding occupancy.</p> <p>Location: On ground and 1st floor of Main Factory Building-2</p> | <p>Provide defined storage areas and limit the storage arrangement as follows:<br/>Maximum height of 2.45 m and maximum area of 23 m<sup>2</sup> and is separated by a minimum 3.0 m (10ft) from other storage areas and they do not exceed 10 percent of the building area of the story in which they occur.</p> <p>or,</p> <p>If sprinkler protected, Maximum height 12 ft (3.66 m) and maximum area of 1000 ft<sup>2</sup> (93 m<sup>2</sup>) and separated by a at least 25 ft (7.62 m) and does not constitute more than 10 percent of the building area or 4000 ft<sup>2</sup> (372 m<sup>2</sup>) of the sprinklered area, whichever is greater.</p> <p>or,</p> <p>Enclose the storage area from the surrounding occupancy with a minimum 1 hour construction.</p> | Within 3 Months |

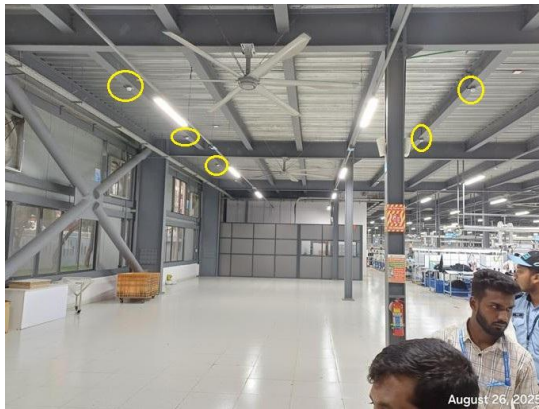
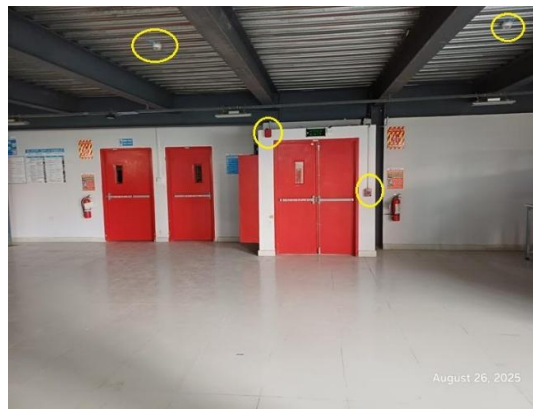
| SI No. | Category | Findings | Required Action | Remediation Time Frame |
|---|---|---|---|---|
| F28 | Fire Alarm & Detection System (FADS) | <p>The factory has installed a fire alarm and detection system that requires a detailed review to confirm compliance with NFPA 72 and RSC Technical Guidelines (Standard).</p> <p><b>Location:</b> Main Production Building-2</p> | <p>Submit the fire alarm and detection system design to RSC for review.</p> <p>Once the design is reviewed, install and modify the fire detection and alarm system throughout the building in accordance with review comment, RSC Technical Guidelines (Standard) and NFPA 72.</p> <p>After installation/modification the owner shall conduct internal testing and commissioning and then contact the RSC for witness of final acceptance testing.</p> | Design within 2 month and modification/ installation with 4 months |

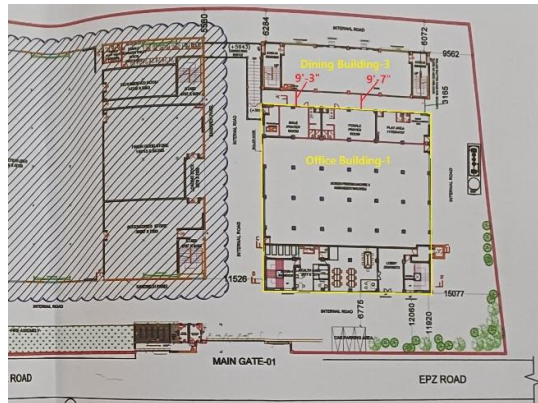
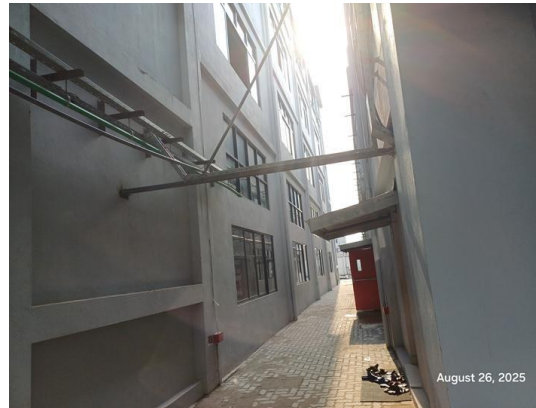
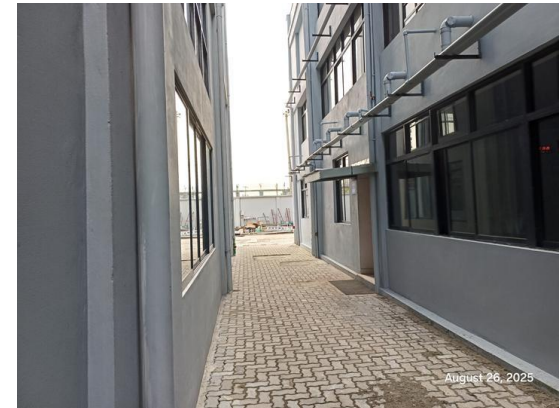
| SI No. | Category | Findings | Required Action | Remediation Time Frame |
|---|---|---|---|---|
| F-37 | Fire Rated Construction | The required fire separation distance for Dining building-3 and wastage shed-1 does not comply with the requirements of BNBC 2020. | The exterior walls shall have a fire resistance and opening protection as specified in BNBC 2020 Part 3 Table 3.2.2 & 3.2.3 and BNBC 2020 Part 3 Section 2.4.1.3. | Within 6 Months |

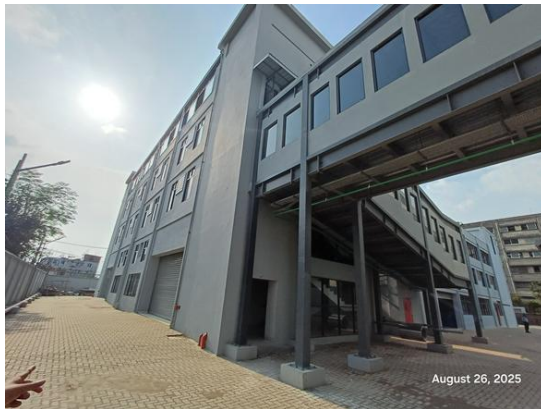
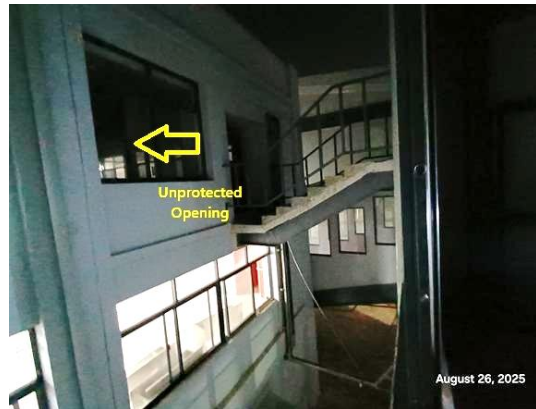
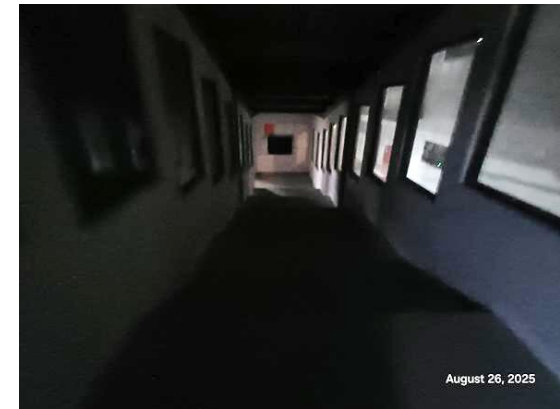
| SI No. | Category | Findings | Required Action | Remediation Time Frame |
|---|---|---|---|---|
| F-38 | Fire Rated Construction | <p>A non-rated connecting corridor has been constructed between two buildings which is not fire separated from the adjacent building.</p> <p>Location: Connecting corridor between Production building-2 &amp; Dining building-3 staircase and connecting corridor between Dining building-3 stair &amp; Office building-1.</p> | <p>Separate the buildings with a minimum 2-hour fire-rated construction on both sides of the connecting corridor. Opening protection extending up to 10 feet beyond the connecting corridor shall meet section 4.6 of RSC Technical Guidelines (Standard)<sup>1</sup> V1.0.</p> | Within 3 Months |

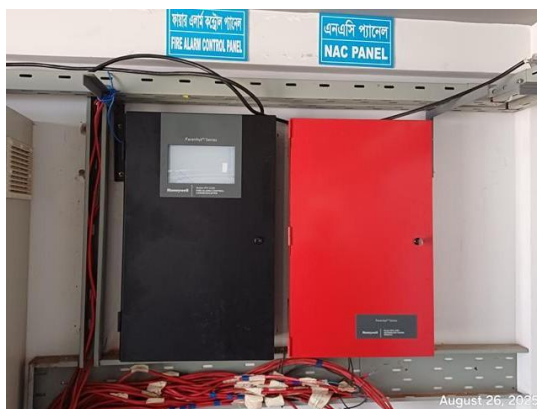
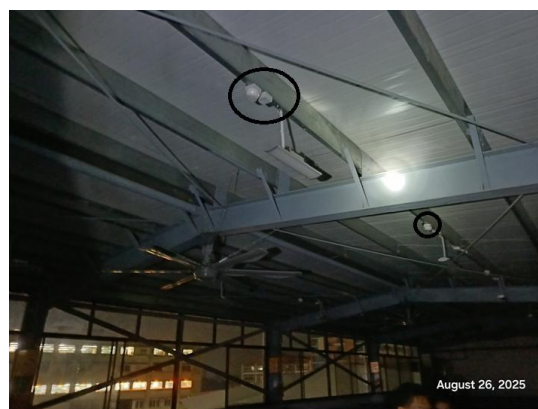
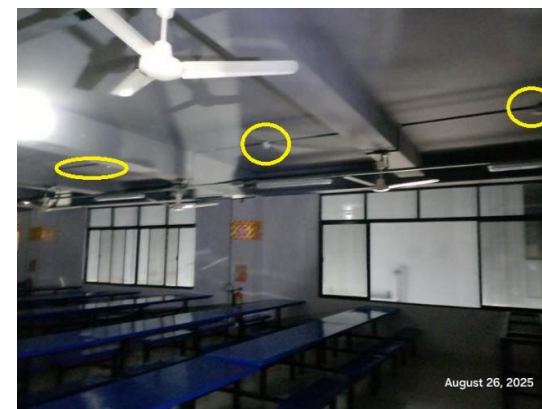
| SI No. | Category | Findings | Required Action | Remediation Time Frame |
|---|---|---|---|---|
| F-41 | Fire Alarm & Detection System (FADS) | <p>The factory has installed a fire alarm and detection system that requires a detailed review to confirm compliance with NFPA 72 and RSC Technical Guidelines (Standard).</p> <p><b>Location (s):</b> Dining Building-3 (G+3), Utility Building-4 (Part-1), Utility Building-5 (Part-2) (G), Building-7 Guard Room-2 (G), Building-6 Guard Room-1 (G), Building-8 Fire Panel Room (G), Building-9 Fire Pump Room &amp; U.G.W.R (G+B), Building-10 Maintenance Workshop (G) and New Waste Store Shed-1 (G)</p> | <p>Submit the fire alarm and detection system design to RSC for review.</p> <p>Once the design is reviewed, install and modify the fire detection and alarm system throughout the building in accordance with review comment, RSC Technical Guidelines (Standard) and NFPA 72.</p> <p>After installation/modification the owner shall conduct internal testing and commissioning and then contact the RSC for witness of final acceptance testing.</p> | Design within 2 month and modification/ installation with 4 months |

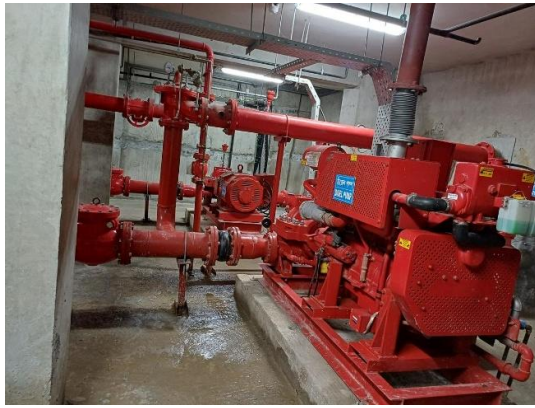
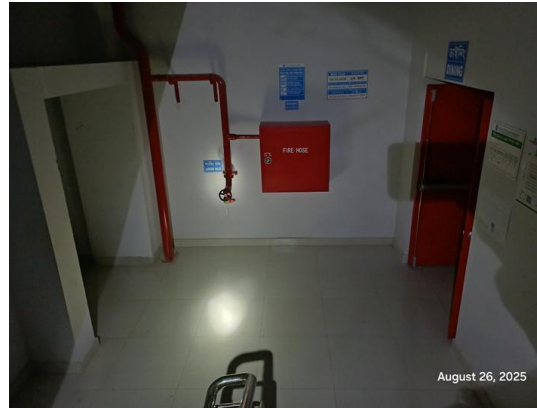
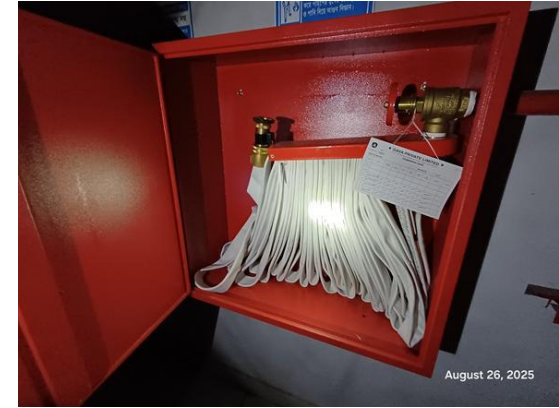
| SI No. | Category | Findings | Required Action | Remediation Time Frame |
|---|---|---|---|---|
| F-44 | Fire Suppression System (SUPS) | <p>The factory has installed a standpipe &amp; Hose system that requires a detailed review to confirm compliance with NFPA 14,20, 24 and RSC Technical Guidelines (Standard).</p> <p><b>Location:</b> Dining Building-3</p> | <p>Submit the standpipe system drawing to RSC for review.</p> <p>Once reviewed, install or modify the standpipe system throughout the building in accordance with RSC Technical Guidelines (Standard)<sup>1</sup> V1.0. and NFPA 14, 20,22 and 24.</p> <p>After installation the owner shall contact the RSC for witness of conducting the final acceptance testing of the standpipe system.</p> | Design within 2 month and modification/ installation with 4 months |

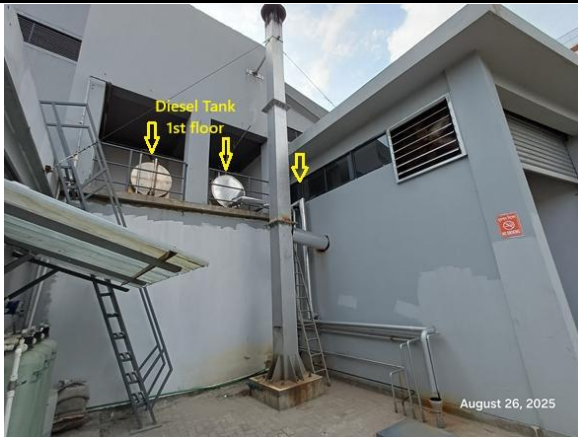
| SI No. | Category | Findings | Required Action | Remediation Time Frame |
|---|---|---|---|---|
| F-54 | Fire Rated Construction | <p>Boiler is not properly separated by fire rated construction with other Occupancies.</p> <p><b>Location:</b> Unprotected opening with Diesel tank room on 1st floor</p> | <p>Boilers or other heat producing equipment shall be separated from other occupancies by a minimum 1-hr fire rated construction (wall, floor, slab etc.). Seal all penetrations and openings (door, window etc.) should be protected by 0.75-hr (45 min) fire rated materials to maintain the fire separation if required. All exhaust systems shall discharge to the exterior of the building in a safe location.</p> <p>Or</p> <p>Relocate it to exterior of the building and maintain a minimum 3m (10 ft.) spatial separation distance from the building. Boiler room separation shall meet section 3.4.2.1.2 of RSC Technical Guideline (Standard) .</p> | Within 3 Months |
