Revision: Issue 1
Date: 16th June 2014

Universal Menswear Ltd.

Plot 234-238, 252-254, Adamjee EPZ, Narayanganj
(23.676969, 90.518717)
7th June, 2014

Structural Inspection Report

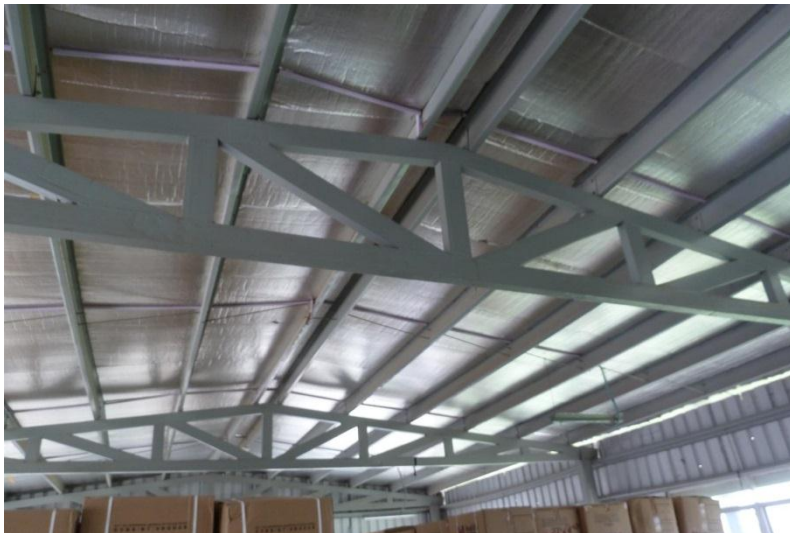
Trusses to part B

(A) Lateral stability system to roof frame is not clearly defined – absence of roof cross bracing and wall cross bracing
(B) Unclear portal frame action, column-to-truss connection details appear non-engineered
(C) Purlin lateral torsional buckling observed

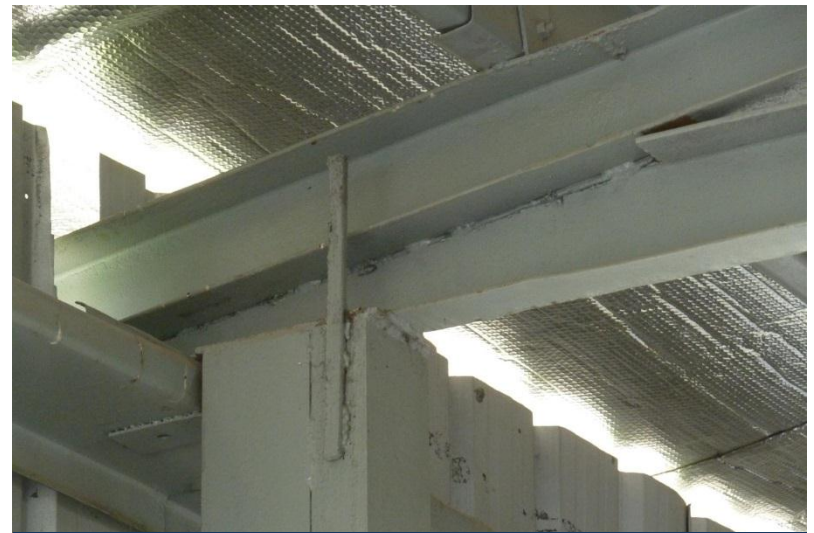
Truss supported on box section column, fabricated from individual sections

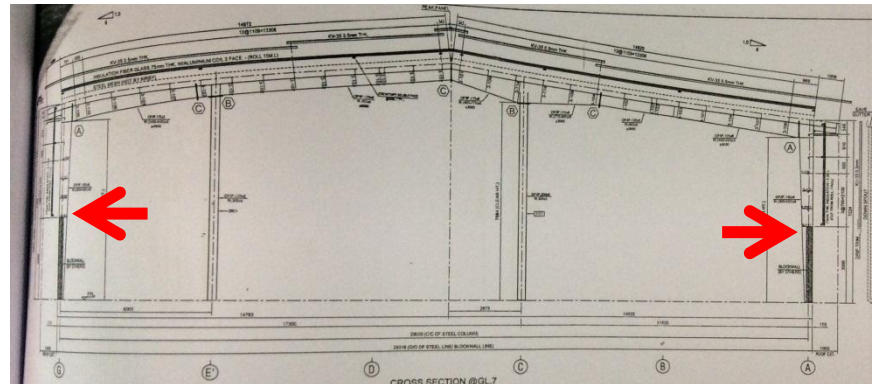
As constructed, lateral support to tops of brick walls is not clearly defined

Unclear lateral support to tops of brick walls

- Building engineer to verify stability of brick walls according to BNBC and modify if necessary

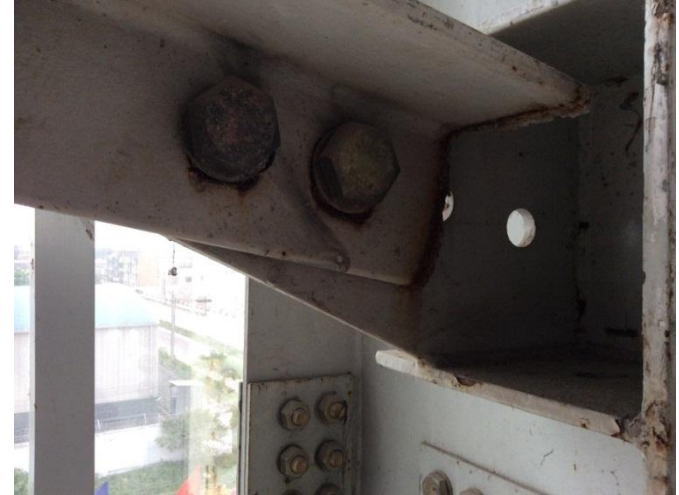
Item 1 and actions

Apparent lack of fire protection to the primary steel structure of all inspected buildings

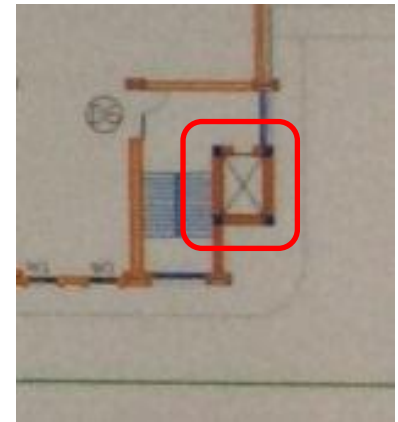
- In a number of locations throughout Building 1, cross bracing elements were either missing, or had end connections which were cut, missing bolts or misaligned

Cross bracing elements missing or modified

- Building Engineer to assess the as-built construction to BNBC and modify if required
- Building Engineer to carry out as-built survey of converted area and produce accurate complete as-built drawings

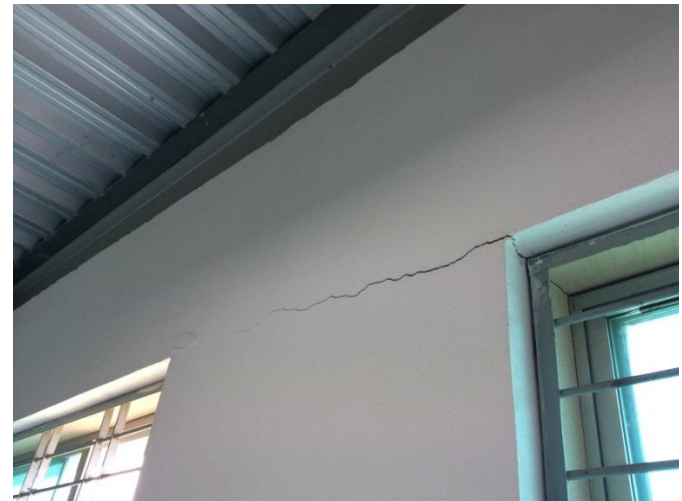
Item 3 and actions

Cracking observed to brick perimeter walls

- Building engineer to record all cracking throughout factory compound and monitor on an on-going basis
- If further cracking occurs Building Engineer to investigate and remediate as appropriate

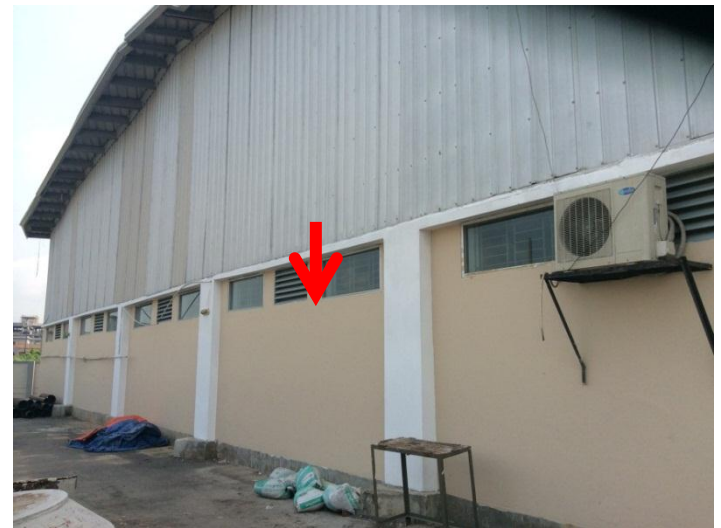
Item 2 and actions

Unclear lateral support to tops of brick walls

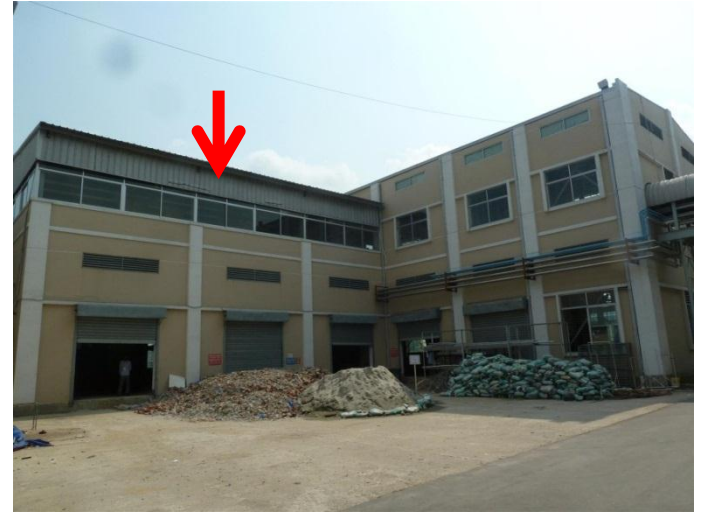
Item 3 and actions

Roof structure added beyond permit drawings

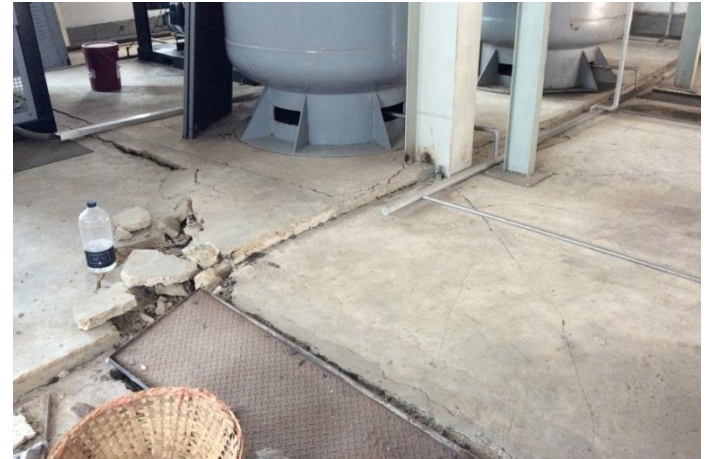
Item 4 and actions

Significant settlement of ground floor slab

Priority 1

(Immediate - Now)

- Building Engineer to monitor uneven settlement
- Building Engineer to assess effect of temporary ties on the permanent structure. Ties to be substituted by an alternative safe temporary system if deemed unsafe for the permanent structure

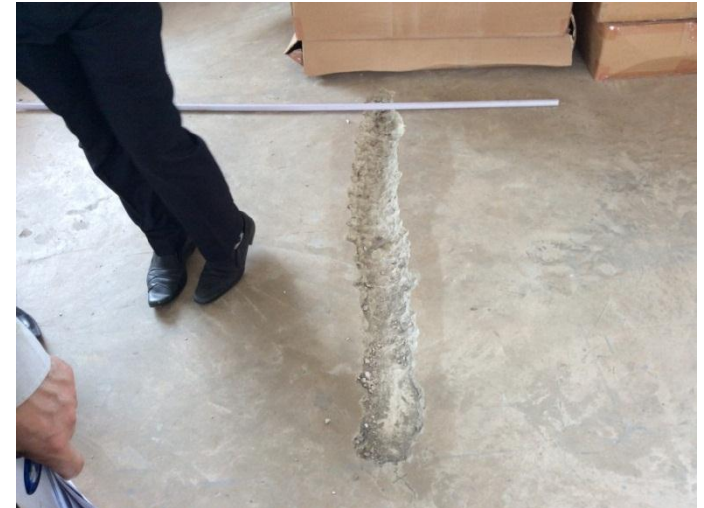
Item 5 and actions

Cracking to screed and repair attempts

Priority 1

(Immediate - Now)

- Building Engineer to consider local repairs to slab cracking
