# Safia Apparels Ltd

Plot-b-46/47 & 64/65, BSCIC Industrial Estate, Panchobati, Fatullah, Narayanganj  
(23.62576, 90.47897)

12<sup>th</sup> April 2014

# Observations

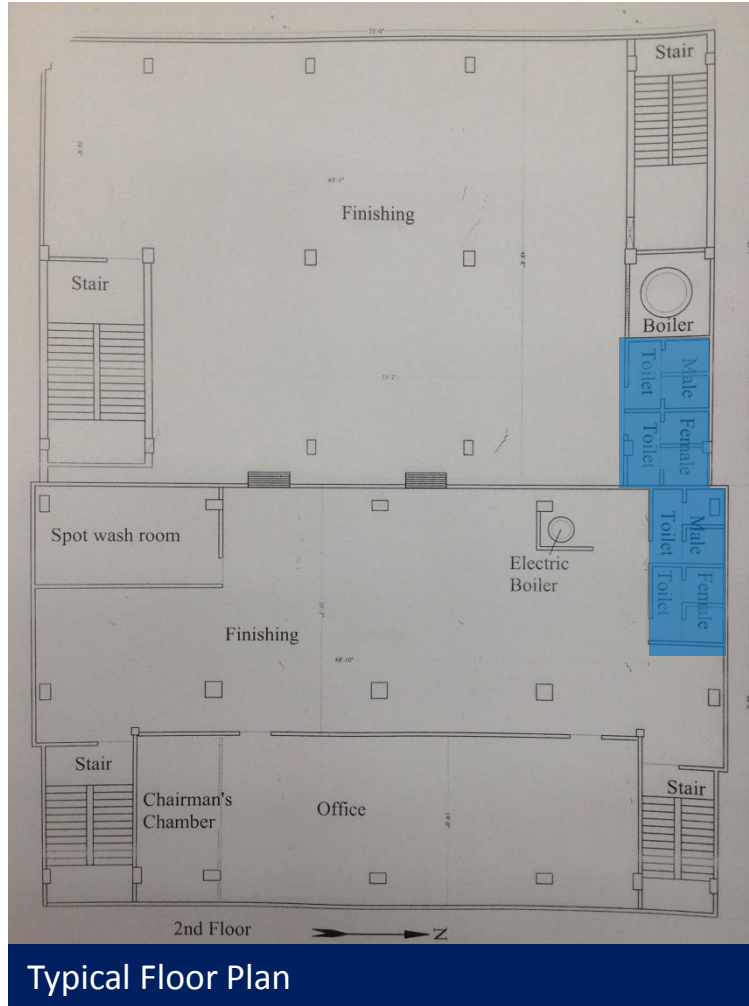
**Heavy floor loading: Toilet areas of both buildings  
(slab build-up) and cantilever slab to Building 1  
(high storage)**

Heavy loading was noted in the toilets along the North elevation of Buildings 1 & 2, in the form of plinths and walls. Building Engineer to check that the slabs and beams have been adequately designed to accommodate this loading.

300mm Plinth to Toilets

Extent of Toilets to all Floors

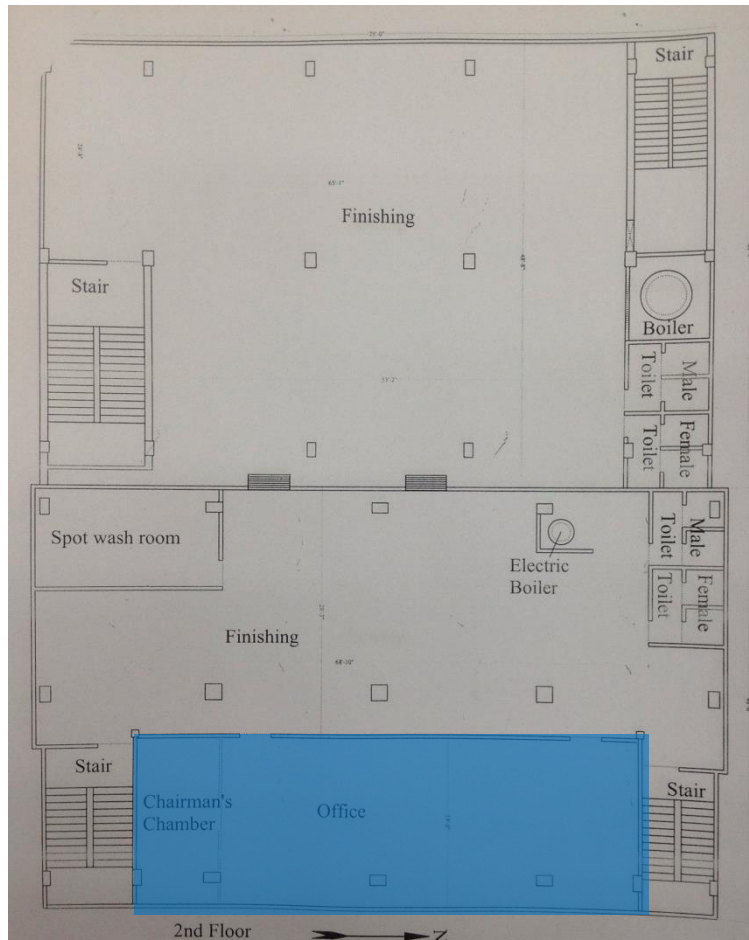
Typical Floor Plan

Heavy loading, in the form of temporary storage of fabric, was noted along the North elevation of Buildings 1, particularly to 4<sup>th</sup> and 5<sup>th</sup> Floor levels. Building Engineer to check that the slabs and beams have been adequately designed to accommodate these loadings, particularly at the cantilever location where there are no downstand beams.

Fabric Storage – Up to 2.5m High

Extent of Storage Loading to 4<sup>th</sup> and 5<sup>th</sup> Floors

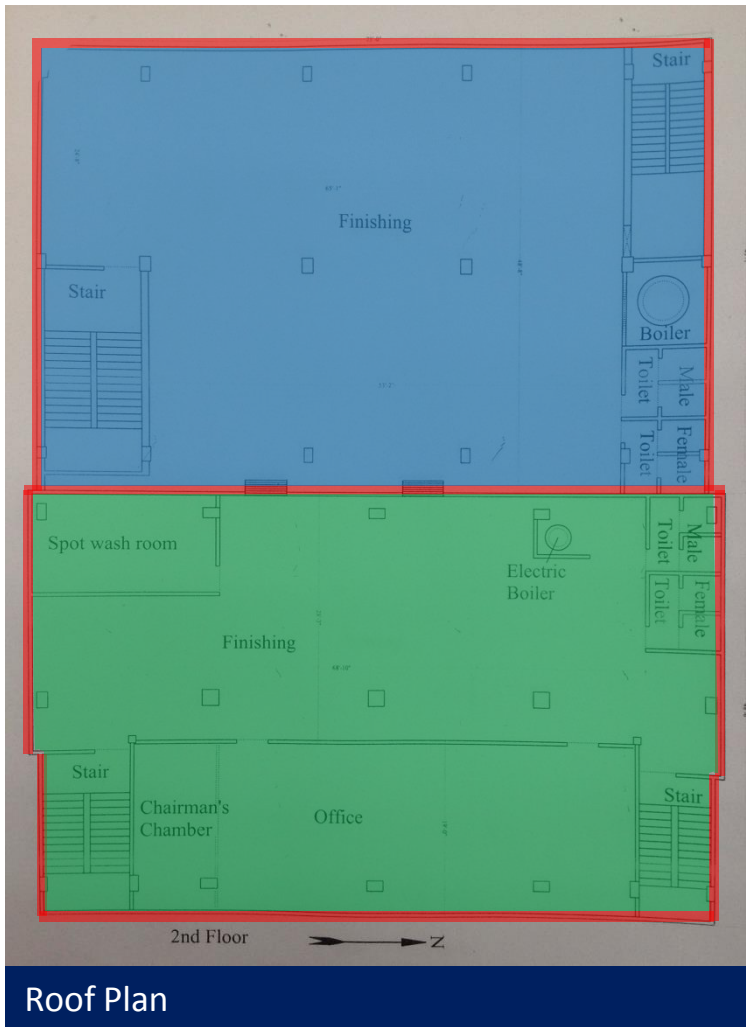
# **Lack of any guarding / edge protection at Roof Level**

There is no edge protection to either building Roof, where construction works are ongoing. Building Engineer to install adequate fall barrier with immediate effect.

Height of Parapet to Roof

Edge Protection to be Provided

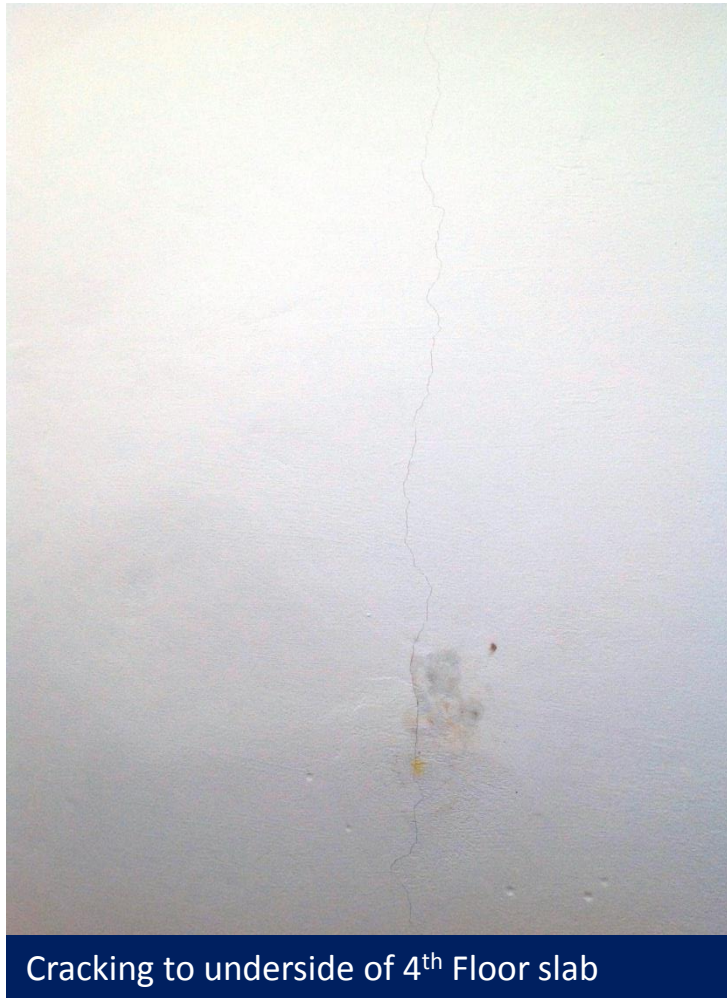
# **Hairline cracking on beams and some slab soffit areas**

Hairline cracking was observed to the soffit of a number of beams and slabs at 1<sup>st</sup>, 2<sup>nd</sup>, 3<sup>rd</sup> and 4<sup>th</sup> Floor levels. Building Engineer to investigate and carry out remedial works to the structure as required.

**ITEM 4:** Hairline cracking on beams and some slab soffit areas.

| Item No. | Observation | Recommended Action Plan | Recommended Timeline |
|---|---|---|---|
| 5 | Hairline cracking in beams and slab soffits | Monitor cracks on beams. Engage a Building Engineer to investigate if cracks are only in the plastering | 6-months |

| Item No. | Observation | Recommended Action Plan | Recommended Timeline |
|---|---|---|---|
| 6 | Hairline cracking in beams and slab soffits | Engage a Building Engineer to advise on load reduction and repair and strengthening of the beams if required | 6-months |

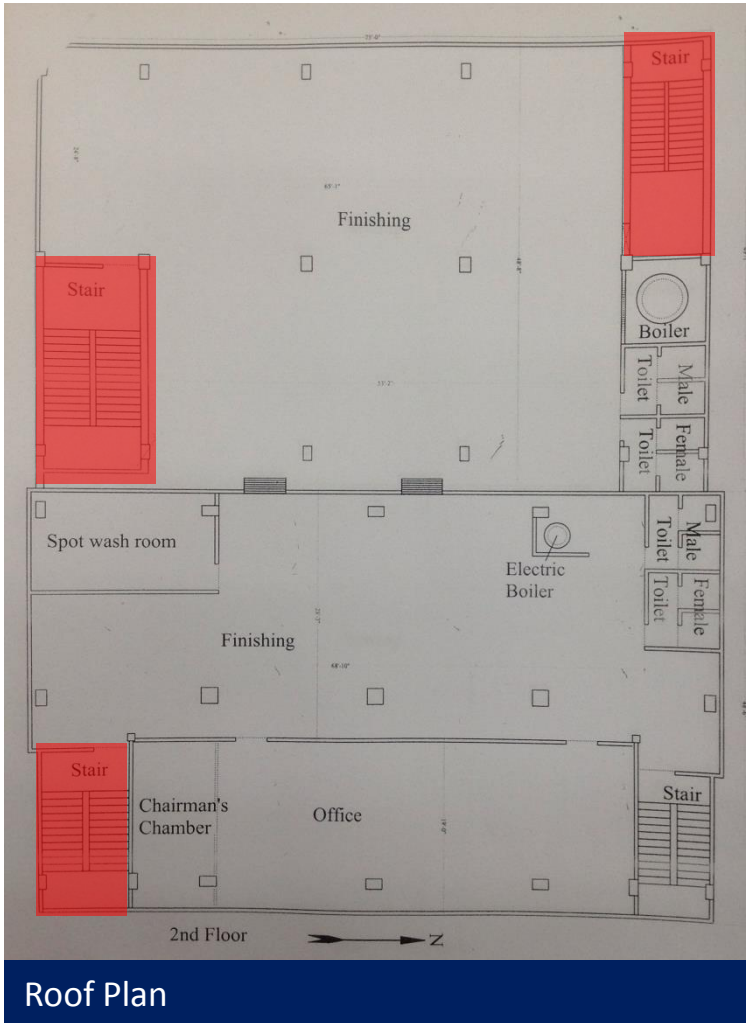
## Lightweight Steel Roofs

# **Apparently non engineered roof structure to stair enclosures above main roofs**

Building Engineer to review the design of the lightweight roof structures the staircores to both buildings, which do not appear to be engineered. Building Engineer to implement any upgrade works, including removing / securing loose metal sheeting, as required.
