# Sweatertech Ltd. (Extension 2)

Plot # 898,1351, Gacha Road, Gazipur Sadar, Gazipur-1704

22 April 2026

### Observation-01: Mismatches in as-built drawing (Warehouse Shed)

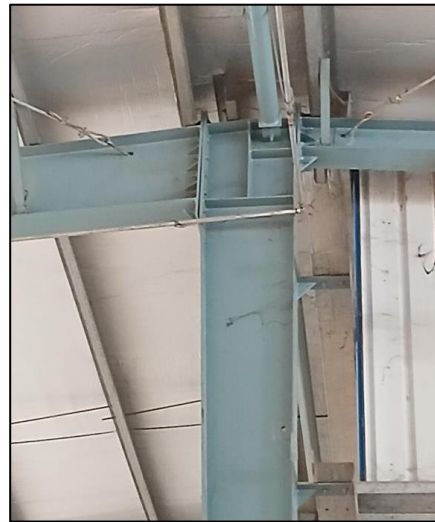
Wall girt missing at grid I

**Description:** During inspection several mismatches including mismatches in connection details & flange thickness of steel columns, missing in flange brace & wall girt were observed.

The building engineer is required to survey the structure, update the as-built drawing as per onsite conditions, revise design report accordingly and submit updated design report to RSC.

| Item No | Observation | Action Plan | Timeline |
|---|---|---|---|
| 1. | Mismatches in as-built drawing (Warehouse Shed) | Update the as-built drawing as per onsite conditions | within 6 weeks |
