# RGR Sweater Ltd

Madhakhala Shreepur, Gazipur  
(24.180929N, 90.435039E)

7<sup>th</sup> November 2015

# Observations

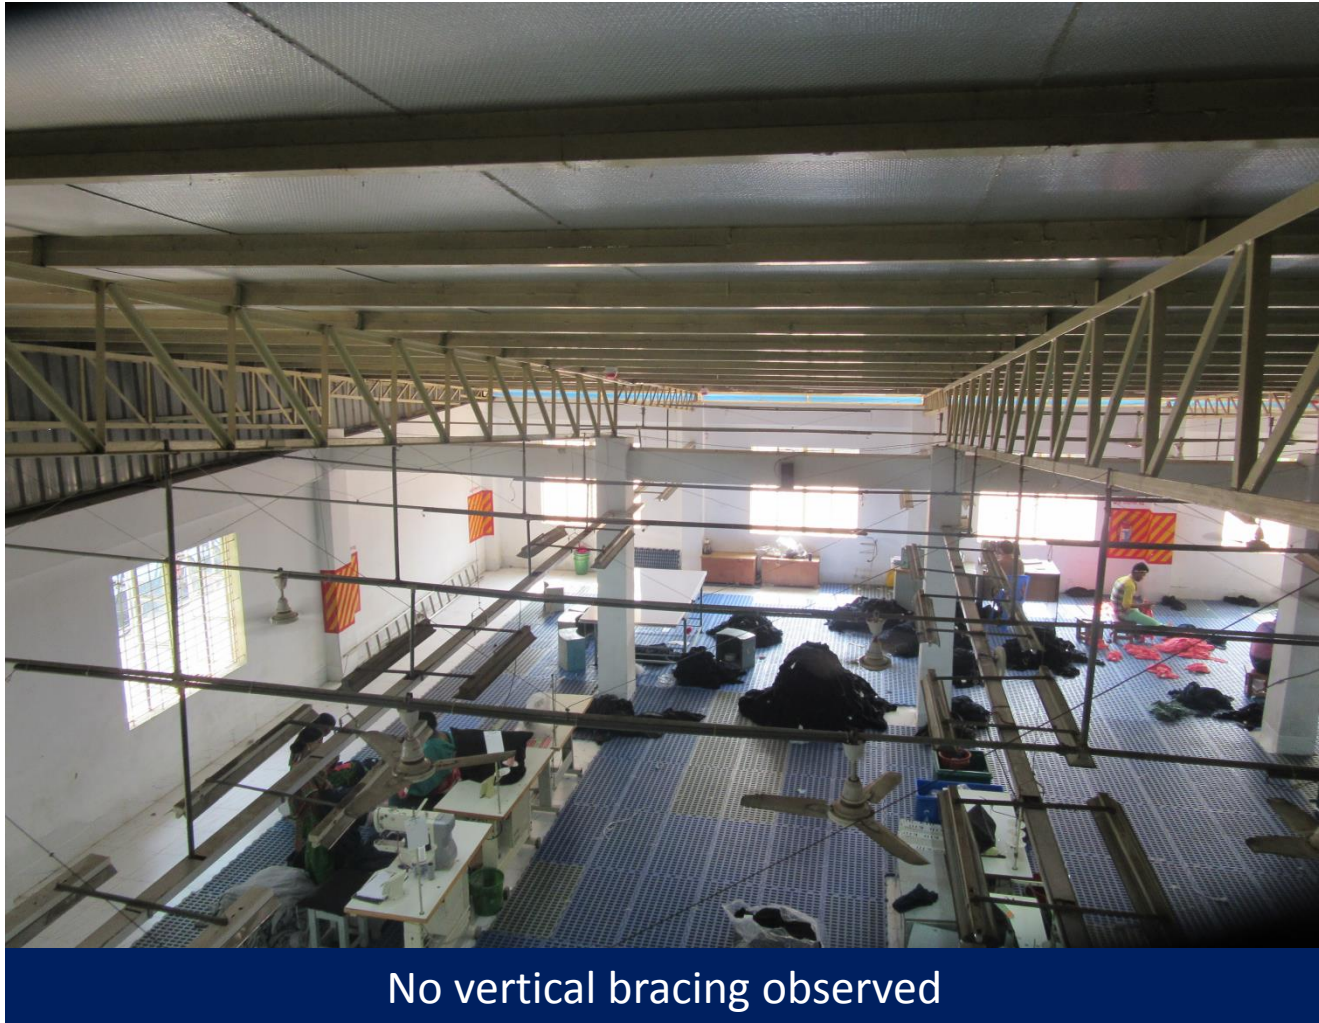
## **Building – 2 (Steel shed)**

| Item No. | Observation | Recommended Action Plan | Recommended Timeline |
|---|---|---|---|
| 2 | Missing horizontal braces on the roof for lateral stability | Building Engineer to carry out a stability analysis and provide additional stability system. | 6-months |

**ITEM 2:** : Lateral stability of the roof for Building 2 needs to be verified by the Building engineer.
