# Maxcom International Ltd

25.MARCH.2014

## Identified Priority 2 Concerns

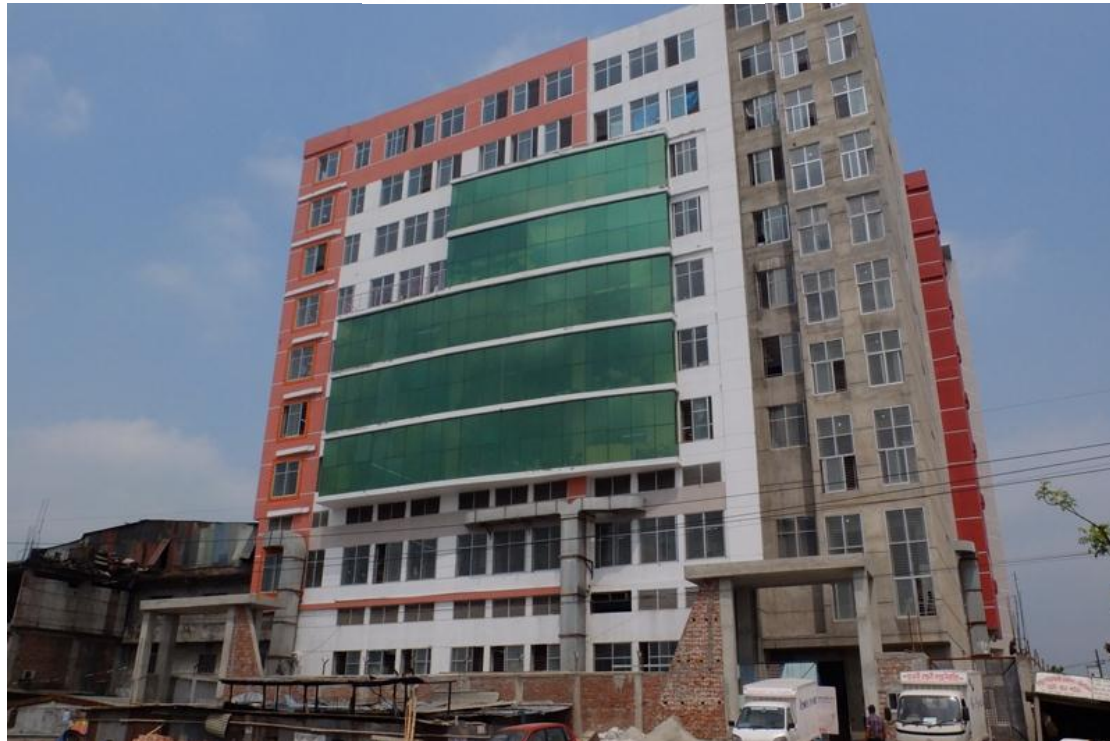
The main building is claimed to have an imposed load rating of 150psf per floor (7.18kPa). Having run the column run-down analysis, using 7.18kPa on all floors causes a **RED** warning. However, applying 10% live load reduction to the 1/F, and 20% live load reduction on 2/F to 8/F brings the column into an **AMBER** warning. Furthermore, reducing imposed load of 1/F to 8/F to 3.0kPa maximum live load returns the column to a **YELLOW** warning.

Fortunately, site conditions suggest an actual imposed load of much less than the design load, and so reducing the imposed load limit to 3.0kPa on all floors except G/F is considered reasonable.

Column unstable under full live load
