# Uttara Knitwears Ltd Uttara Knitting and Dyeing Ltd

07 June 2014

## Structural Inspection Report

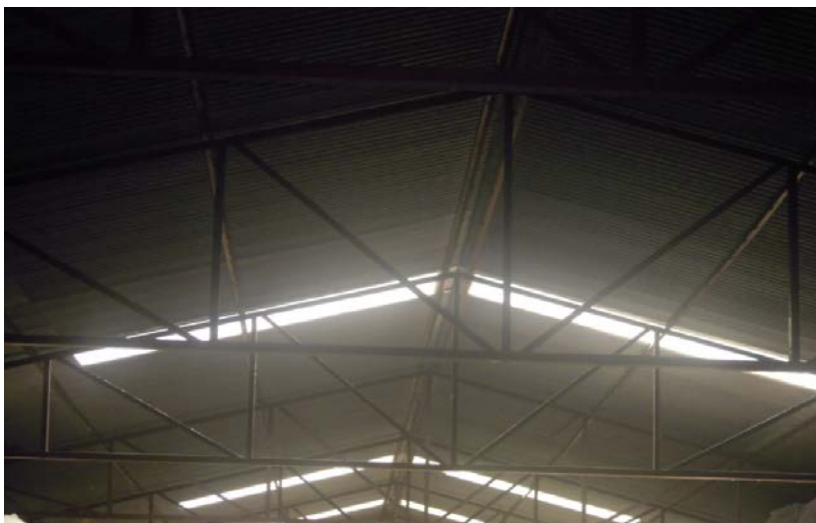
Light steel structure - storage

Light steel structures are generally un-braced or rely  
solely on masonry infill walls when present.  
Frame action in the concrete structures

- No bracing noted in most of the light weight steel roofs and structures viewed on site.
- The Building Engineer is to assess the adequacy of the structures to resist wind loading (pressure, suction & uplift). The installation of bracing and any other remedial measures to be carried out as directed by the Building Engineer.
