4A Yarn Dyeing Ltd.

Kaichabari, Savar, Dhaka-1340, Bangladesh
(23.945831, 90.261923)

25 March 2014

Observations

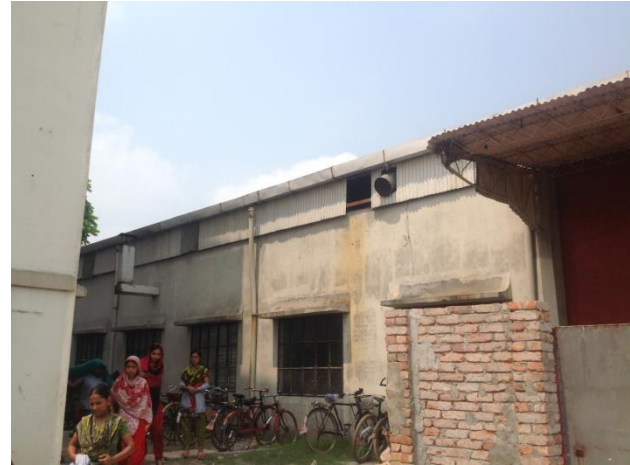
No roof bracing observed in single storey industrial building. Cantilevering perimeter walls are the only evident stability structure.
