# Denitex Limited.

## Client Summary Report

### Observations & Actions

On Tuesday 22 March, 2016 Md. Abdul Momin, Abu Daud Kabir Ahmed & Md. Kamruzzaman Shohug of Bangladesh ACCORD foundation carried out a visual structural survey of the Denitex Limited at the address and coordinates given on the cover page of this report.

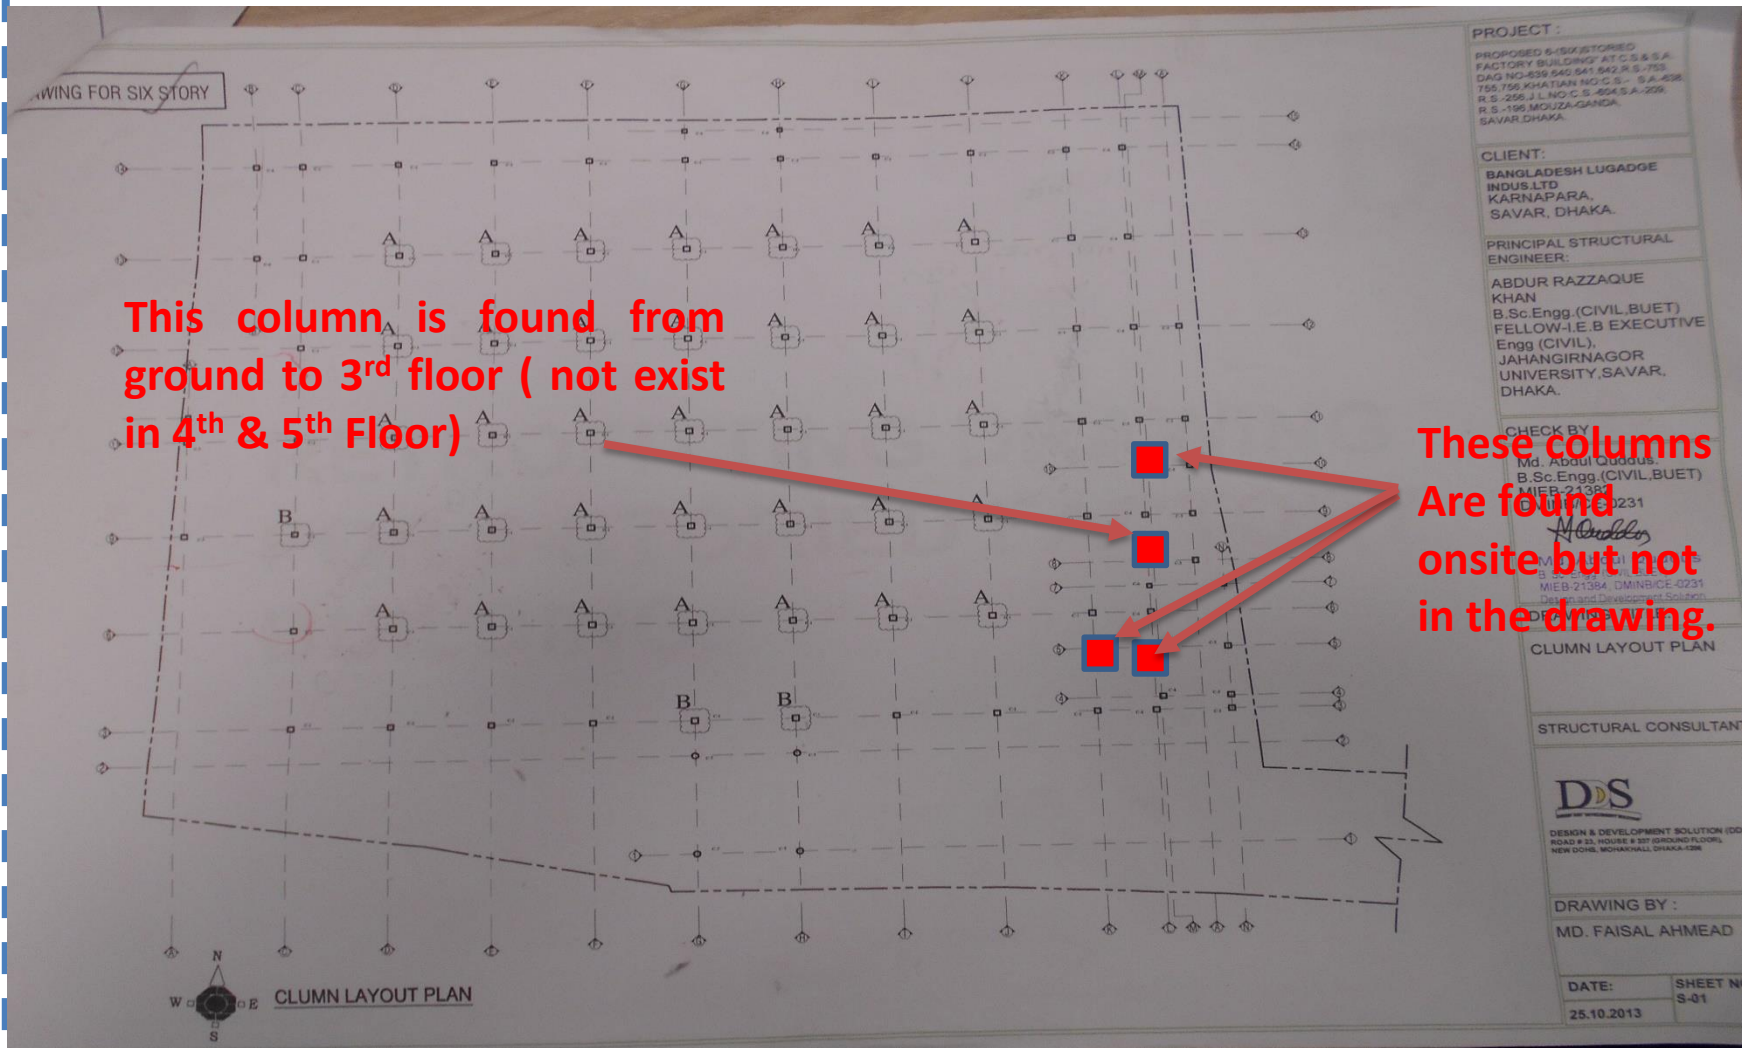
# **Inconsistencies of drawings and As built construction.**

## Inconsistencies of drawings and As built construction.

C5, C6 & C7 column is not shown in column schedule but found in column layout of structural drawing.
