# Fame Sweaters Ltd. SS Sweaters Ltd.

Holding-124,Darail, Sataish bazar, Tongi; Gazipur, Dhaka  
(23.91601N, 90.36467E)

05 March 2014

# Observations

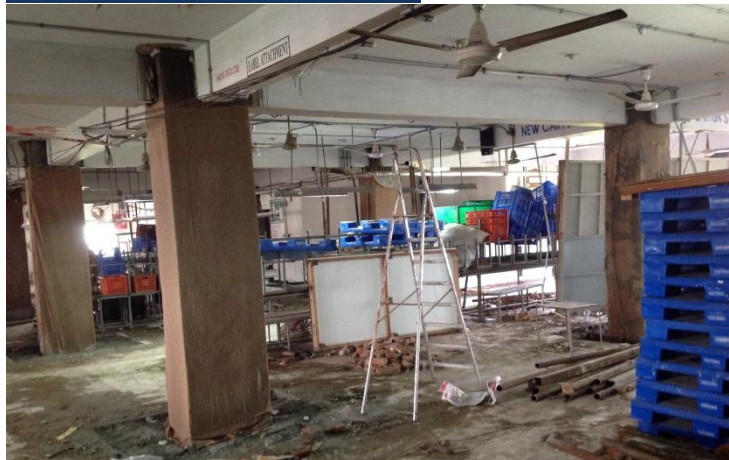
Strengthened column

Cursory calculations indicate that the working stress in internal and perimeter columns is at a high level at ground floor level and 1<sup>st</sup> floor. Remedial works, designed by others, are on-going at ground and 1<sup>st</sup> floor level to strengthen columns.
