# Mondol Fashion Ltd Shoe Maker Ltd.

Rashid Tower, Tongabari, Asulia, Savar  
(23.90585, 90.32248)

8<sup>th</sup> April 2014

# Observations

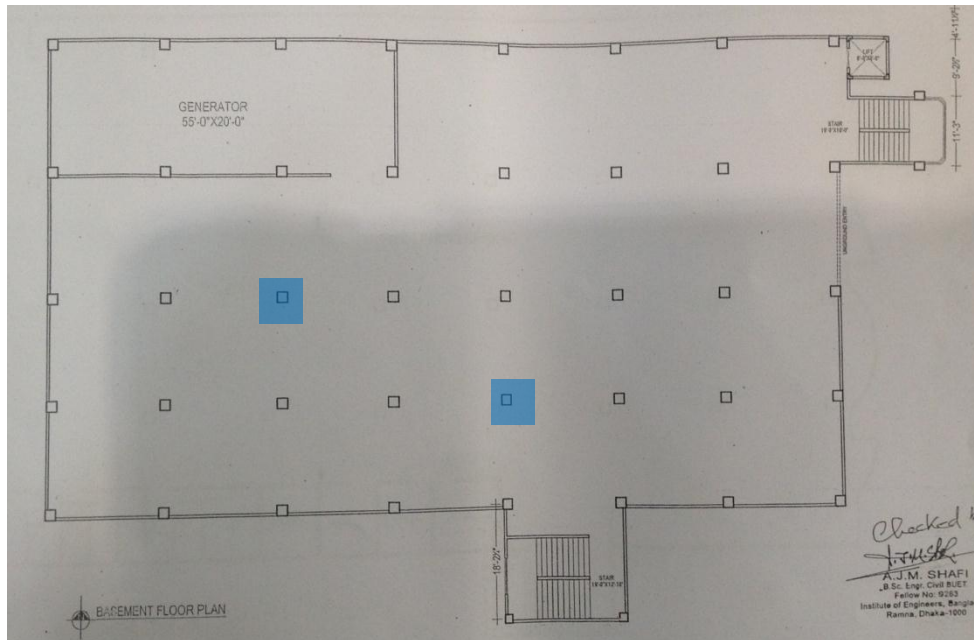
Ground Floor (Semi-Basement) Floor Plan

# Stress Levels in Columns

Cursory calculations indicate that the working stress of the columns at Ground Floor and First Floor levels are at a high level. Refer to Action 1.

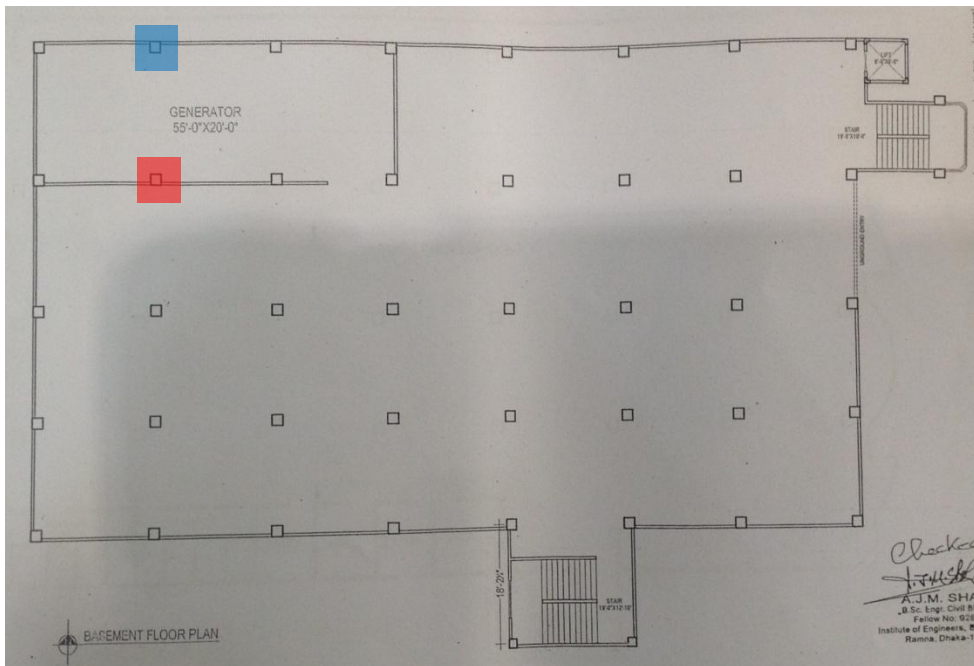
Ground Floor (Semi-Basement) Floor Plan

Construction of the building began in 2006, with construction of Foundations up to 2<sup>nd</sup> Floor level completed in 2007. Levels 3, 4 and 5 were subsequently constructed between 2012 and 2013. Stone aggregate was noted in the Ground Floor (or semi-basement) columns, although brick aggregate was observed at the head of one of the exposed columns at the intersection with the 1<sup>st</sup> Floor Slab. It is understood that the columns up to 2<sup>nd</sup> Floor level have stone aggregate and all other structural concrete members contain brick aggregate. There is a discrepancy between the drawings and the constructed building in relation to the size of the columns at Basement level. The columns were observed to vary in size in a random manner, and are typically smaller than is indicated in the drawings. Steel reinforcement quantities were also observed to be smaller than is indicated in the drawings. Grade 72 High Strength steel, which is called up in the structural drawings, was observed in the columns at Roof level.

Exposed Aggregate

Exposed Rebar to Roof

High strength reinforcement steel bars were observed at Roof level. The number of bars observed at Roof level is comparable with observations at basement level using the ferros scanner, but is inconsistent with what is indicated in the Structural Drawings.
