# JERICO IMEX LTD.

Montree Bari Road, South Shalna, Shalna Bazar, Gazipur  
(24.031292, 90.390023)

20<sup>th</sup> September 2016

# **Insufficient documents and discrepancies between drawings & site observations**

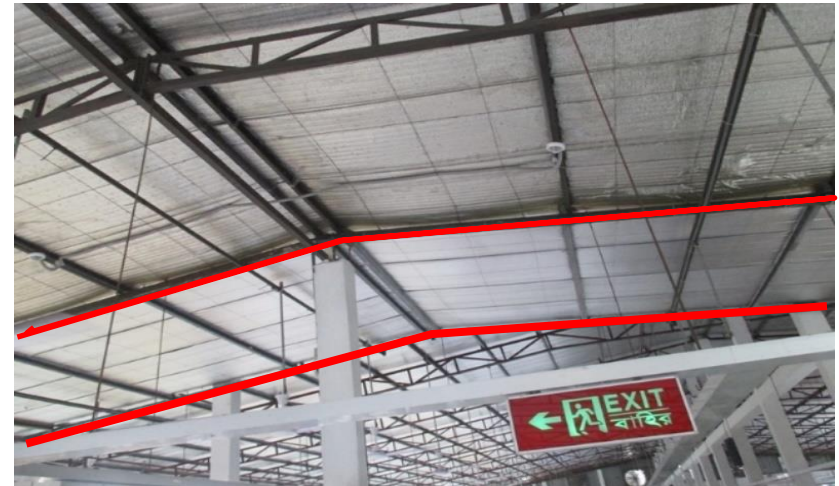
## Column and steel truss layout plan

Existing truss sections are not matched with drawings.
