BD Knit Design Ltd(New)

Sharitpur, National University, Gazipur
(23.965860N, 90.368274E)
4th September, 2016

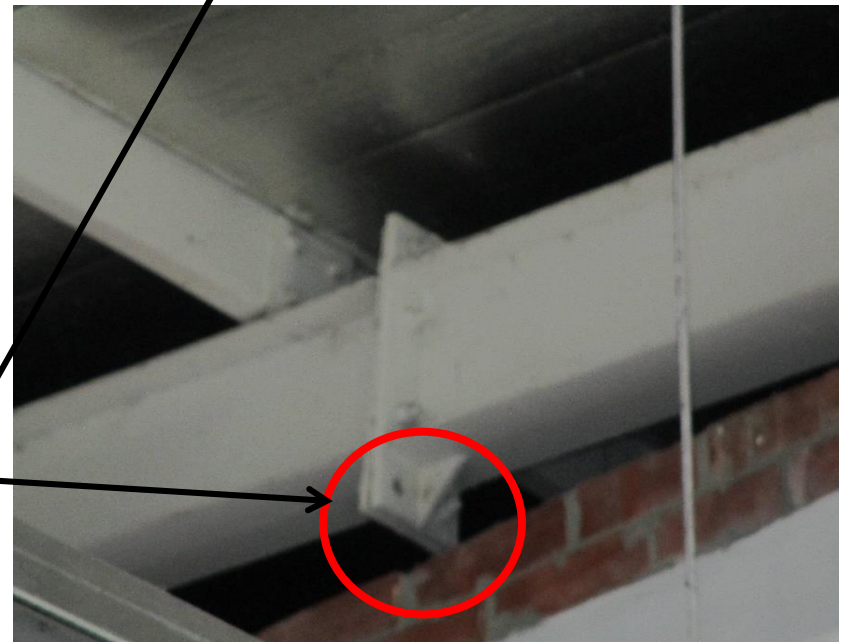
**Missing bolts and defected shear clip
connection observed.**

Defected shear clip in critical shear path at bolted connection was observed.

Bolt missing was observed in connection of rafter to rafter and beam to beam connection.

Item No.	Observation	Recommended Action Plan	Recommended Timeline
1	Overall stability of the structure	Building Engineer to review bracing system for lateral wind loading as per BNBC with consideration for minor axis bending of rafters due to eccentricity of members at node points. Review design of rafter considering compression flange restraint	6-weeks
2	Overall stability of the structure	Building Engineer to design and detail structural upgrading work where necessary to ensure adequate stiffness of bracing system.	6-weeks
3	Overall stability of the structure	Where required, remedial measures to steelwork to be carried out.	6-months
4	Loose cable bracing	Existing cables in braced bays to be tightened	6-weeks
5	Missing bolts and defected shear clip connection observed	Building Engineer to identify all the omissions and supervise remedial works to the missing bolts in the connections and defective shear clip	6-weeks
