# Deluxe Fashions Ltd

178/179 Baizid Bostami Road, Nazirabad Area, Chittagong  
(22.39048N, 91.81110E)

18 March 2014

# Observations

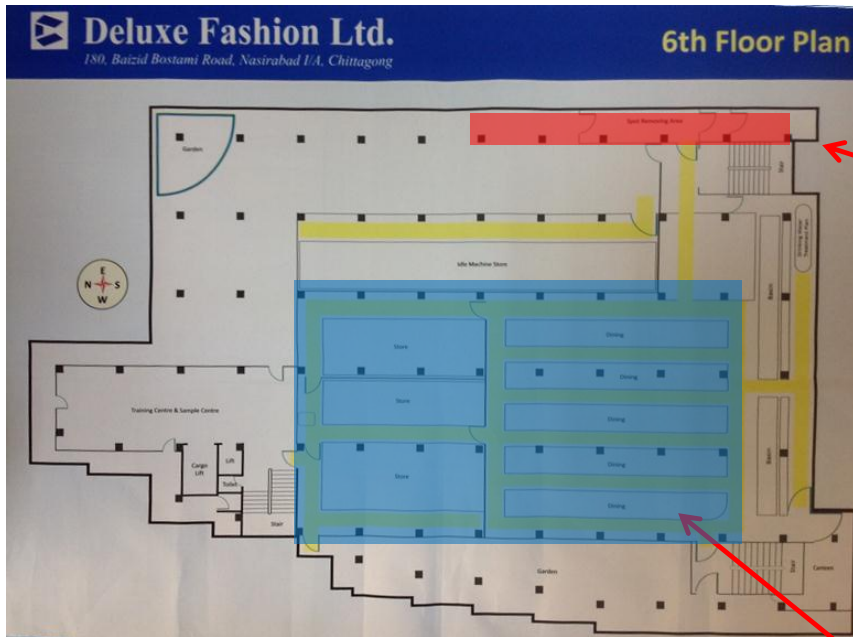
6th Floor Plan

Steel structure used for dining on the roof does not appear to have any vertical bracing. Also, lean-to structure appears to be non-engineered. Building Engineer to review both issues.
