Aman Sweaters Ltd.

Rajaghat, Rajfulbaria, Savar, Dhaka
(23.8122779, 90.260986)

19 MARCH 2014

Observations Made

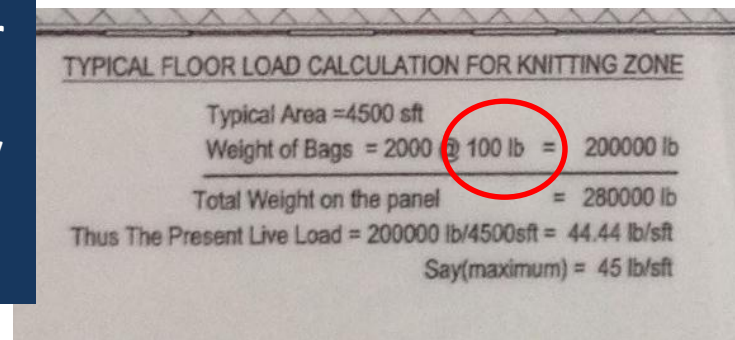
Aggregate type and planned increases in column loads

Brick aggregate discovered, understood to be stone.

Loading plans consider full floor area. An individual column may experience higher loading
