# MAAA APPARELS Ltd.

Plot # 1187, 1214-15, Gacha Maddhapara, Gazipur Sadar  
(23.936233, 90.376661)

30<sup>th</sup> August 2016

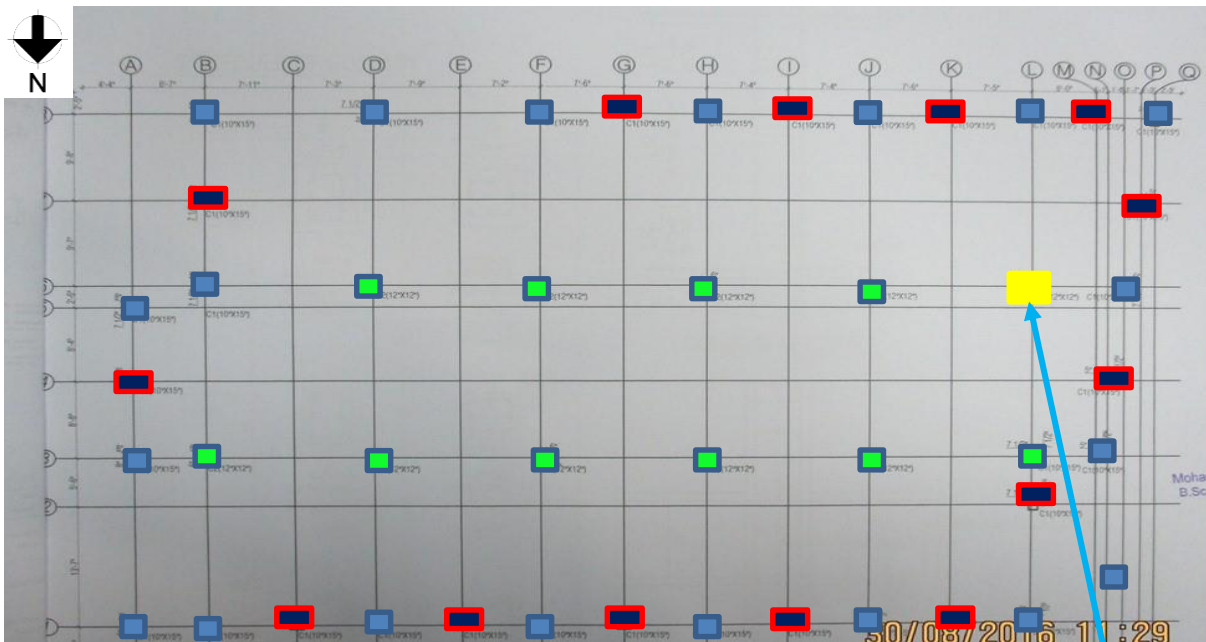
Column layout plan

**Observation : Building-1**

This column is not shown in column schedule. On site measurement the column size was 10x10 inch and 4 nos. of rebar observed by Ferro scanner.

External columns are measured 10x10 inch but in column schedule it is shown as 10x15 inch. Some brick columns are found which is marked as red colour on column layout plan.

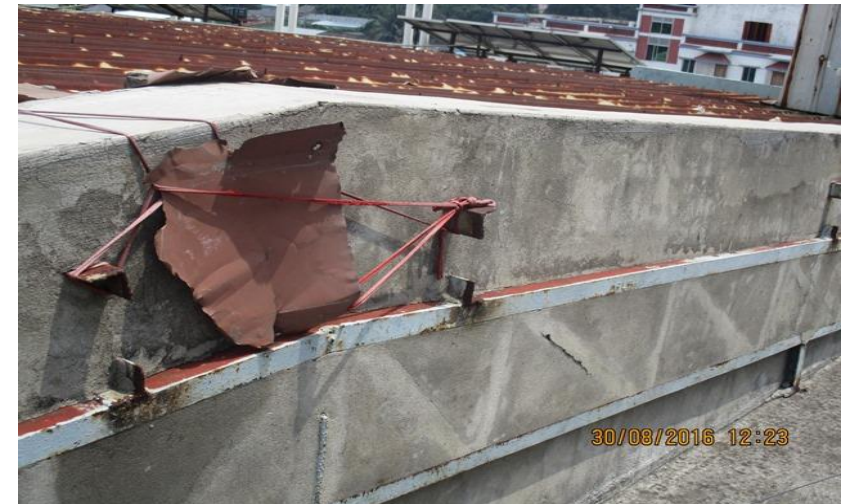
Apparently non engineered steel shed at roof. Steel truss rest on RC column. No drawing was found during inspection.

Item No.	Observation	Recommended Action Plan	Recommended Timeline
9	Apparently non-engineered roof shed and steel stair	A Detailed Engineering Assessment to be conducted in order to determine the adequacy of steel stair & rooftop truss arrangement.	6-weeks
10	Apparently non-engineered roof shed and steel stair	Engage a qualified structural engineer to confirm satisfactory structural performance of the steel shed under wind loading as part of DEA.	6-weeks
11	Apparently non-engineered roof shed and steel stair	Carry out any remedial measures recommended by above mentioned detailed engineering assessment	6-months
12	Discrepancies between Structural drawings and site observations	Building Engineer to survey as-built structure and prepare accurate as-built drawing including all columns, beams and slabs as part of engineering assessment.	6-weeks
13	Discrepancies between Structural drawings and site observations	Verify in-situ concrete strength and aggregate type by taken min. 4 nos. 100mm dia. core samples from columns.	6-weeks

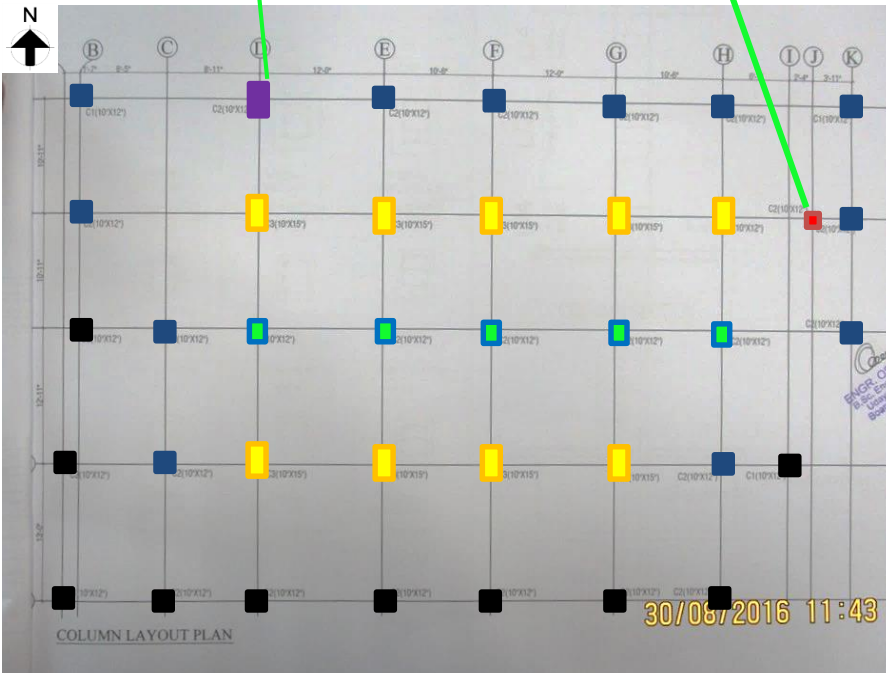
Column Layout Plan

Column sizes are not matched with column schedule. One external column was found 10x15 inch shown in purple. On site measurement black marked columns were found 10x10 inch which is not shown in column schedule.

One brick column was found at GF & 1<sup>st</sup> floor marked as red in column layout plan which does exist at upper floor.

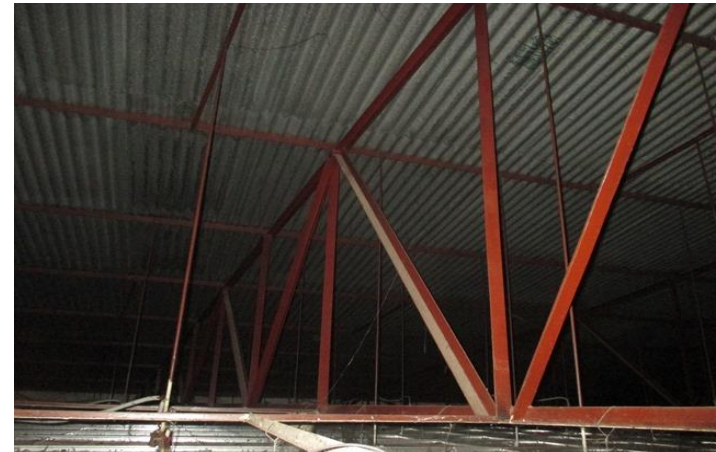
Steel truss are poorly connected with column. No roof bracing was observed in both shed. Factory engineer required to check the connection and overall stability of both sheds.

Steel pipe to truss connection for shed-2
