Euro Knitwear Limited

Chowdhury Bari, Vogra, Gazipur, Bangladesh.

23rd August, 2016

Observations

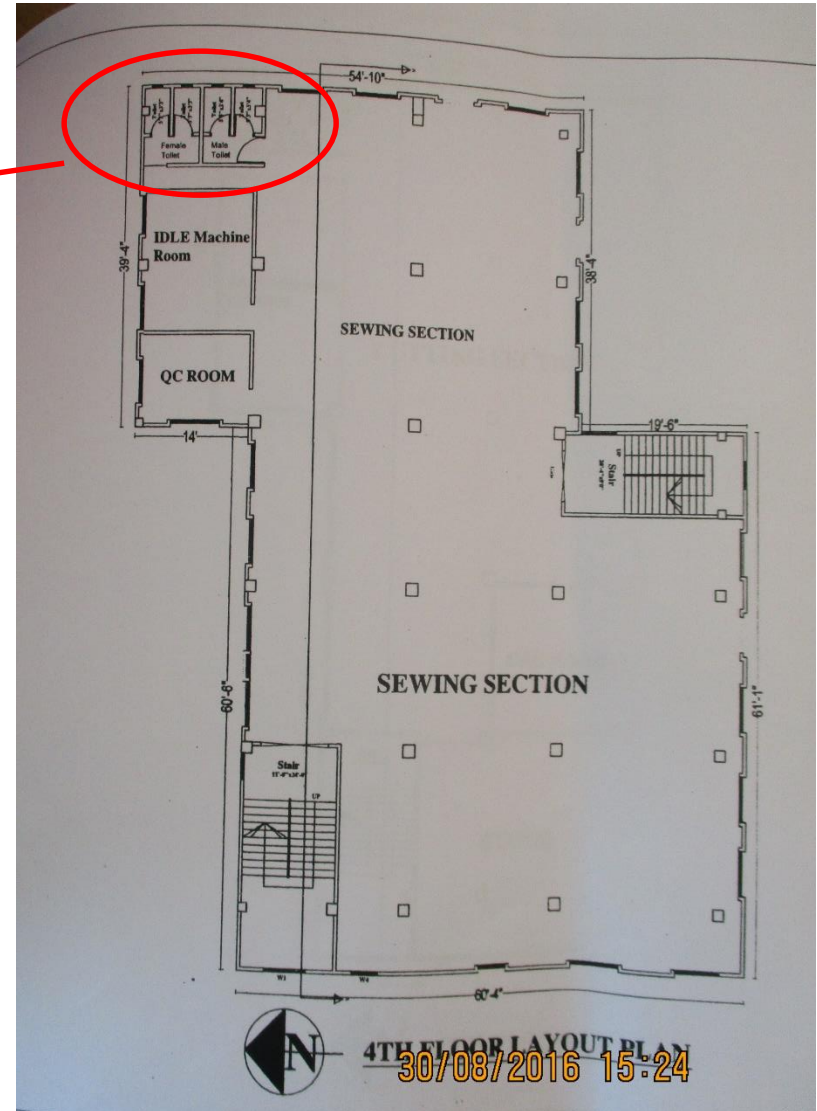
Toilet build up (all floors)

12cm high floor build-up in toilet area supported by concrete slab.
Building Engineer to check that the slab has been adequately designed to carry floor build-up loads
