# Farseeing Knit Composite Ltd

Faridpur, Telihati, Sreepur, Gazipur.  
(24.264389, 90.401611)

7<sup>th</sup> May 2014

# Observations

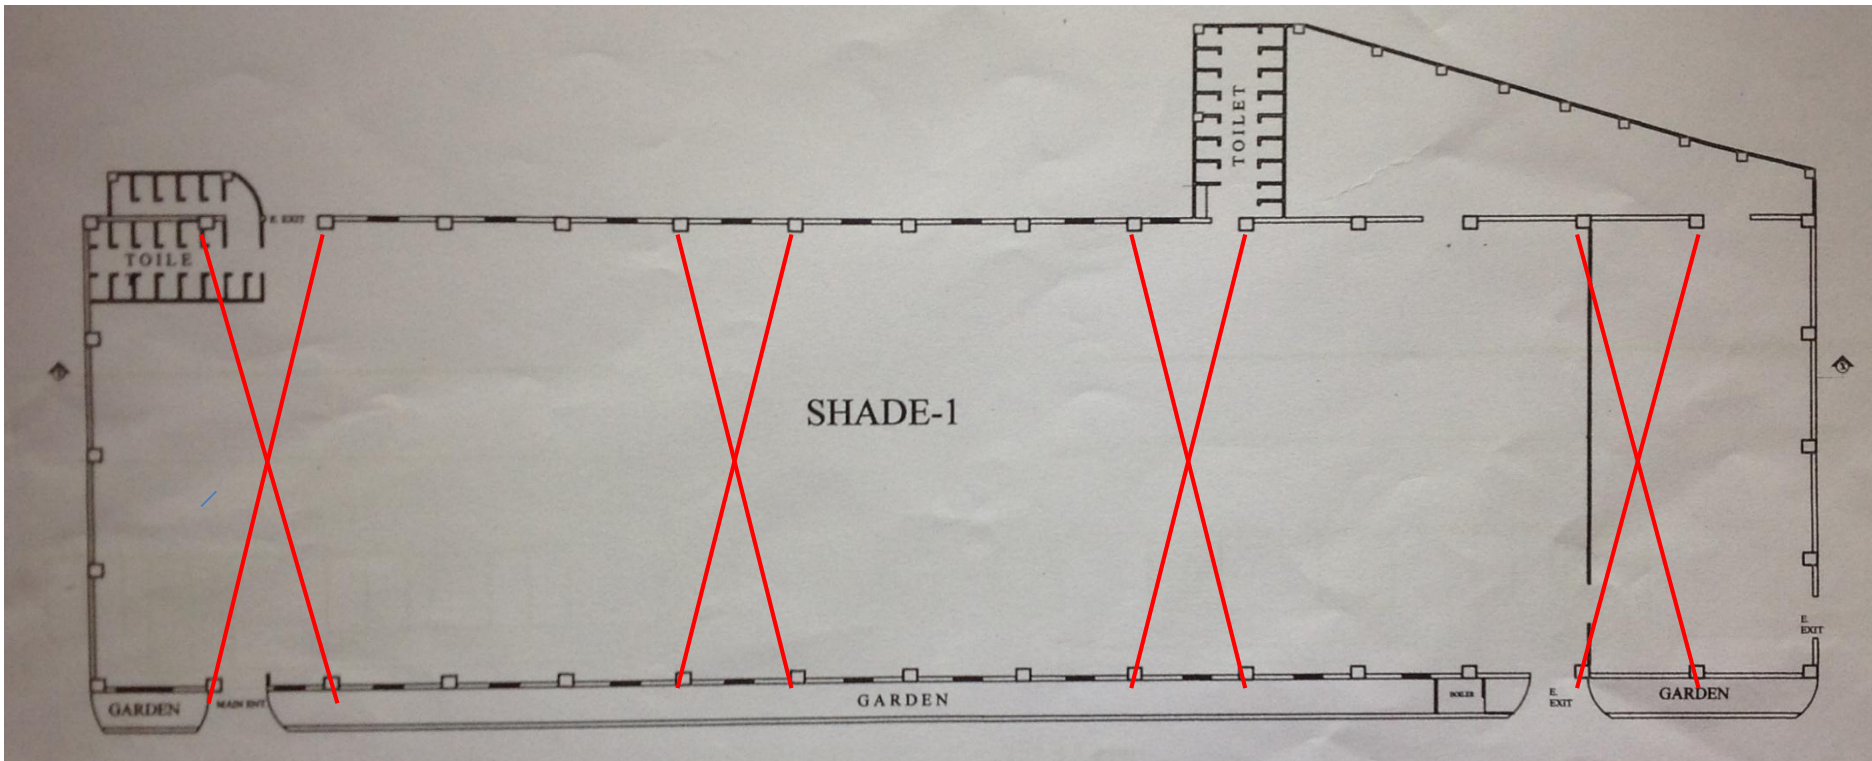
Main Production & Office Building

The lateral stability system to the Main Production structural steel shed is unclear – vertical bracing and eaves beams have not been provided. Note that provision for lateral stability is not shown in the as-built drawings. Building Engineer to carry out a lateral stability analysis of the shed and specify the necessary remedial works. Furthermore, Building Engineer to review the design of the cantilevered columns to ensure they can adequately resist the horizontal loads imposed by the portal frame.

Extent of Horizontal Bracing

Building Engineer to review the design of the portal frame with regard to lateral stability. The Building Engineer should provide guidance on the requirement or otherwise for vertical bracing and eaves beams in the external wall to enable the horizontal wind loads to be transferred down to foundation level. Furthermore the Building Engineer is to review the design of the cantilevered concrete columns to ensure that they are adequate to resist the horizontal loads imposed by the steel portal frame.

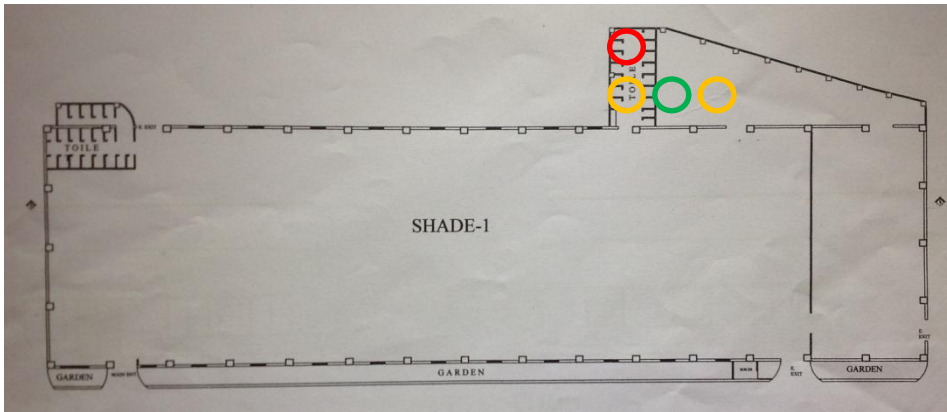
Main Production / Office Building Layout Plan

An area of high loading was observed above the toilet area to the South of the main Production / Office building where there are four plastic water tanks located at Roof level. There is one 5000L capacity tank on a 160mm plinth, two 2000L capacity tanks on 900mm plinths, and one 2000L capacity tank that is damaged and appears to be out of use. Building Engineer to check that the roof structure has been adequately designed to accommodate this loading.
