Apparel 21 Ltd.

Shirir Chala, Bagher Bazer Gagipur Shadar, Gazipur, Bangladesh
(24.171452N, 90.415817E)

3rd May 2014

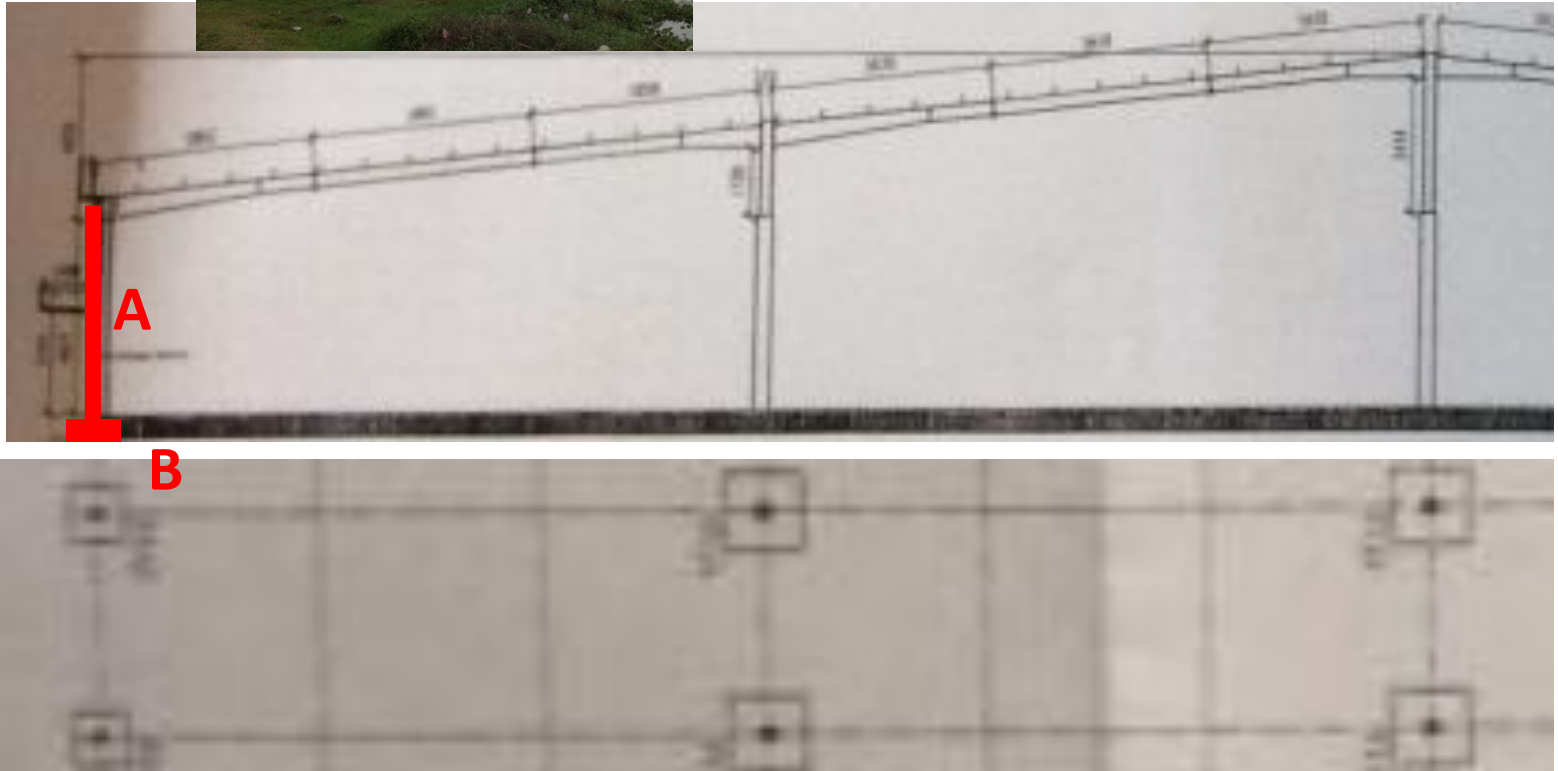
Lateral stability of Building 1 in E-W direction

- Lateral stability East-West relies on façade columns (A) cantilevering from small pad foundations (B).
- At the southern end of the building the curved structure along the W elevation (C) buttresses the columns, but most of this structure (D) has yet to be built.

Item No.	Observation	Recommended Action Plan	Recommended Timeline
1	Prop temporary opening in wall of Boiler building	Temporary opening to be propped. This was pointed out to the factory management on site.	Immediate - Now
2	Lateral stability of Building 1	Building engineer to check ability of column, wall and foundation structure on each side to resist E-W wind loading.	6-weeks
3	Lateral stability of Building 1	Building engineer to assess N-S stability of portal structure.	6-weeks
4	Lateral stability of Building 1	Building Engineer to advise on additional measures to provide structural resistance to lateral loads if required.	6-months
5	Wind load on gable walls of Building 1 and Boiler building	Building Engineer to check ability of the Building 1 gable columns and foundations to cantilever from ground to resist N-S wind loading.	6-weeks
6	Wind load on gable walls of Building 1 and Boiler building	A similar check is to be carried out on the gable walls for the Boiler building.	6-weeks

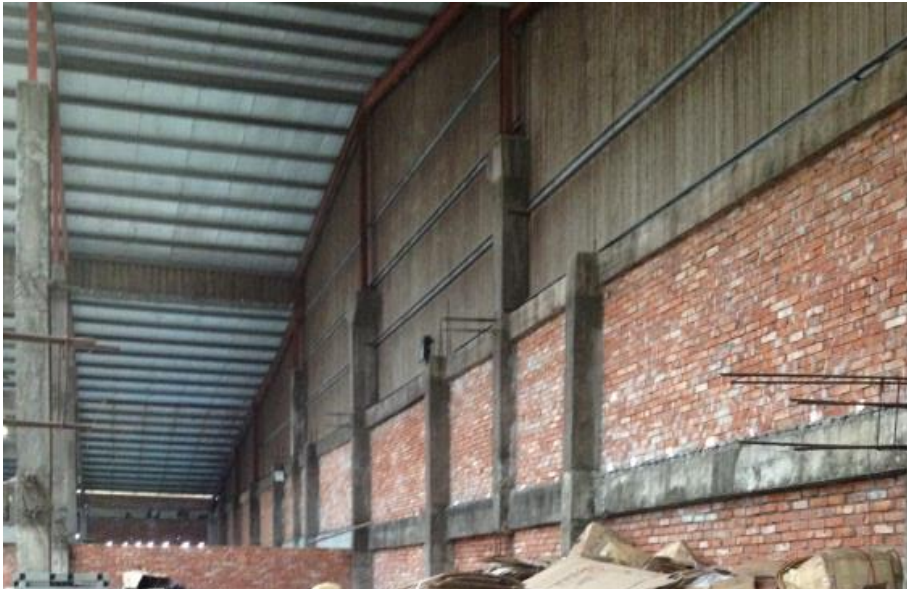
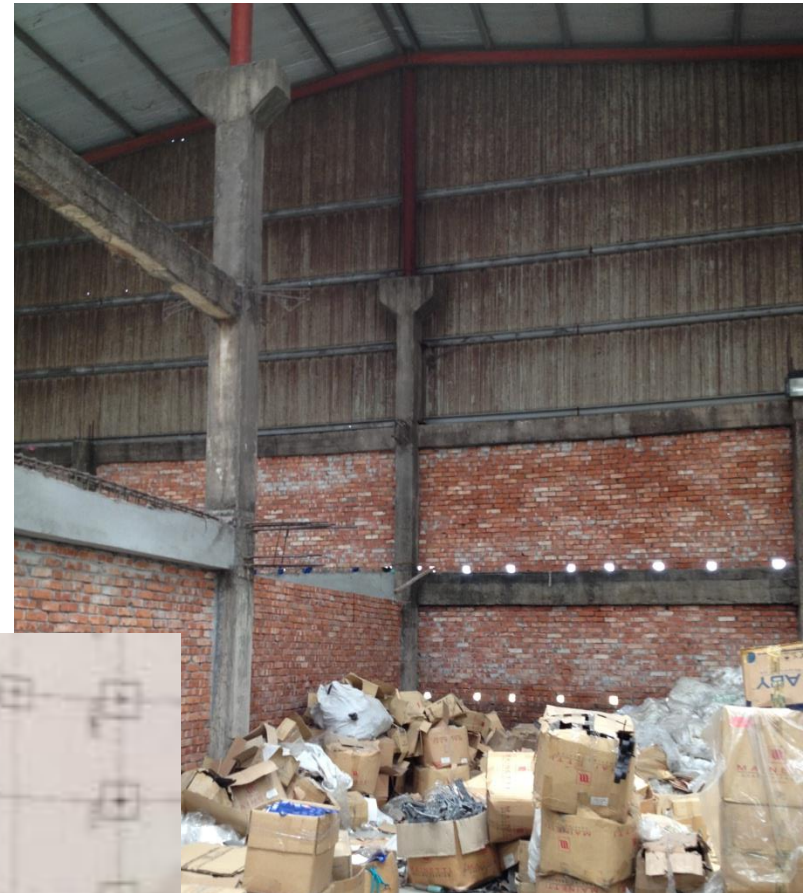
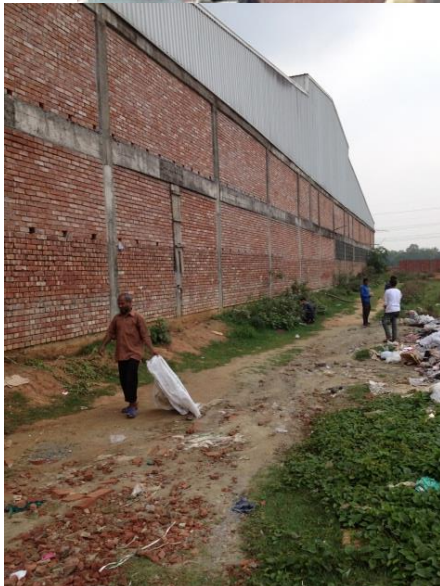
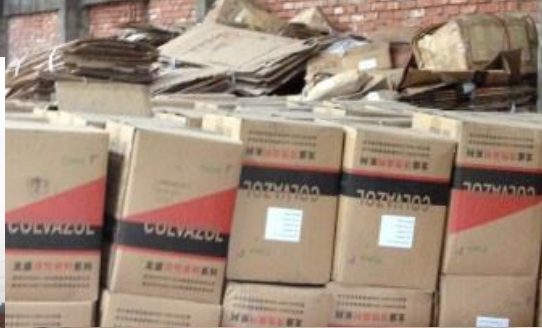
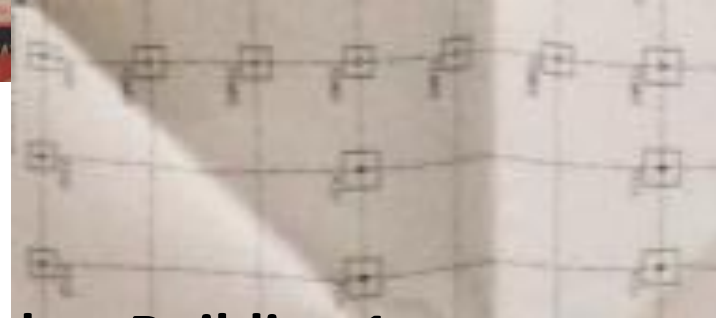
Lateral stability of North gable of Building 1

- Wind load on north gable is resisted by columns cantilevering from small pad foundations, as the mezzanine which buttresses the columns is not yet constructed.
