# Cotton Dyeing & Finishing Mills Ltd

10 No. Habirbari PO, Seed Store Bazzar Thana, Valuka, Mymensing, Dhaka  
(+24.315N, 90.38389E)

10 May 2014

# Observations Garments Building

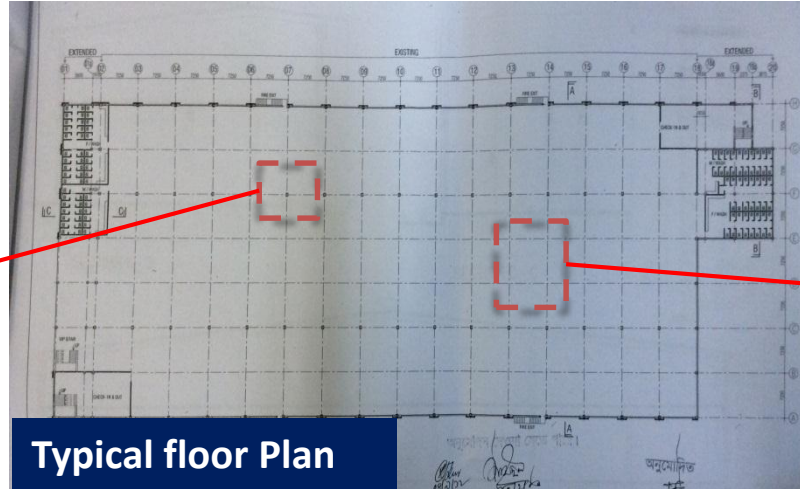
**Typical floor Plan**

# **Cracking of floor finishes/slab and management of floor loads**

**Cracks in 1<sup>st</sup> floor slab**

**Cracks in Ground floor slab**

**Building Engineer to prepare controlled loading plans, based on floor slab and column capacity, for all floors which will designate allowable storage density and where storage may be placed. Crack repairs to be carried out as necessary.**

- Produce and actively manage a loading plan for all floor plates within the factory giving consideration to floor capacity and column capacity.
- Building Engineer to review typical floor finish cracks at ground and 1<sup>st</sup> floors and confirm that cracking is in finishes only. Where required, remedial works to be carried out.

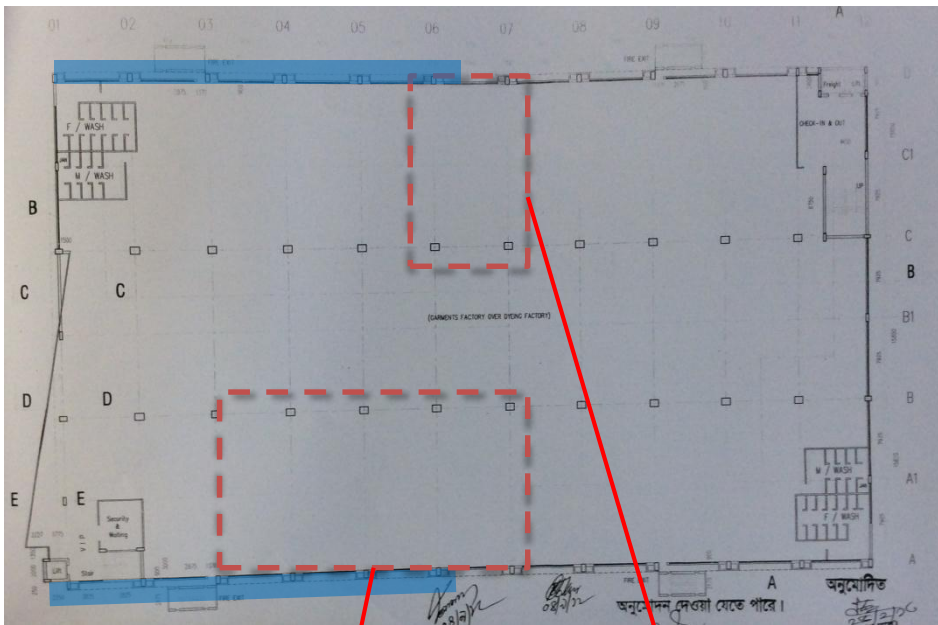
**Typical Floor Plan**

# **Cracking of floor finishes/slab and management of floor loads**

**1<sup>st</sup> floor slab**

**2<sup>nd</sup> floor slab soffit**

**Building Engineer to prepare controlled loading plans, based on floor slab and column capacity, for all floors which will designate allowable storage density and where storage may be placed. Crack repairs to be carried out as necessary.**

- Produce and actively manage a loading plan for all floor plates within the factory giving consideration to floor capacity and column capacity.
- Building Engineer to review typical floor finish cracks and confirm that cracking is in finishes only. Where required, remedial works to be carried out.

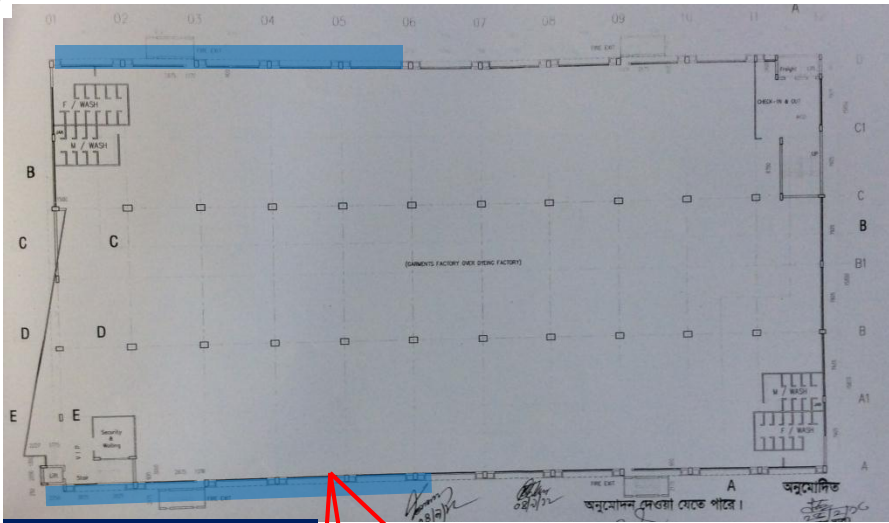
**Typical Floor Plan**

# **Cracking of external cantilever slab and building façade**

**Façade cracking**

**Cracks on the upper and lower cantilevers propagating from the column towards the tip of the cantilevers**

**Building Engineer to investigate reasons for cracking and implement repairs as necessary**

- Building Engineer to inspect area where cracking has occurred and propose a suitable repair to ensure that rainwater does not penetrate the building fabric and cantilever slab.
- Building Engineer to provide a method statement for the on-going maintenance of the external facades.

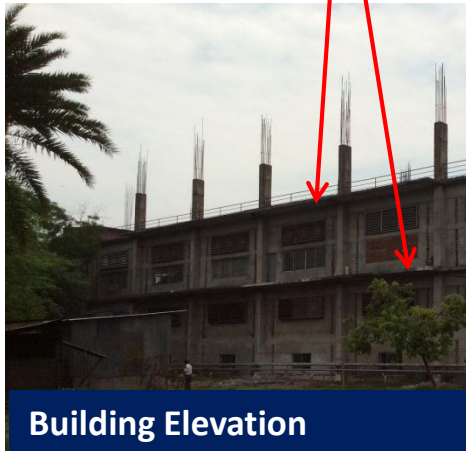
**Building Elevation**

**Cracks on the lower level cantilever**

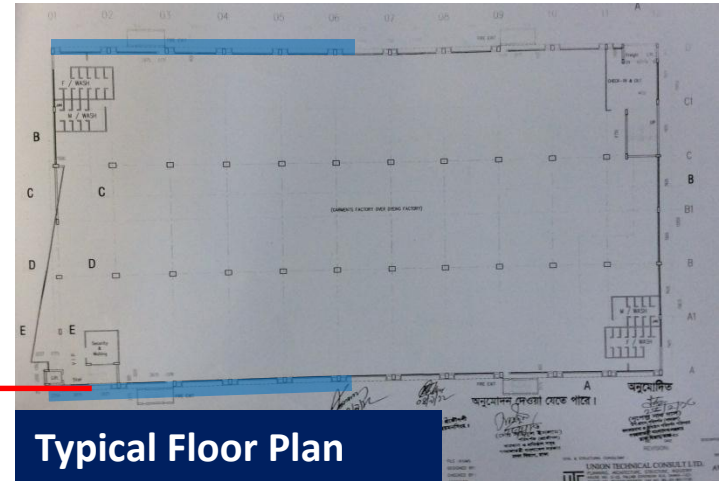
**Typical Floor Plan**

Mezzanine is shown covering 2 full bays at the west end of the building on the RC drawing. As constructed it only covers 1 bay at the middle section of the mezzanine.

**Discrepancies between the drawings and as constructed**
