# W. Apparels Chancellor Garments Ltd.

295/JA/4 Rayer Bazar, Dhaka  
(23.74143N, 90.36202E)  
08 March 2014

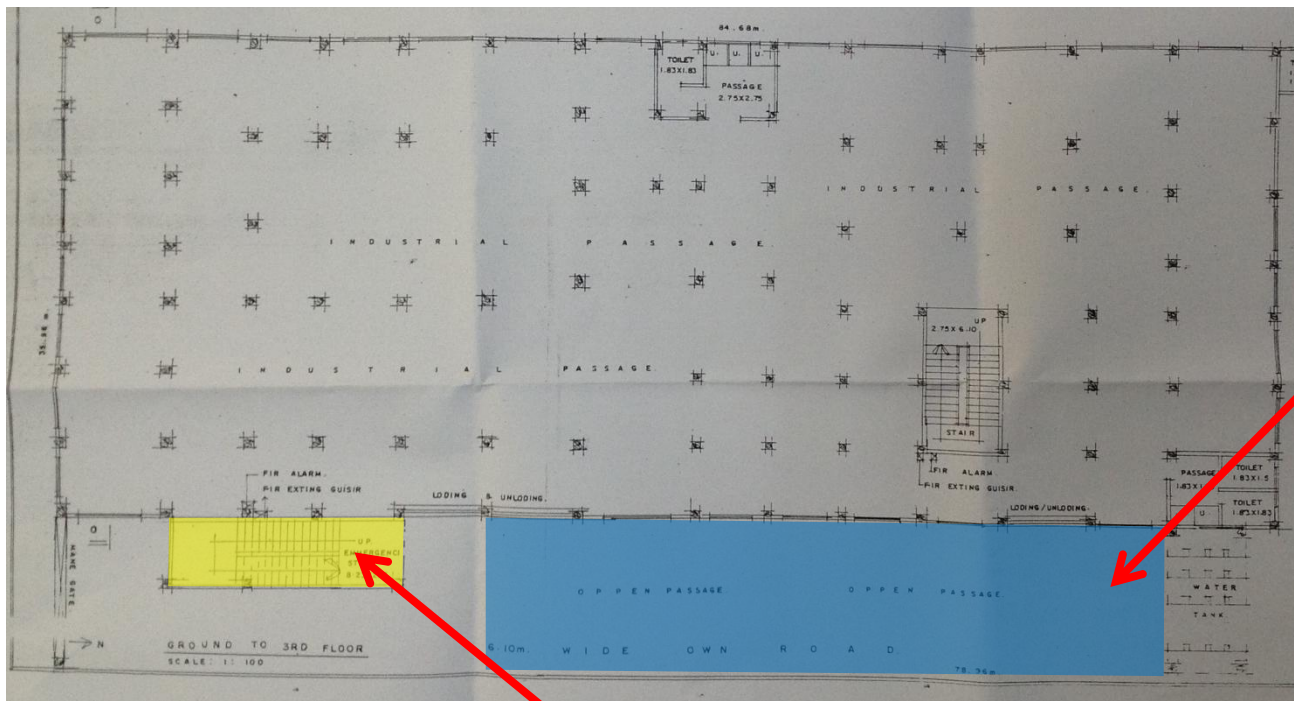
Site Plan

**Check required to confirm that steel frame to lean-to entrance structure and steel stairs is adequately braced and designed to resist high wind loading and that connections are adequately designed and confirmed to be as-built**

Additional steel stairs and lean-to structure not on structural drawings.

Engineer to check design of steel structures to resist high wind and lateral loads and completeness of connections on site.

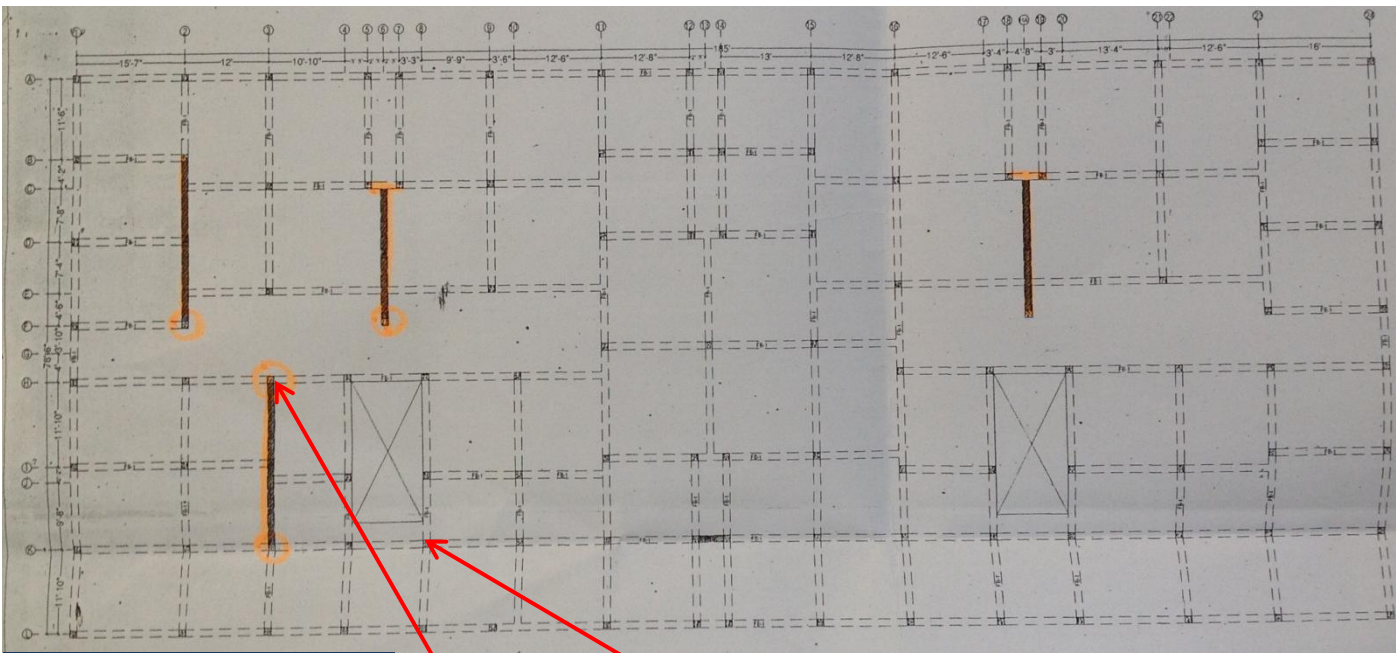
Typical Floor Plan

# **Cracking of 2 No columns on 3<sup>rd</sup> floor and cracking on the soffit of 3<sup>rd</sup> and 4<sup>th</sup> floor slabs**

**ITEM 4:** Cracking of 2 No columns on 3<sup>rd</sup> floor and cracking on the soffit of 3<sup>rd</sup> and 4<sup>th</sup> floor slabs

Column cracks to be reviewed by removing plaster to confirm that cracks do not extend into structure.

| Item No. | Observation | Recommended Action Plan | Priority |
|---|---|---|---|
| 11 | Cracking of 2 No columns on 3rd floor and cracking on the soffit of 3rd and 4th floor slabs | Sections of plaster finish to columns and slabs to be removed to investigate if cracks penetrate the building structure. | 6-weeks |
| 12 | Cracking of 2 No columns on 3rd floor and cracking on the soffit of 3rd and 4th floor slabs | Building Engineer to carry out design check on columns and slabs to confirm that these cracks are non-structural. | 6-weeks |

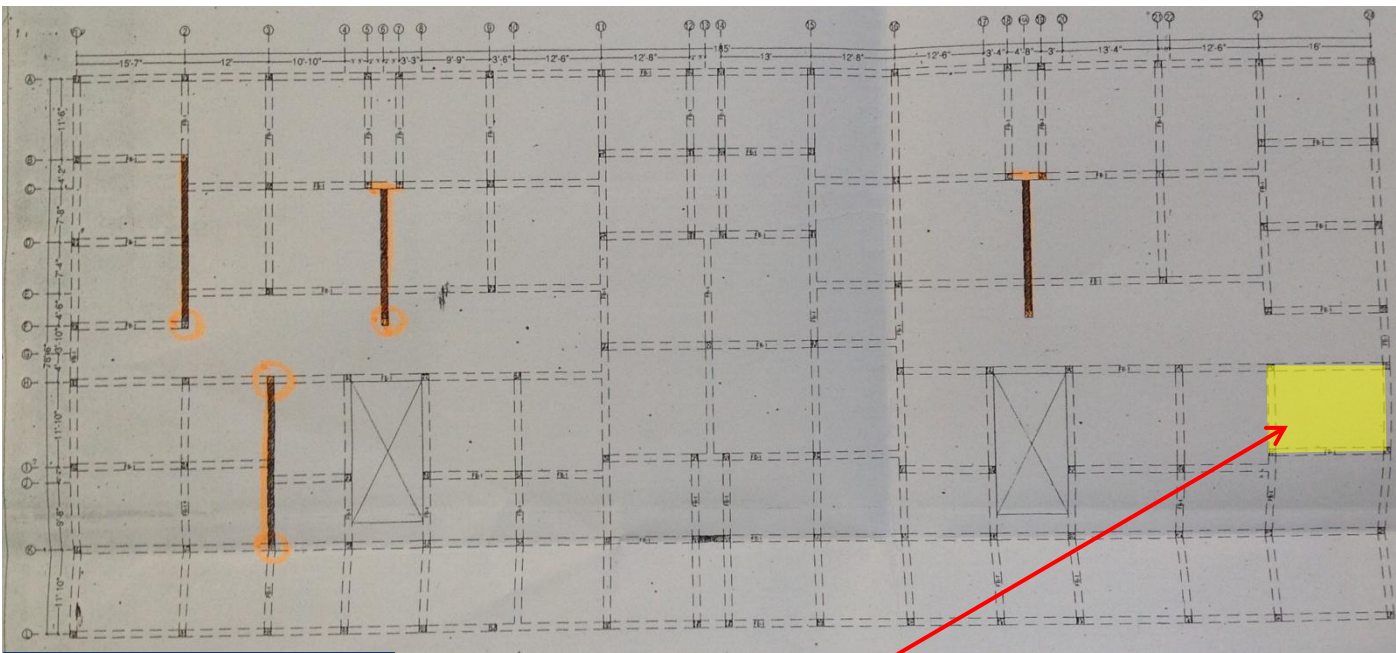
Typical Floor Plan

# Management of loads on 3<sup>rd</sup> floor

Building Engineer to create controlled loading plans for all floors which will designate where storage can be placed.

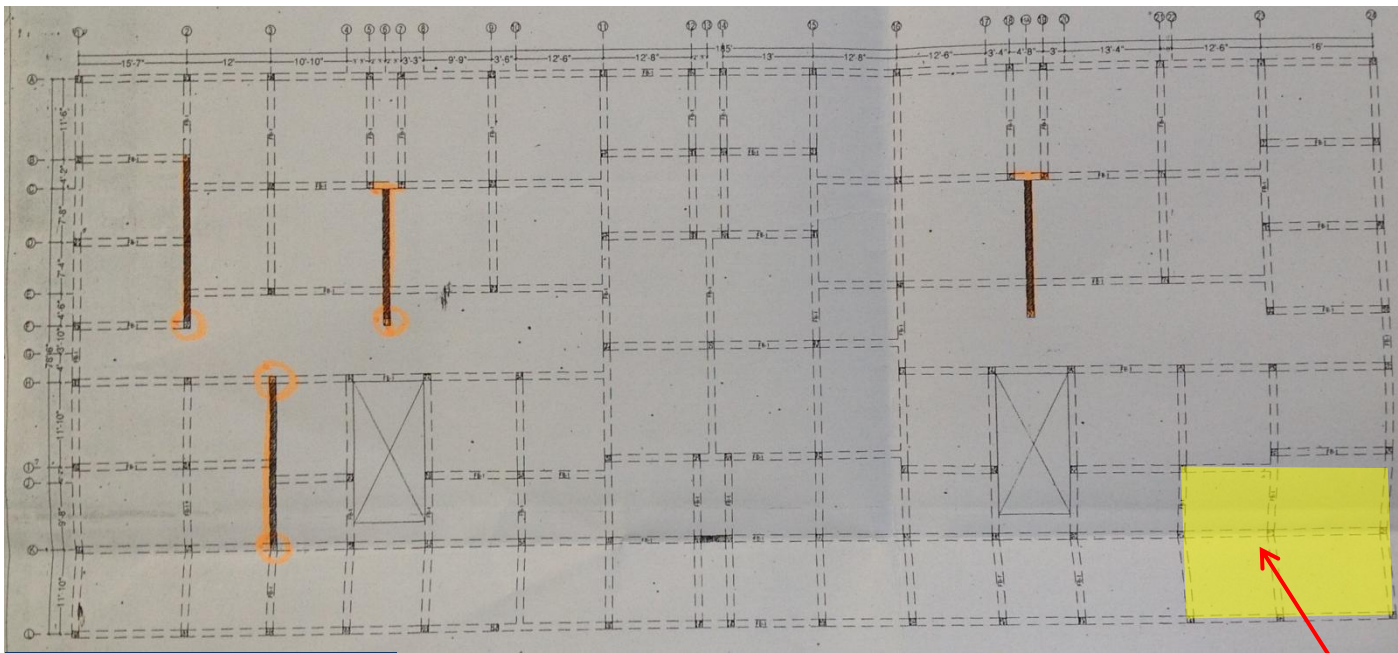
Floor Plan

**Design check required for floor build-up in toilet area on 3<sup>rd</sup> floor to confirm floor slab load capacity**

**Building Engineer to review and confirm floor slab load capacity to carry floor build-up loading in toilet area.**

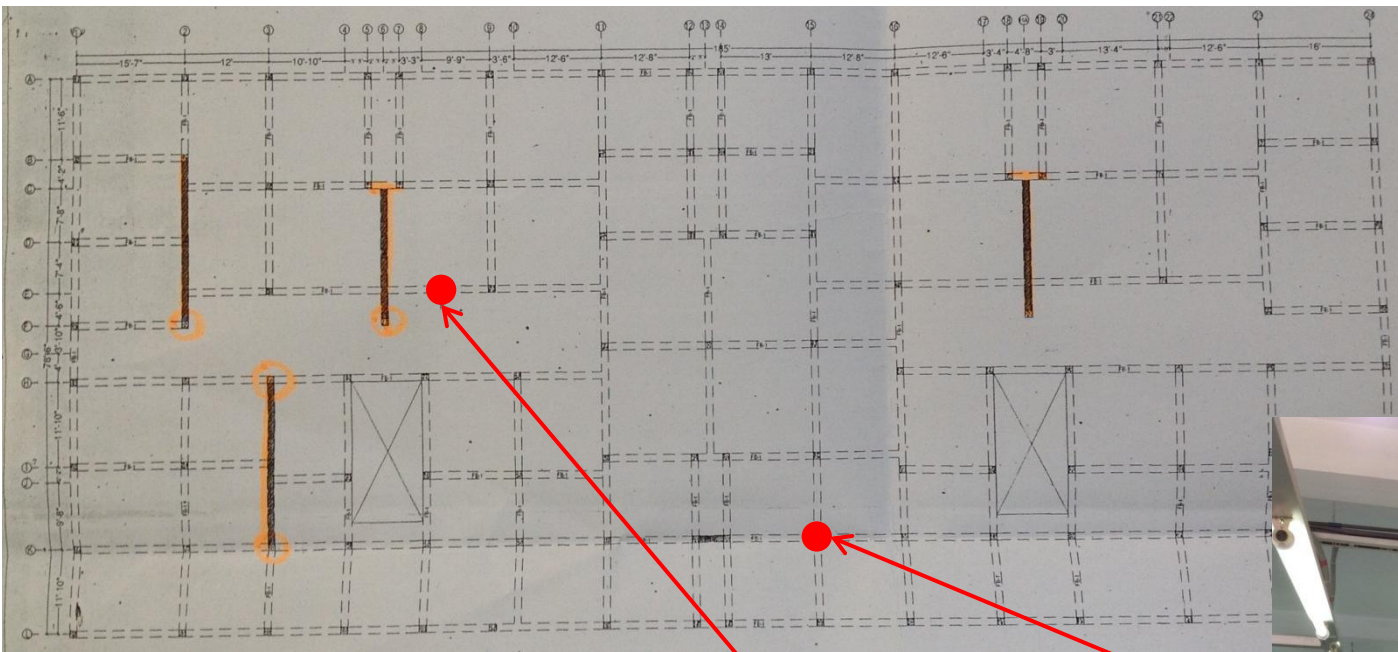
Floor Plan

**Redundant brick columns on 3<sup>rd</sup> floor may be supporting beam/slab above**

**2 No brickwork columns  
(locations shown on plan)  
to be removed**
