Radial International Ltd. Array International Ltd.

Zirani Bazar, Kashmirpur, Gazipur Sadar.
(23.997823, 90.254950)
20th April 2014

Observations

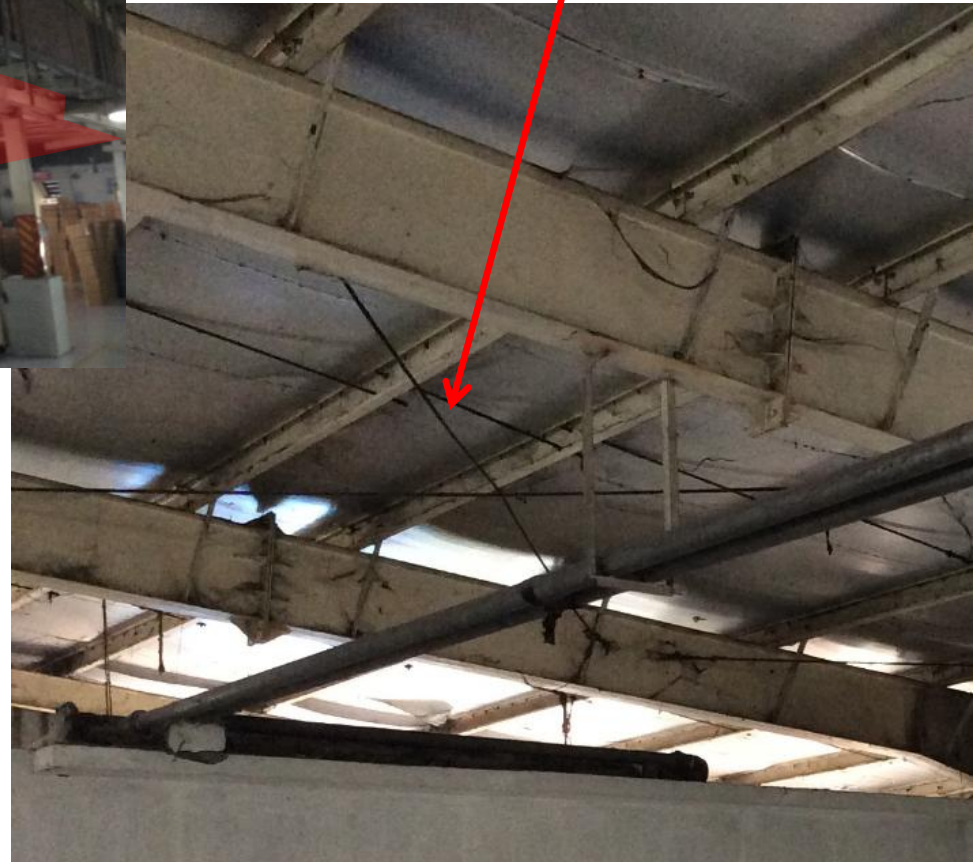
Steel Roof over Main Production Building

Changes have been made to the structure with part of the portal frame removed and replaced with a composite deck for fire safety reasons. This modification has removed an entire bay of roof bracing.

Some bracing elements are slack and should be tightened to ensure they are functioning properly.

Item No.	Observation	Recommended Action Plan	Recommended Timeline
1	Main Building Steel Roof Structures over Fifth Floor	Full structural survey and analysis of existing steel roof structures to be carried out by Factory Building Engineer	Immediate - Now
2	Main Building Steel Roof Structures over Fifth Floor	Lateral stability of roof to be assessed	Immediate - Now
3	Main Building Steel Roof Structures over Fifth Floor	Support bearings and connections to be assessed	Immediate - Now
4	Main Building Steel Roof Structures over Fifth Floor	Slight sagging in beams under new concrete roof (West side) to be assessed	Immediate - Now
5	Main Building Steel Roof Structures over Fifth Floor	Strengthening measures to be designed where required by Building Engineer	Immediate - Now
6	Main Building Steel Roof Structures over Fifth Floor	Diagonal bracing, removed to construct new concrete flat roof, to be replaced	6-weeks

7	Main Building Steel Roof Structures over Fifth Floor	Missing diagonal bracing (walls and roof) to be installed	6-weeks
8	Main Building Steel Roof Structures over Fifth Floor	Tension in all cross-bracing to be restored	6-weeks
9	Main Building Steel Roof Structures over Fifth Floor	Strengthen bearings, connections, support brackets and structural sections where required by the Building Engineering Structural analysis	6-months
10	Main Building Steel Roof Structures over Fifth Floor	Implement other Building Engineer's recommendations.	6-months

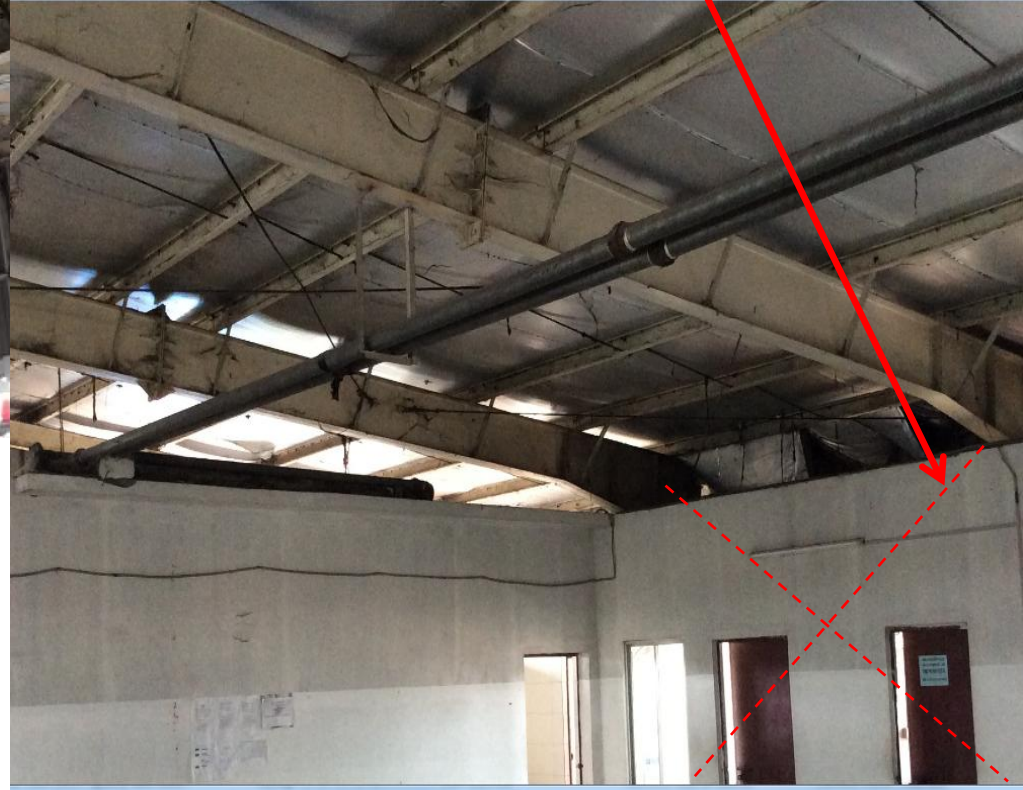
Steel Roof over Main Production Building

Bracing elements missing on elevation both sides (north and south).

Bracing in steel roof for lateral restraint.

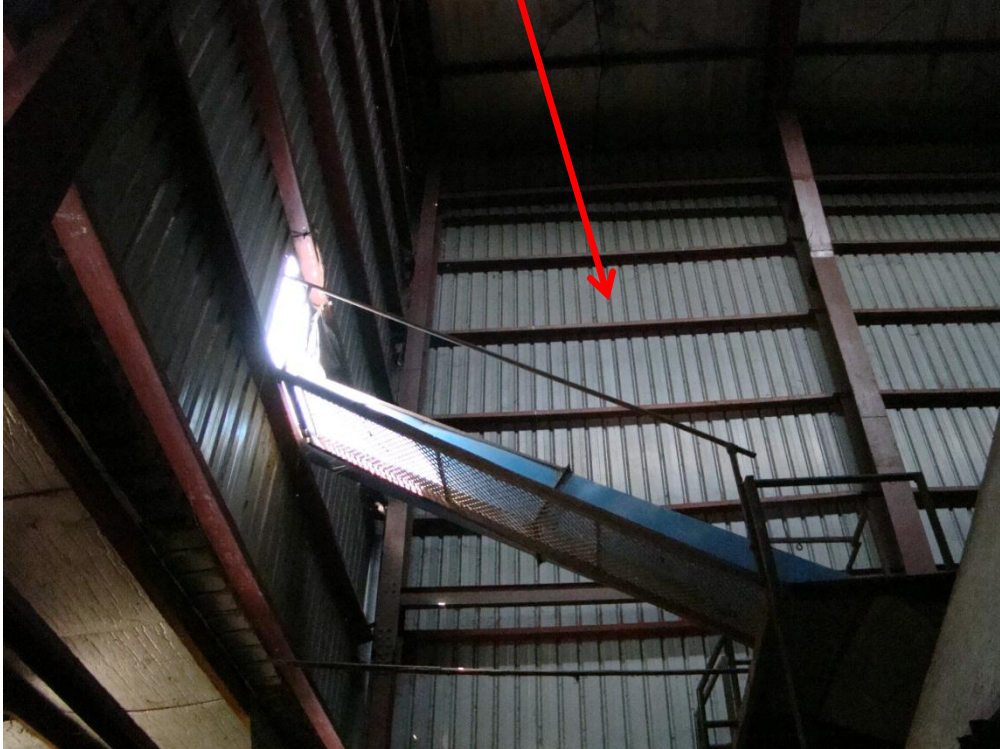
Single-Storey Building: Boiler House

Boiler house columns are larger section at higher levels than at lower levels. Bolted connection at mid-height is poorly aligned.

Boiler house steel structure is tall without the benefit of floors or effective bracing.

Item No.	Observation	Recommended Action Plan	Recommended Timeline
18	Single-Storey Buildings: Boiler House Steelwork	Full survey and structural analysis of the Boiler House steel structure to be carried out by the Factory Building Engineer to assess section sizes, connection details and lateral stability.	Immediate - Now
19	Single-Storey Buildings: Boiler House Steelwork	Additional steelwork and strengthening measures to be designed by the Factory Building Engineer.	6-weeks
20	Single-Storey Buildings: Boiler House Steelwork	Strengthening works to be implemented before the cyclone season to ensure the building is laterally stable against wind loads.	6-months
21	Single-Storey Buildings: Dyeing Shed Steelwork Roof	Full survey and structural analysis of the Dyeing Shed roof steel structures to be carried out by the Factory Building Engineer to assess section sizes, connection details and lateral stability.	Immediate - Now

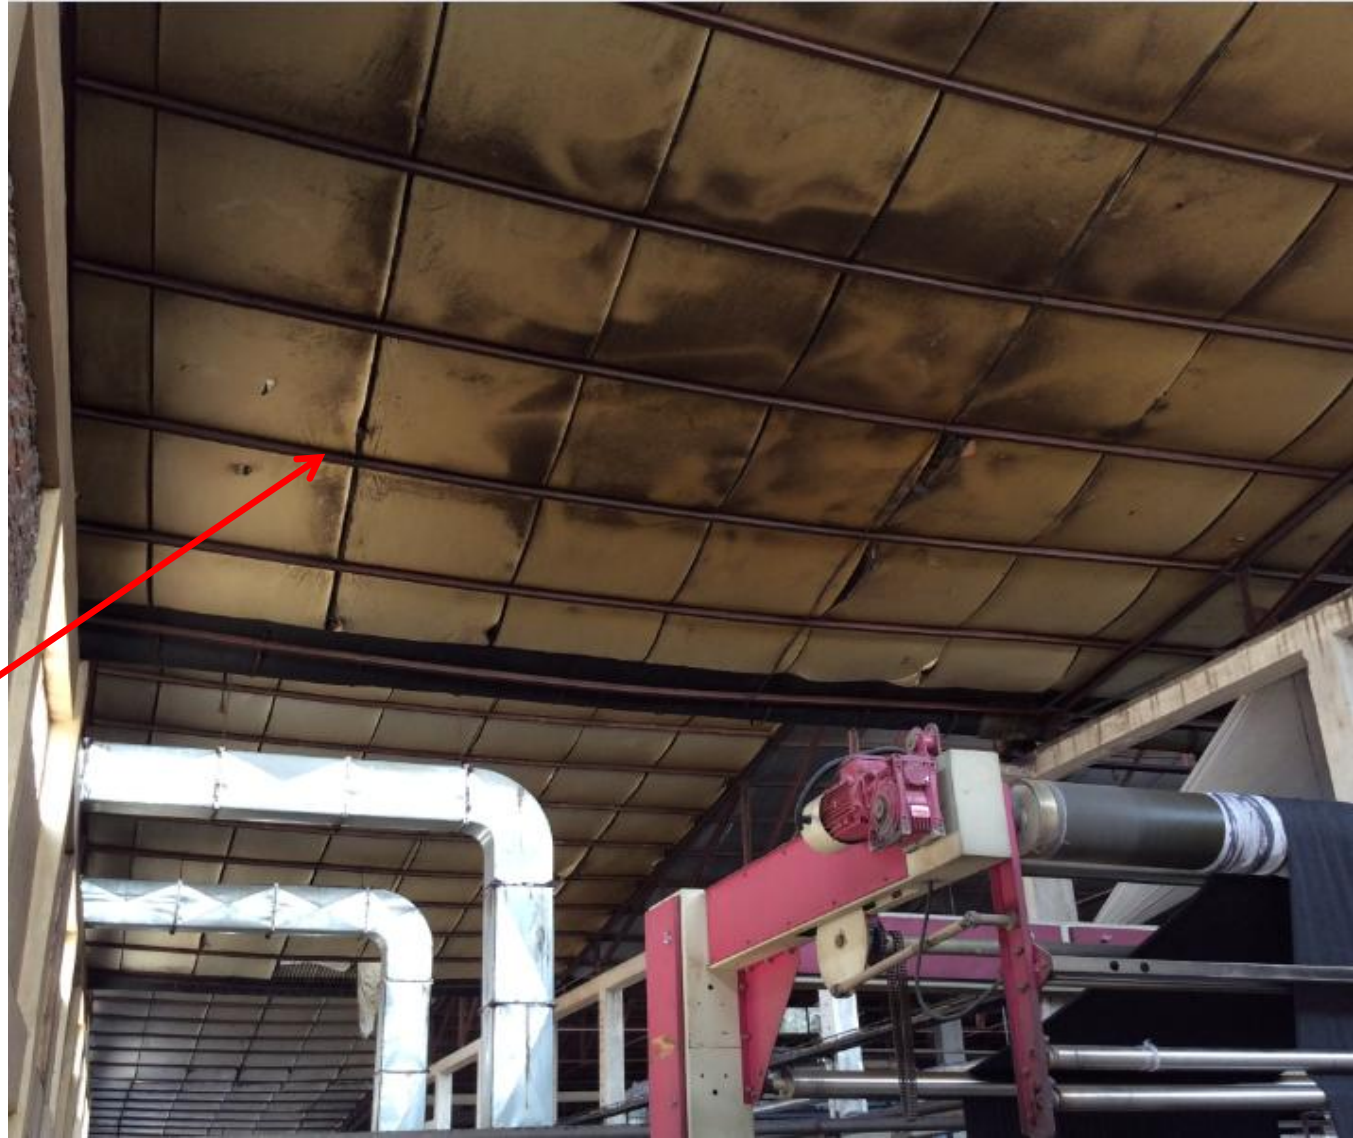
Single-Storey Building: Dyeing Shed

Steel purlins in roof of Dyeing Shed are deflecting heavily.
