Ettade Jeans Limited

1670/2091, West Sholashahar, Building #3, Aturer Depot, Chittagong
(22.382352N, 91.827703E)
20 April 2014

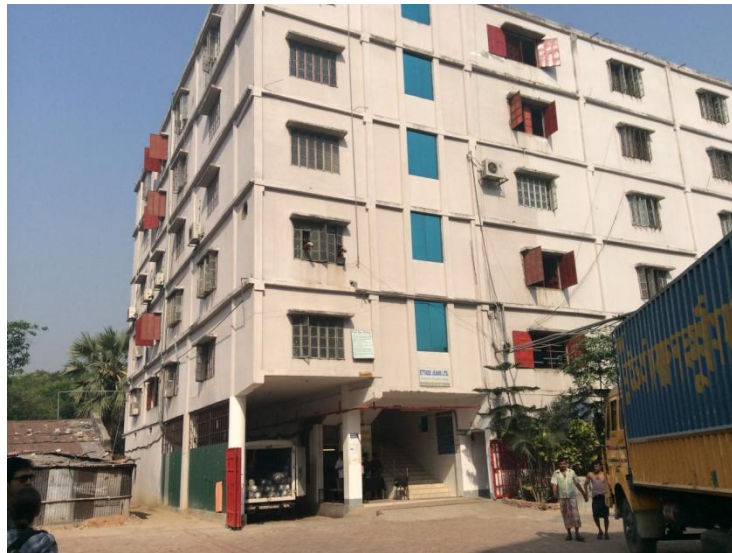
Observations

High stress in columns

Columns support a cantilever of 1.8m carrying a brick façade.

Cursory calculations at ground floor level indicate that edge column's working stresses are at a high level.

Some columns extend below.
