Logos Apparels Ltd. (10917)

No. 73, Ward No.06, Mouchak Kaliakoir, Gazipur Bangladesh

06.APRIL.2014

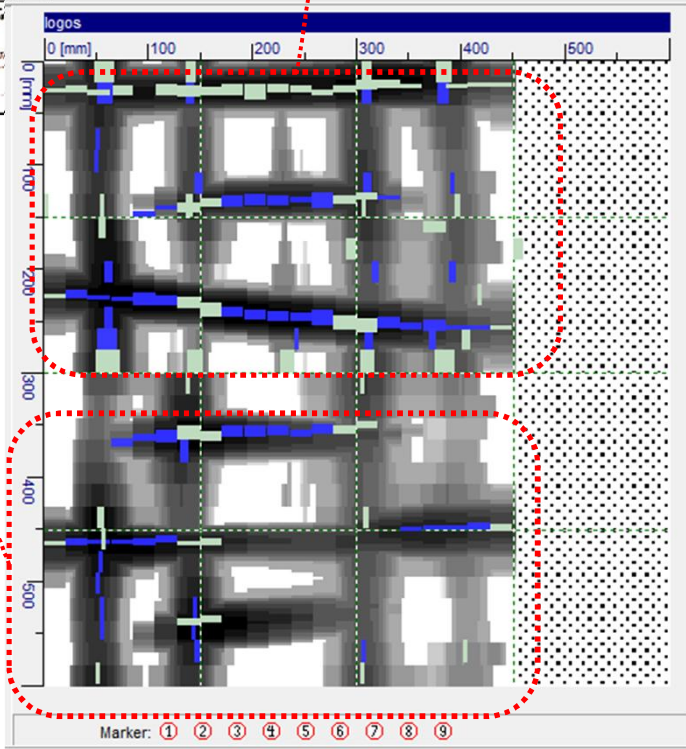
1st Priority 2 Concern

This area shows 5 longitudinal bars.

This column C2 at grid B6 was randomly checked with a Ferros scanning device.

This area shows 4 longitudinal bars.

The column C2 is supposed to have 5 bars each side.

The Ferroskan image shows an inconsistency with the reinforcement configuration between the structural design and the as-built structure.

- Building survey must be taken to verify the system with regard to reinforcement configuration
- Building engineer to verify the system to ensure the structural consistency between design and as-built structure
