# AMS International (Sweaters) Ltd.

34 Choydana, P.O. National University Gazipur-1704  
(23°57'43.9"N 90°22'47.2"E)

26 APRIL 2014

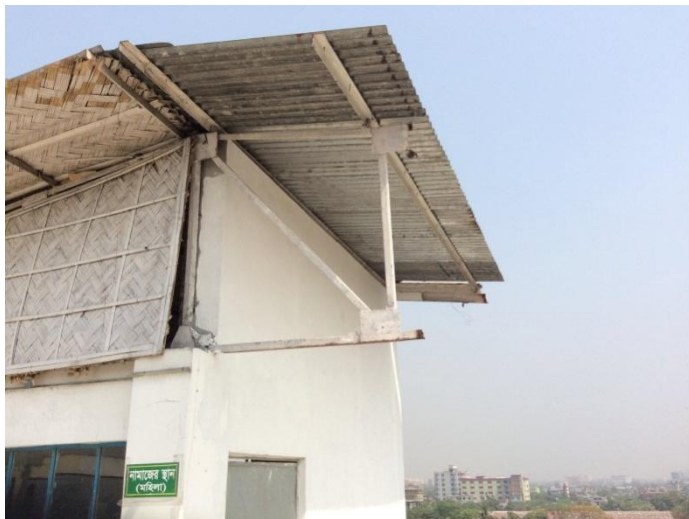
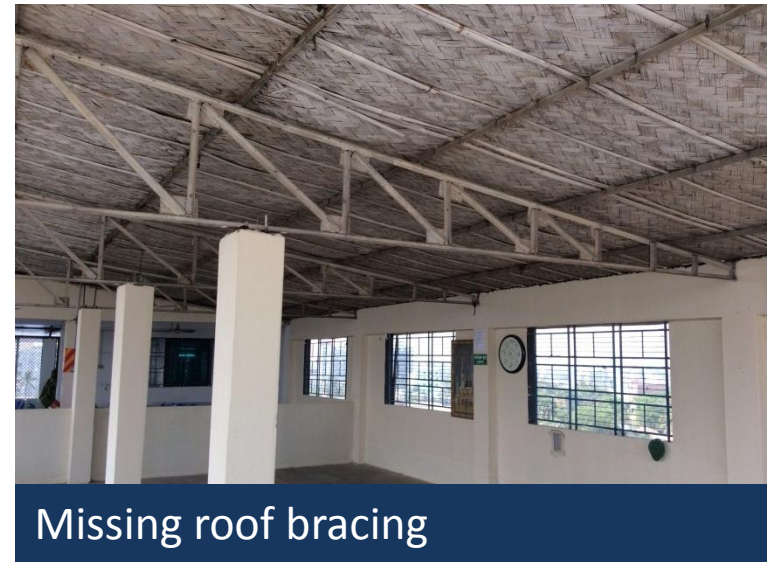
# Undocumented additional steel structure

Building Permit for Building is for 5 storeys - the steel structure is not in scope of permit.  
Non-engineered lightweight steel roof addition does not appear to be strong enough to withstand severe wind events, with limited lateral stability system

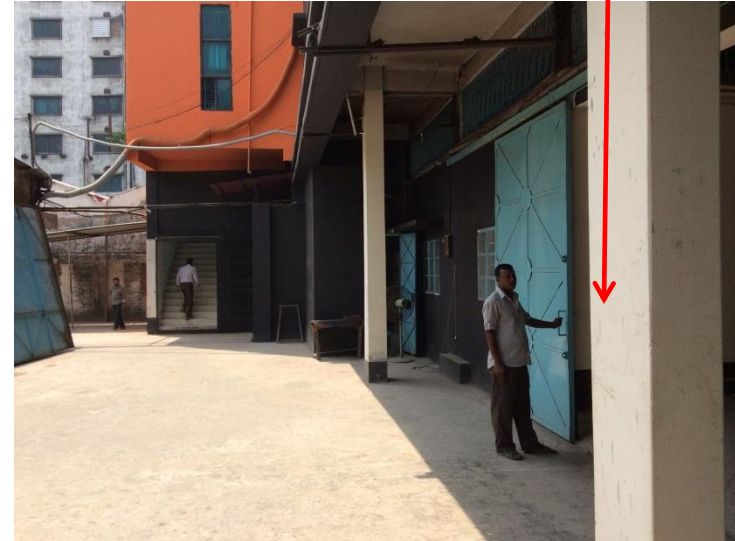
Floor plans from permit, structural and as-built drawings do not fully reflect as-constructed building, as noted
