# Sams Attire Ltd

Bhuiyan Tower, Plot No. 10, Jamgora, Ashulia Road, Savar, Dhaka  
(23.93670N, 90.28447E)

11 March 2014

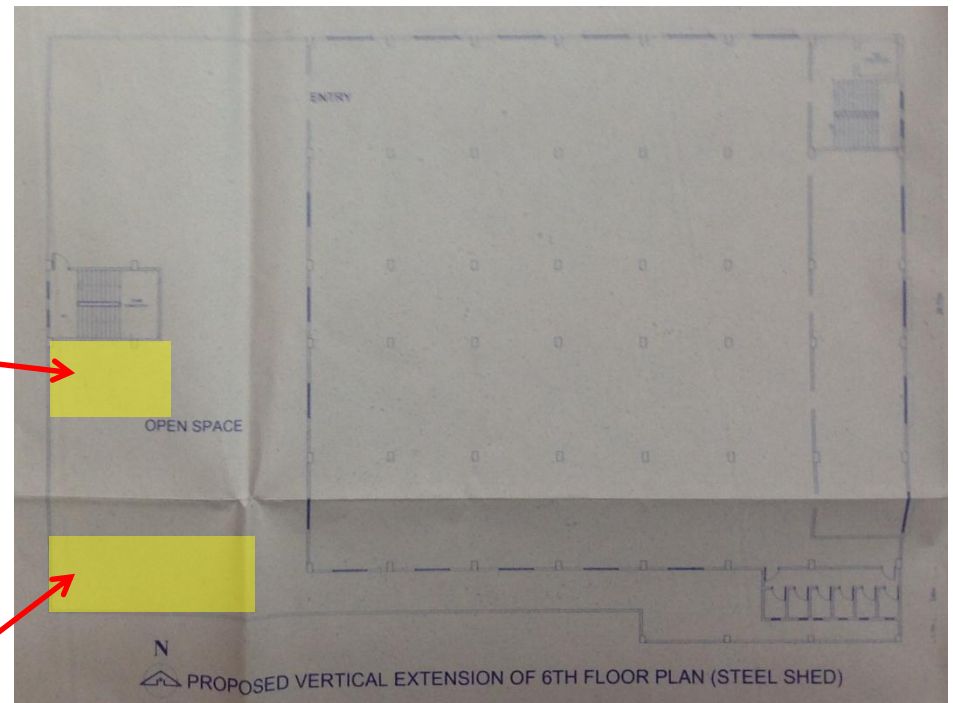
Roof Plan

# **Structural adequacy of concrete roof slab and columns to support antenna house and water tanks**

## High Loading on Roof

Building Engineer to check that concrete roof slab and columns have been designed to accommodate loads from Antenna house and water tanks.

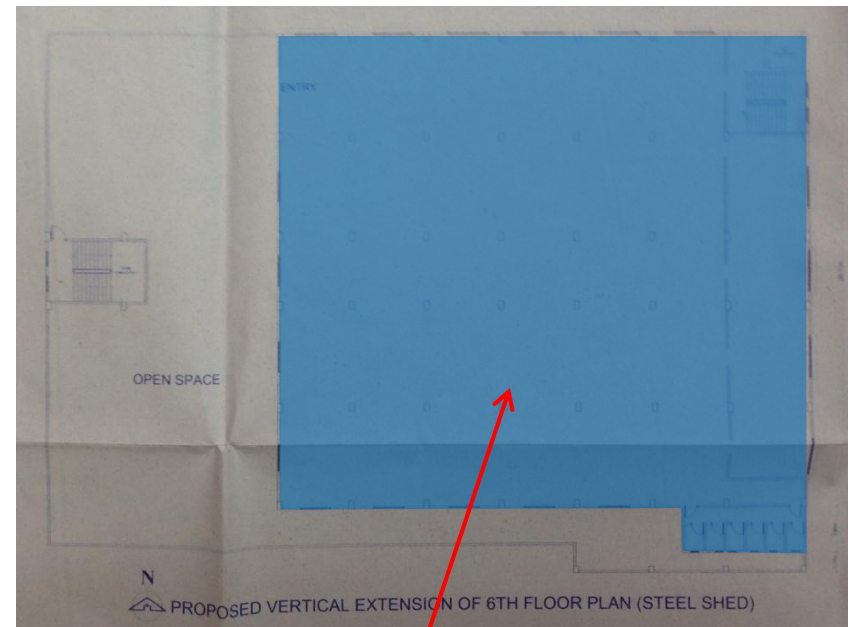
Roof Plan

**Structural drawings not consistent with the  
as-constructed arrangement of the factory**

Building Engineer to survey as-built structure and update drawings including verification of steel structure at roof level

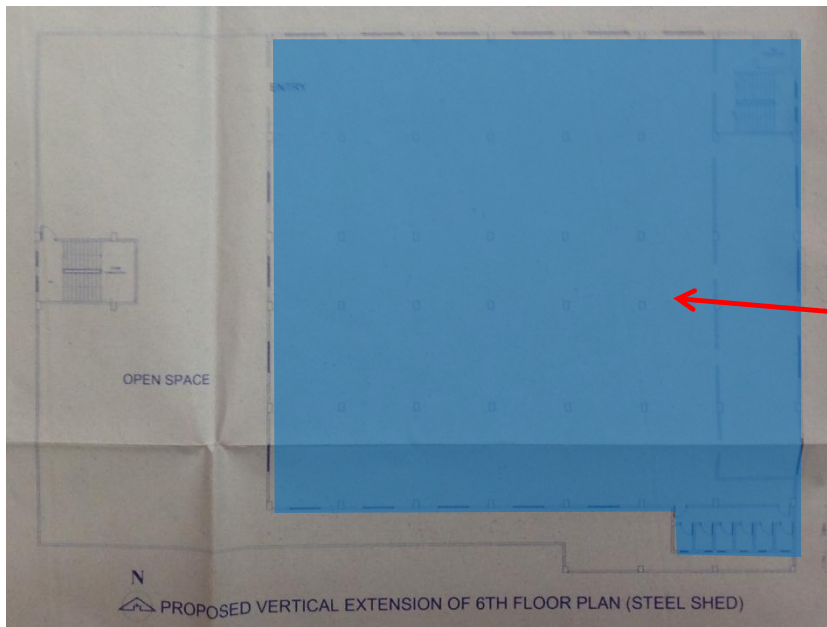
Roof Plan

**Check required to confirm that the steel roof  
rafters over the dining area are adequately  
designed to allow for notch in the steelwork for  
the roof gutter**
