# PN Composite Ltd.

Ambagh, Konabari, Gazipur  
(24.0201 N, 90.32127 E)

13 April 2014

# Observations

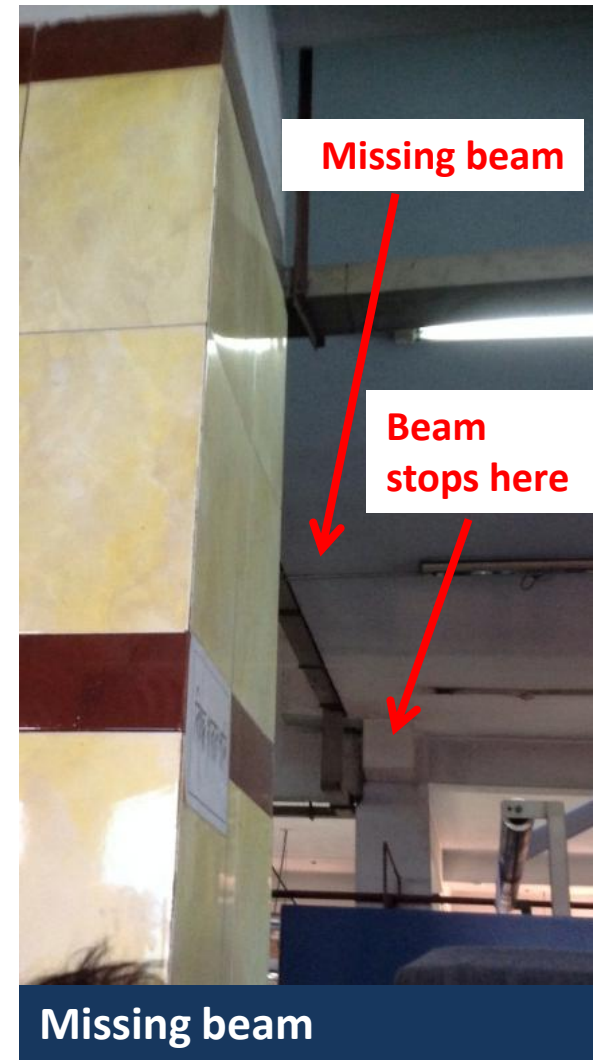
Several observations in the main factory building did not correlate with the information presented in the structural drawings.

A non-exhaustive list of discrepancies includes:

- Structural system (beams vs. flat slab)
- Beam locations
- Column sizes
- Grid dimensions

1. Development of Full Engineering As-Built Drawings showing Structure, loading, elements, dimensions , levels, foundations and framing on Plan, Section and Elevation drawings .
