# Moon Readywears Ltd.

Beron, Diakhali, Asulia, Savar  
(23.937438,90.299281)  
13 April 2014

# Observations

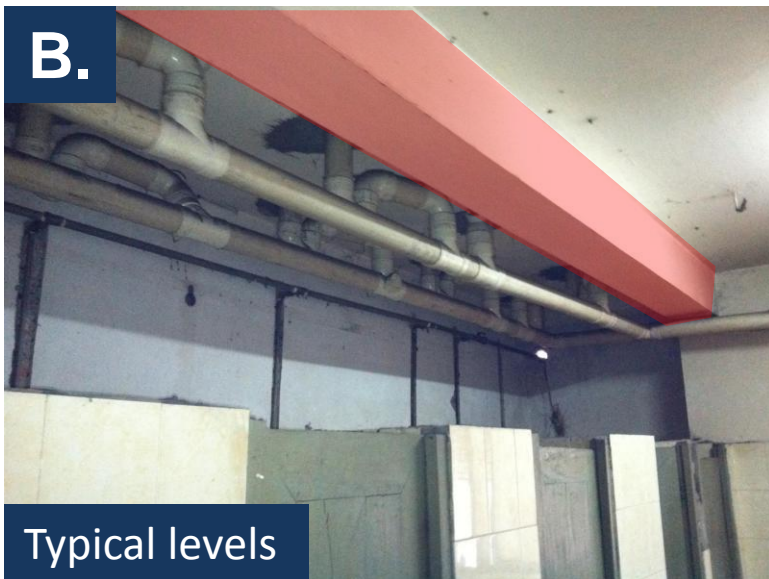
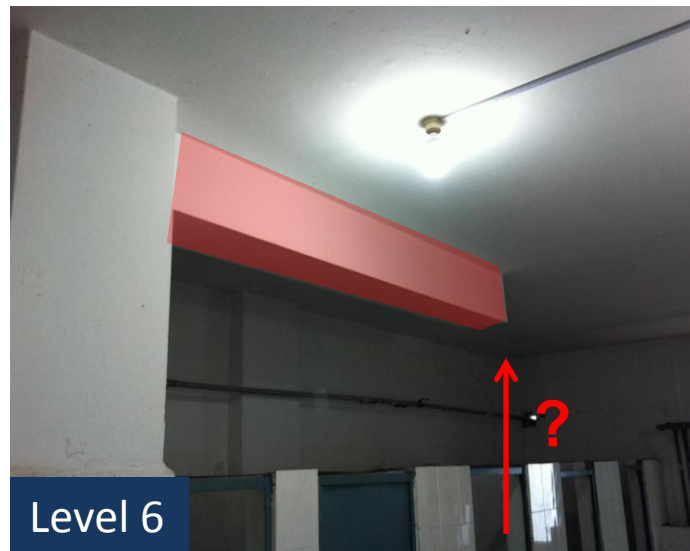
- A. As built edge of lift core and adjacent column do not align as shown on structural drawings. Beam cantilever created.
- B. From review of the level 6 soffit it is clear the beam support arrangement within the men's toilet area does not match other floors. Design load path at level 6 unclear.

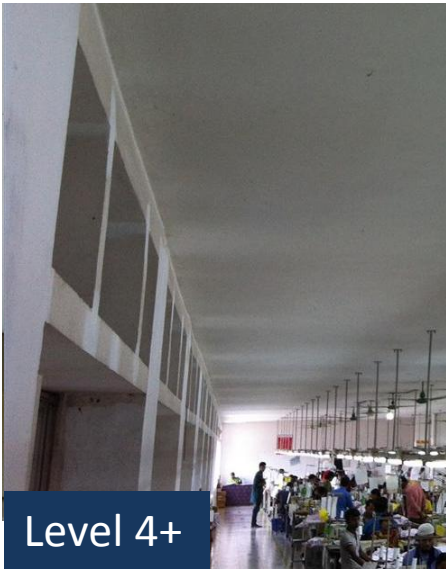
Level 4+

- Structural design documents specify an expansion joint at all floors.
- Expansion joint filled with brick/render finish at level 1 and 2.
- Expansion joint not constructed above level 3.
- Lateral system design may not account for forced compatibility at levels where joint not installed/ improperly installed.

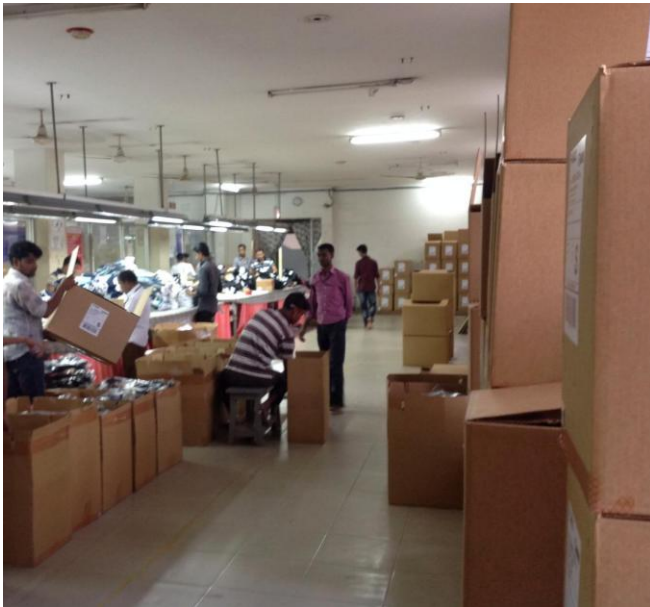
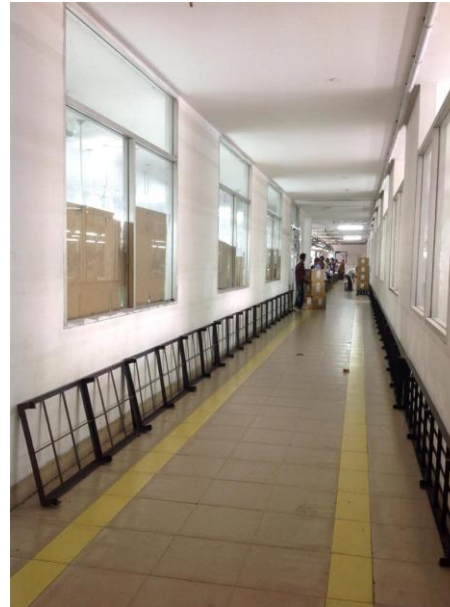
- Floor load management system incomplete as no loading plans observed at the suspended floors.
- Localised areas of storage loading.
- Heavyweight internal brick partitions constructed on suspended floors.
