Shagore Garments Ltd. Optimum Garments Ltd.

Amir Complex, Plot 43, Sector 3, Uttara, Dhaka
(23.867624, 90.399812)
10th March 2014

Observations

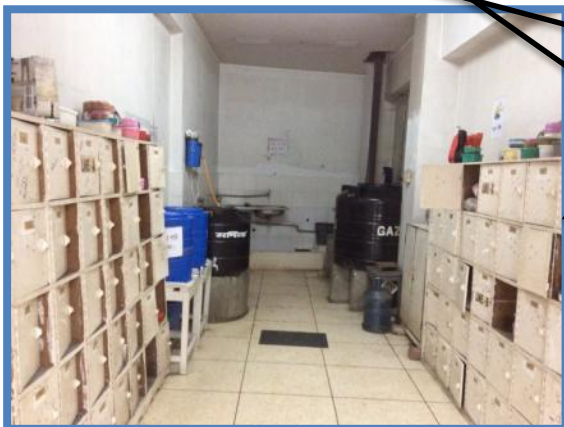
Some kitchen areas with additional tanks on some levels

Floor loading – storage areas

Loading plans (i.e. plan and height restrictions) to be introduced to prevent future overloading – to be developed by building engineer

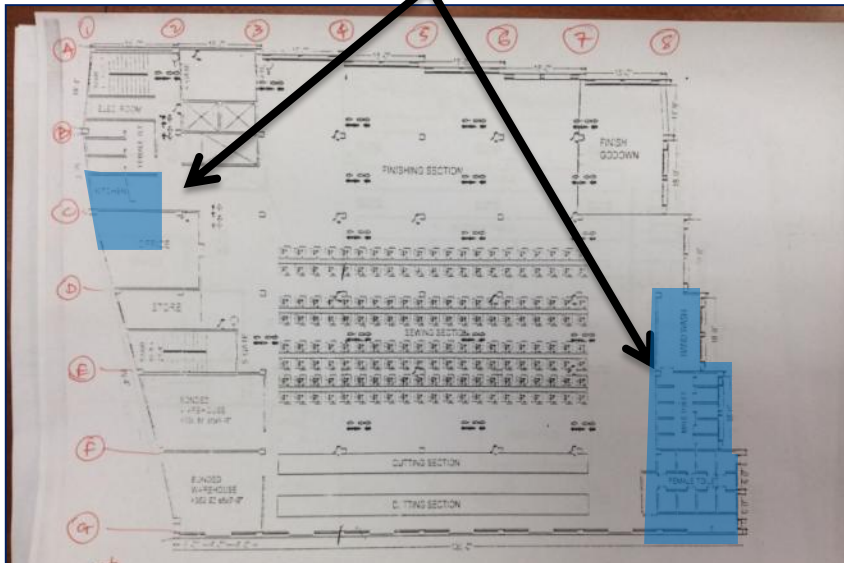
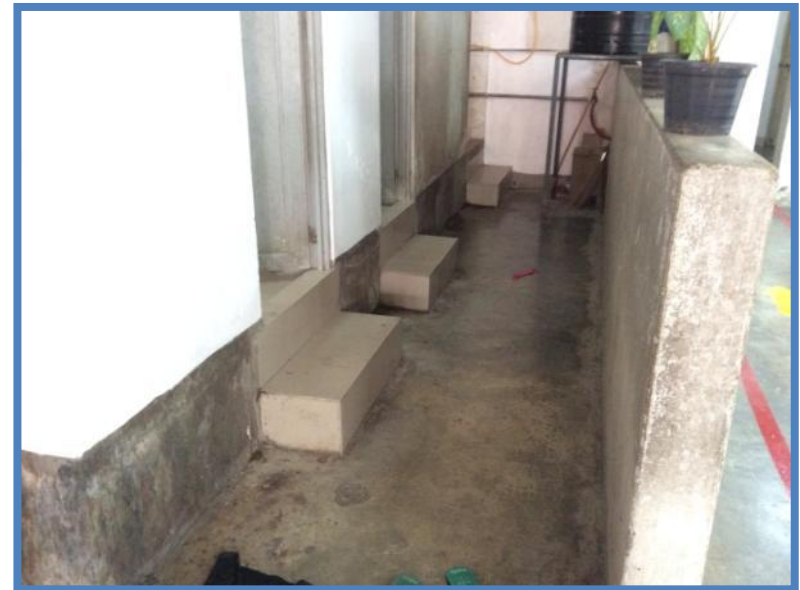
High loads arising from heavy toilet floor build-up, up to 500mm thick

Heavy toilet build-up in these locations on most floors

Item No.	Observation	Recommended Action Plan	Priority
16	Check on Column and Slab stresses due to high loading in toilet areas.	Building's Engineer to ensure the structure is not loaded beyond capacity by the high loading from high build up in toilet areas.	6-weeks
17	Check on Column and Slab stresses due to high loading in toilet areas.	Building Engineer to create controlled loading plans for all floors.	6-weeks
18	Check on Column and Slab stresses due to high loading in toilet areas.	Continue to implement load plan.	6-months
19	Large water tank over stair core in southwest corner of building	Building's Engineer to ensure the structure is not loaded beyond capacity by the high loading from high build up in toilet areas.	6-weeks
20	Large water tank over stair core in southwest corner of building	Building Engineer to create controlled loading plans for all floors.	6-months
21	Structural drawings are not in agreement with the arrangement of the building structure	Building engineer to carry out as built survey of the building, collect and produce accurate complete as-built drawings as part of Detail Engineering Assessment	6-weeks

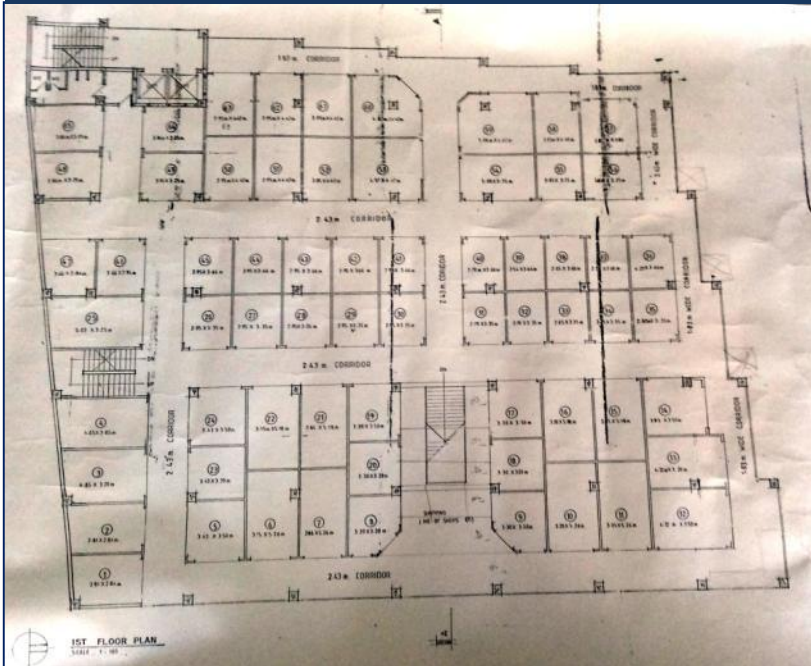
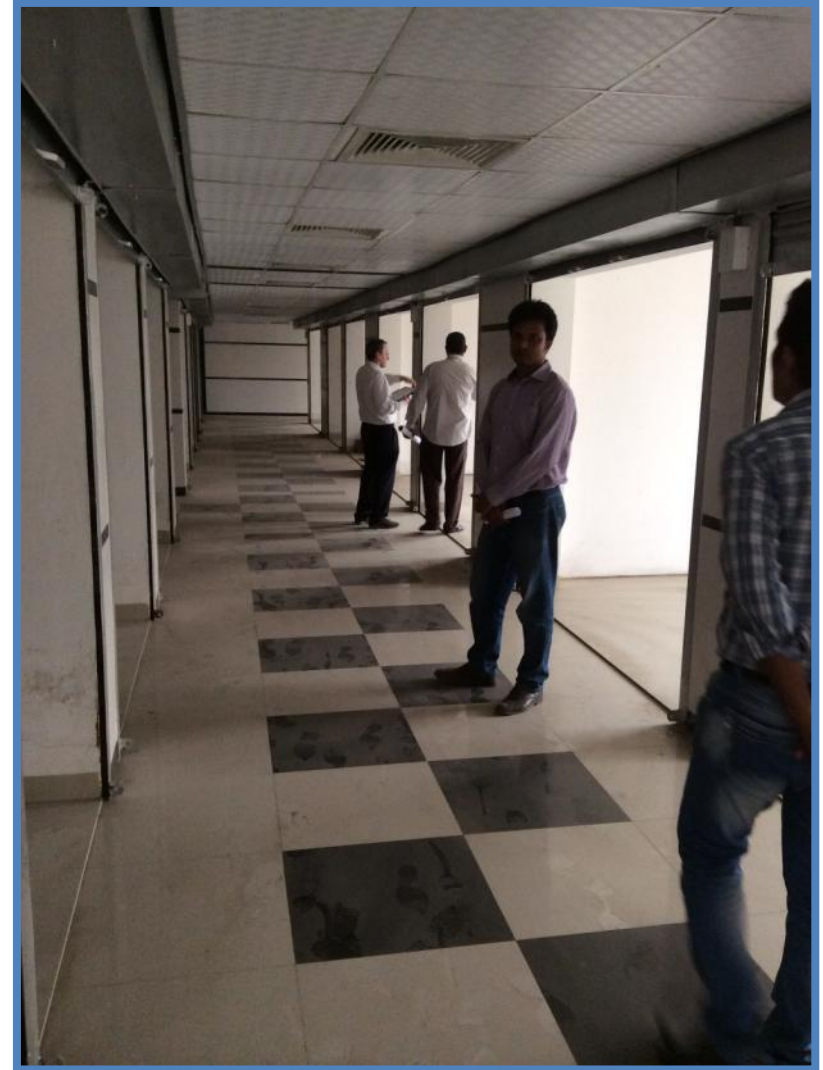
Dense layout of solid masonry partition walls throughout market area, with possibility of high storage loads once all levels fully occupied
