# KNIT Concern Ltd. (9499)

No. 62, Water Works Road, Godnail Narayanganj – 1400, Dhaka Division, Bangladesh  
(+23.641536N, +90.514255E)

07.APRIL.2014

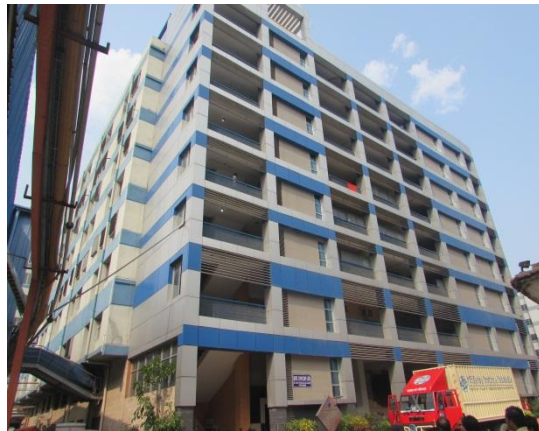
Based on the load rundown analysis with the agreed minimum design live load assignment, the column in the clouded area seems significantly inadequate to carry the dead and live loads, giving a firm AMBER warning. The building was constructed before 2005, with brick aggregate.

**ITEM 1: (1<sup>st</sup> Priority 2) One column mentioned above has been found to possess insufficient loading capacity.**

There is one column has been found to possess insufficient loading capacity.

- Based on the building survey, develop full structural records, and also propose strengthening works or repair works if the as-built structure appears to be insufficient in any way.
